DEVELOPMENT ASSESSMENT REPORT			
Application No.	DAREV/2019/1		
Address	Strata Scheme, 15 King Street, BALMAIN NSW 2041		
Proposal	Review of Determination of D/2018/563 which was refused		
	seeking consent for removal of tree in southern corner of		
	site.		
Date of Receipt	23 January 2019		
Applicant	Verdun Walsh Strata Management		
Owner	The Owners of Strata Plan No 21630		
Number of Submissions	8 submissions (2 objections and 6 letters of support)		
Reason for determination	Confirm original determination by way of refusal		
at Planning Panel			
Main Issues	Landscape Amenity; Tree Removal		
Recommendation	Refusal		
Attachment A	Building Report & Arboricultural Tree Assessment		
Attachment B	Draft conditions of consent (if not refused)		
ROVE RD SEP T

- 1.2 I understand that there is a large tree within the subject property at 15 King Street, Balmain that is causing damage to the common area surrounds. The purpose of this report is to assess the nature and extent of the damage to the property and the contribution of the tree towards the damage.

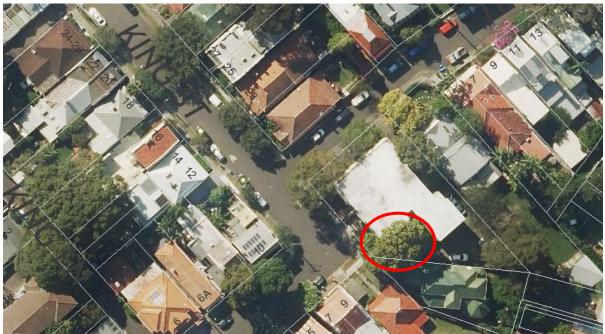
Figure 1: Location of subject tree at 15 King Street.

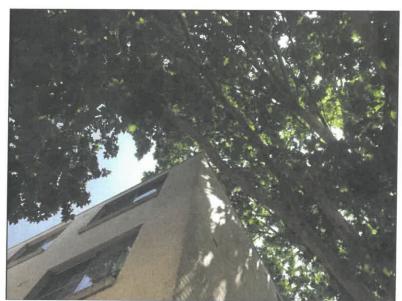
PHOTOGRAPH 3: Showing canopy of offending tree extending over subject property.

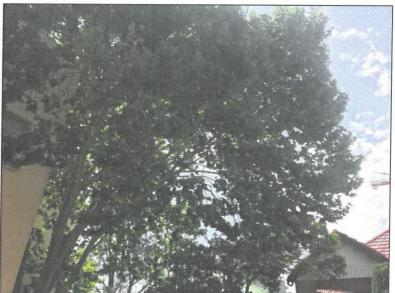
PHOTOGRAPH 4: Showing canopy of offending tree extending over adjacent property at 13 King Street, Balmain.

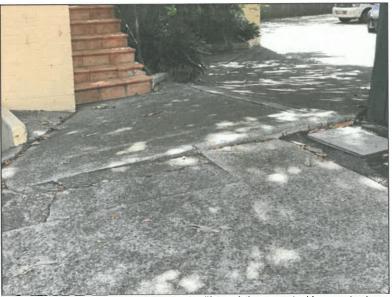
The uplift to the concrete driveway in my opinion has been caused by tree root pressure.

Based on the extent of uplift to the concrete driveway, I am of the view that the uplift would fall into the bracket of Damage Category 3 or 4 in accordance with Table C2 and constitute structural damage.

The current levels of uplift has created unevenness to the concrete driveway which in my view constitutes a trip hazard and a safety issue for the residents and visitors.

PHOTOGRAPH 6: Showing cracking and uplift to existing concrete driveway at entrance to subject property.

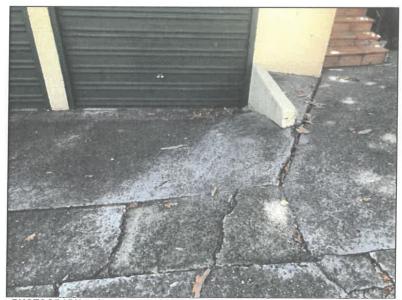
PHOTOGRAPH 7: Showing cracking and uplift to existing concrete driveway adjacent to front entry and southernmost undercroft garage.

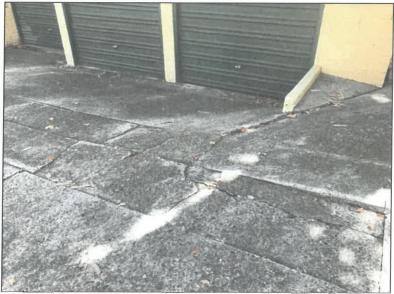
PHOTOGRAPH 8: Showing further view of cracking and uplift to existing concrete driveway adjacent to front entrance and southernmost undercroft garage.

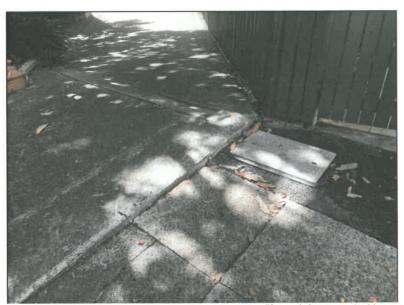
PHOTOGRAPH 9: Showing further view of cracking and uplift to existing concrete driveway at front entrance.

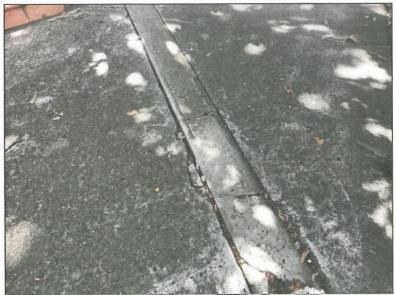
PHOTOGRAPH 10: Showing further view of cracking and uplift to existing concrete driveway at entrance.

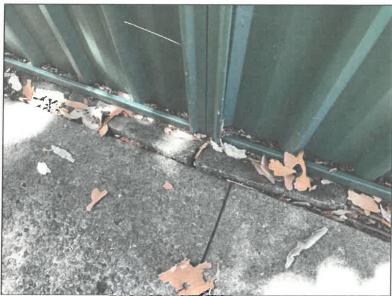
PHOTOGRAPH 11: Showing cracking and uplift of the concrete driveway adjacent to southern Colorbond boundary fence.

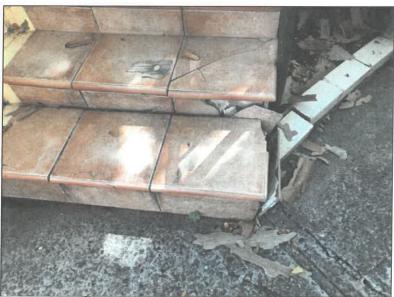
There is significant damage to the concrete staircase. The damage is not limited to the cracking and debonding of the floor and skirting tiles towards the base of the staircase, but rather, the structural fabric of the staircase has been compromised with sections of the concrete cracked and displaced.

PHOTOGRAPH 12: Showing cracked and debonded floor and skirting tiling to southern concrete staircase and damage to low height garden wall.

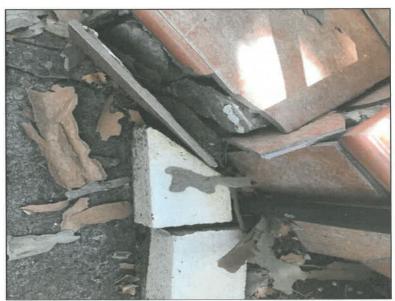
The damage to the staircase in my opinion has been caused by tree root pressure.

Of greater concern is the fact that the concrete staircase, due to uplift from root pressure, is noticeably distorted and leaning towards the external southern brickwork wall. As noted by Bradshaw Tree Services, the tree will continue to mature over time and I believe that further structural deterioration of the staircase is inevitable.

PHOTOGRAPH 13: Showing cracking and displacement to base of concrete staircase.

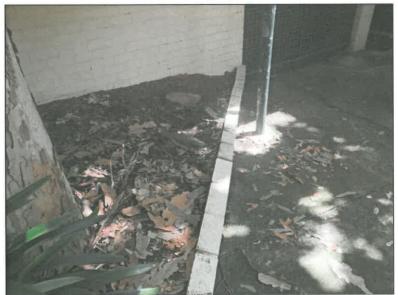
The low height garden walls surrounding the tree have been structurally compromised to the point of failure as a consequence of root damage. I note that the type and construction of the walls has no bearing on their current poor condition.

PHOTOGRAPH 14: Showing lateral displacement to low height garden wall adjacent tree.

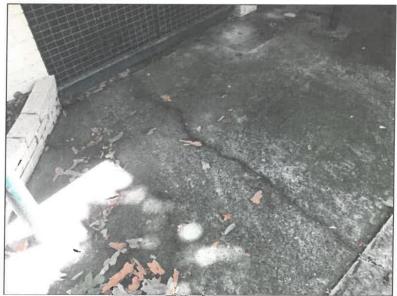
PHOTOGRAPH 15: Showing cracking to concrete driveway adjacent to Unit 14 garage door.

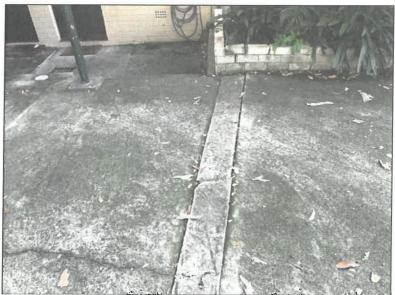
PHOTOGRAPH 16: Showing cracking and uplift to concrete driveway in close proximity to tree.

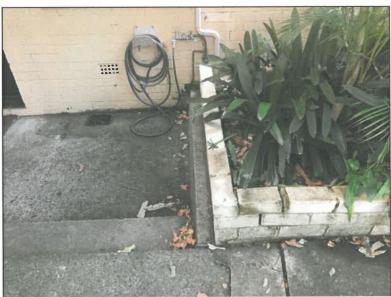
PHOTOGRAPH 17: Showing cracking and lateral displacement to low height garden wall in close proximity to tree.

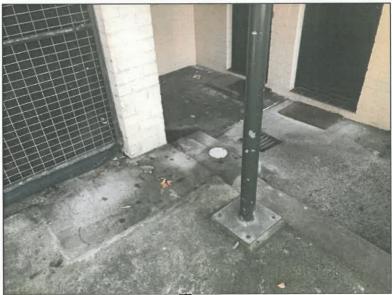
I understand that recent plumbing works adjacent to the eastern laundry have been carried out as a consequence of damage to the sewer line due to root infestation. I note that tree roots are notorious for damage to underground services such as sewer lines. Given the complex root system of the tree, ongoing damage to underground services in the vicinity of the tree is highly likely to continue into the future.

PHOTOGRAPH 18: Showing recent repairs to concrete driveway adjacent Unit 14 garage door to facilitate sewer repairs.

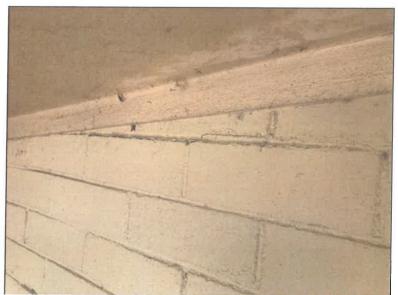
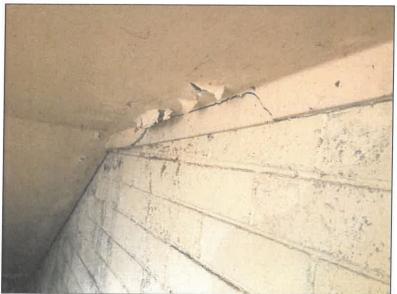
Another issue is the development of cracking to the external southern brickwork wall below the walkway adjacent to the staircase. The cracking whilst no significant at this stage suggests that the external southern brickwork wall is starting to be undermined by root pressure and I am of the view that the damage will escalate over time.

PHOTOGRAPH 19: Showing cracking to external southern brickwork wall beneath concrete walkway.

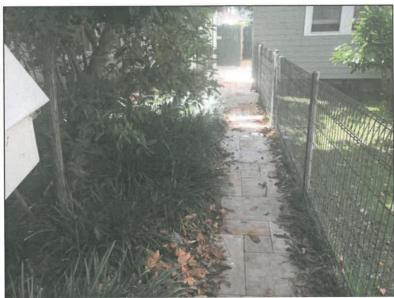
I understand that the neighbouring property at 13 King Street has lodged complaints with the Owners Corporation regarding the overhang of the tree's canopy. I also understand that the neighbouring property recently replaced their pathway due to root damage and has put the Owners Corporation on notice regarding future damage caused to the property by the tree.

PHOTOGRAPH 21: Showing neighbouring property at 13 King Street, Balmain where previous pathway repairs have been carried out.

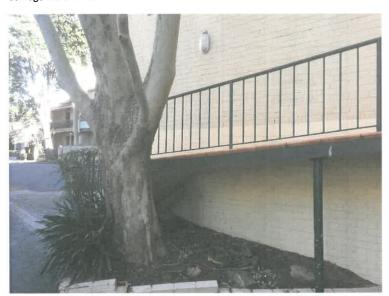
Figure 2 Location of Plane tree

The canopy is not the concern, this tree is causing structural damage to the building and its surroundings. Figure 2 below shows the trees location in proximity to a raised walkway and brick wall of the unit block. The root system from this tree when undertaking secondary growth is unable to lift the brick wall beside it due to the weight from the brick wall. The wall is also part of a garage that is below the ground level of the tree. The wall is acting as a root barrier

The concern is that the wall is approximately 1 metre from the tree, the root system of the tree when undergoing secondary expansion does have the capability to push this wall inwards. This tree is not mature and likely to double in size. The physical expansion of the structural roots is likely to damage the brick wall.
