Hazardous Building Materials Register and Asbestos Management Plan

Ashfield Council

**Pratten Park
Arthur Street
ASHFIELD NSW 2131**

Report Number: 9206.05.HMSR

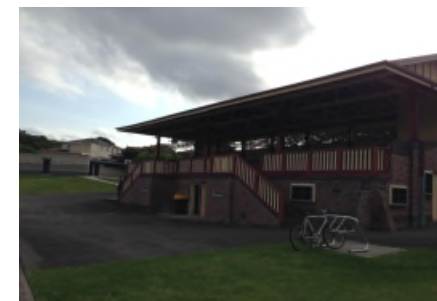
ID	Location	Material Type	Sample No.	Analysis Result	Extent	Condition	Friability	Disturbance Potential	Risk Status	Re-inspect Date	Control Priority	Control Recommendation	Removed	Photos
Exterior														
1	Cream paint Throughout	Paint	9206.05/ LPST02	Negative Lead in Paint <1.0%	-	-	-	-	-	-	-	-	-	Photo 1

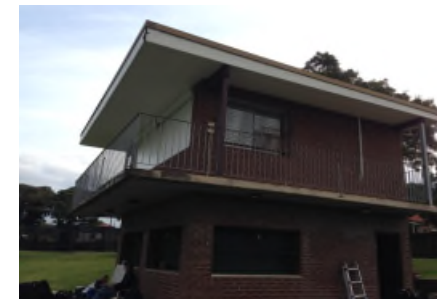
ID	Location	Material Type	Sample No.	Analysis Result	Extent	Condition	Friability	Disturbance Potential	Risk Status	Re-inspect Date	Control Priority	Control Recommendation	Removed	Photos
Exterior														
12	Eaves Throughout	Fibre Cement Sheeting	Previously Sampled by NAA 41310-(300805)-08	Negative No Asbestos Detected	-	-	-	-	-	-	-	-	-	Photo 8

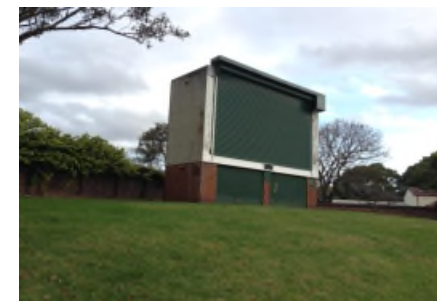
ID	Location	Material Type	Sample No.	Analysis Result	Extent	Condition	Friability	Disturbance Potential	Risk Status	Re-inspect Date	Control Priority	Control Recommendation	Removed	Photos
Exterior														
15	Roller doors Green paint	Paint	9206.05/ LPST12	Negative Lead in Paint <1.0%	-	-	-	-	-	-	-	-	-	Photo 11

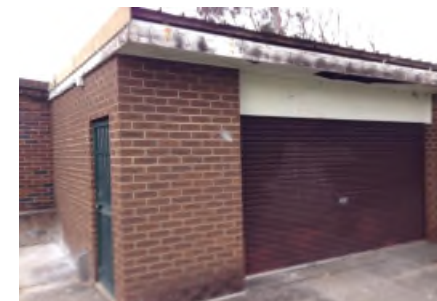
ID	Location	Material Type	Sample No.	Analysis Result	Extent	Condition	Friability	Disturbance Potential	Risk Status	Re-inspect Date	Control Priority	Control Recommendation	Removed	Photos
Exterior														
21	Eaves Throughout	Fibre Cement Sheeting	Previously Sampled by NAA Same as 41310-(300805)-02	Negative No Asbestos Detected	-	-	-	-	-	-	-	-	-	Photo 17
														Fibre Cement Sheeting
22	Entrance gate Green paint	Paint	9206.05/LPST14	Negative Lead in Paint <1.0%	-	-	-	-	-	-	-	-	-	Photo 18
														Green Gate Paint

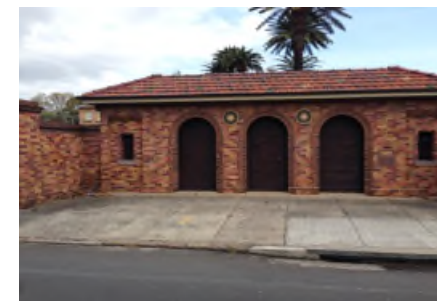
ID	Location	Material Type	Sample No.	Analysis Result	Extent	Condition	Friability	Disturbance Potential	Risk Status	Re-inspect Date	Control Priority	Control Recommendation	Removed	Photos
Exterior														
28	Doors Brown paint	Paint	9206.05/ LPST01	Negative Lead in Paint <1.0%	-	-	-	-	-	-	-	-	-	Photo 24

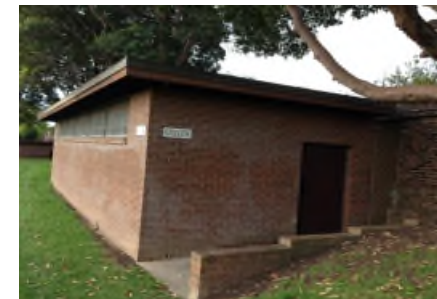
ID	Location	Material Type	Sample No.	Analysis Result	Extent	Condition	Friability	Disturbance Potential	Risk Status	Re-inspect Date	Control Priority	Control Recommendation	Removed	Photos
Interior														
33	Doors and beams Throughout - Brown paint	Paint	9206.05/ LPST05	Negative Lead in Paint <1.0%	-	-	-	-	-	-	-	-	-	Photo 29
														Brown Door Paint
34	Toilet partitions -	Fibre Cement Sheeting	9206.05/ AS03	Negative No Asbestos Detected	-	-	-	-	-	-	-	-	-	Photo 30
														Fibre Cement Sheetting

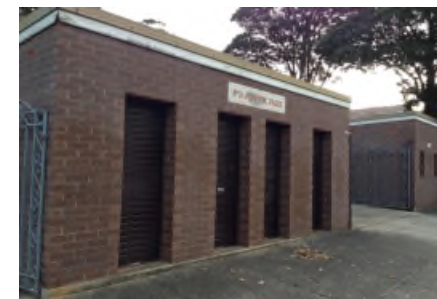
ID	Location	Material Type	Sample No.	Analysis Result	Extent	Condition	Friability	Disturbance Potential	Risk Status	Re-inspect Date	Control Priority	Control Recommendation	Removed	Photos
Interior/Exterior														
36	Ceilings and awnings of booths Throughout	Asbestos Cement Sheeting	Previously Sampled by NAA 41310-(300805)-01	Positive <i>Asbestos Detected</i>	~20m ²	Good	Non-Friable	Low	Low	Sep 2018

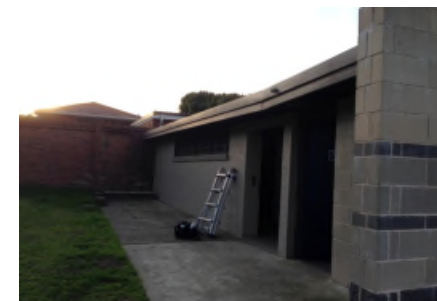
ID	Location	Material Type	Sample No.	Analysis Result	Extent	Condition	Friability	Disturbance Potential	Risk Status	Re-inspect Date	Control Priority	Control Recommendation	Removed	Photos
Exterior														
40	Beams and eaves Dark grey paint	Paint	9206.05/ LPST18	Negative Lead in Paint <1.0%	-	-	-	-	-	-	-	-	-	Photo 35
														Grey Eaves Paint
41	Entrance to Northern toilets Ceiling panel above	Fibre Cement Sheeting	9206.05/ AS04	Negative No Asbestos Detected	-	-	-	-	-	-	-	-	-	Photo 36
														Fibre Cement Sheetting
