Hazardous Building Materials Register and Asbestos Management Plan

Ashfield Council

**Ashfield Civic Centre
260 Liverpool Road
ASHFIELD NSW 2131**

Report Number: 9206.10.HMSR

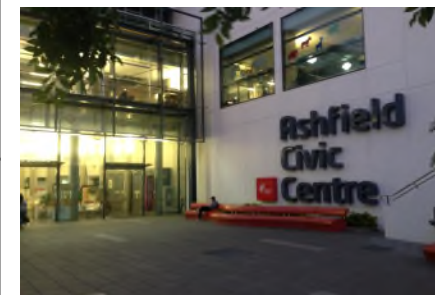
ID	Location	Material Type	Sample No.	Analysis Result	Extent	Condition	Friability	Disturbance Potential	Risk Status	Re-inspect Date	Control Priority	Control Recommendation	Removed	Photos
Exterior														
1	Level 5 balcony Eaves boards and wall panels above windows	Asbestos Cement Sheeting	-	Assumed Positive <i>Assumed to Contain Asbestos (Visually Assessed)</i>	~200m ²	Good	Non-Friable	Low	Low	Sep 2018

P3	Label and maintain in good condition, and do not disturb (e.g. do not drill, cut grind or sand). Remove by a licensed Class A or Class B asbestos removalist as soon as practicable and prior to any refurbishment or demolition works.	Date: _____ Removed by: _____ Report: _____	Photo 1
