# Hazardous Building Materials Register and Asbestos Management Plan

**Yeo Park  
Victoria Street  
ASHFIELD NSW 2131**

**Report Date: 12 November 2015**

**Report Number: 9206.03.HMSR**

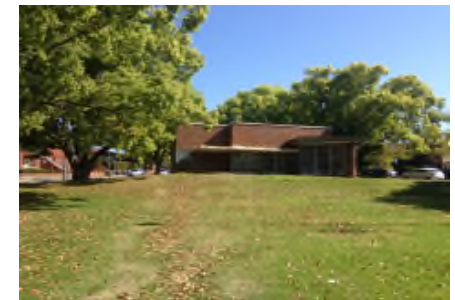
ID	Location	Material Type	Sample No.	Analysis Result	Extent	Condition	Friability	Disturbance Potential	Risk Status	Re-inspect Date	Control Priority	Control Recommendation	Removed	Photos
<b>Exterior</b>														
1	<b>Metal window frames</b>  Throughout - White paint (No access through metal fencing)	Paint	-	<b>Positive</b>  <i>Assumed Lead in Paint &gt;1.0%</i>	~30m <sup>2</sup>	Unsealed, Poor Condition	-	High	Medium	Sep 2016

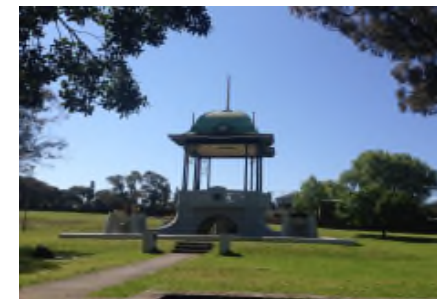
ID	Location	Material Type	Sample No.	Analysis Result	Extent	Condition	Friability	Disturbance Potential	Risk Status	Re-inspect Date	Control Priority	Control Recommendation	Removed	Photos
Rotunda														
12	Ceiling Panels (inaccessible due to height)	Asbestos Cement Sheeting	-	Assumed Positive  Assumed to Contain Asbestos (Visually Assessed)	~10m <sup>2</sup>	Good	Non-Friable	Low	Low	Sep 2018	P3	Label and maintain in good condition, and do not disturb (e.g. do not drill, cut grind or sand). Remove by a licensed Class A or Class B asbestos removalist as soon as practicable and prior to any refurbishment or demolition works.	Date: ____/____/____ Removed by: ____ Report: ____	Photo 12 
														Asbestos Cement Sheeting
13	Ceiling panels and upper decorative metal features  Cream paint (inaccessible due to height)	Paint	-	Positive  Assumed Lead in Paint >1.0%	~24m <sup>2</sup>	Unsealed, Good Condition	-	Low	Low	Sep 2018	P3	Lead in paint level is presumed >1.0%. Confirm percentage lead content by lab analysis. Manage in accordance with AS 4361.2 1998 Guide to Lead Paint Management Part 2: Residential and Commercial Buildings.	Date: ____/____/____ Removed by: ____ Report: ____	Photo 13
