# Hazardous Building Materials Assessment Leichhardt Depot Mechanical Workshop 229 Catherine Street Leichhardt NSW 2040

Inner West Council  
March 2018

Job No: 57722-038

Count ID: 197

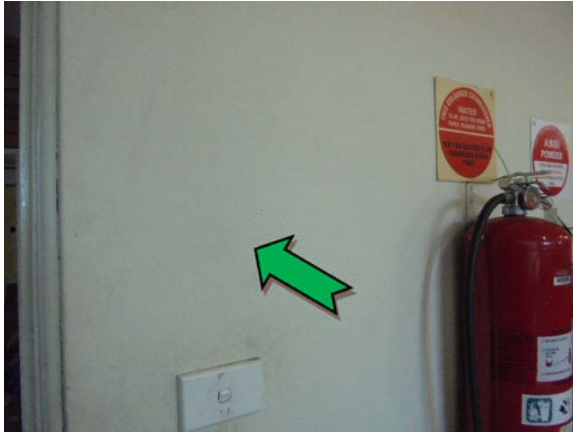
| Client: Inner West Council | | | Site Name: CID: 197 - Leichhardt Depot Mechanical Workshop | | | | Site Address: 229 Catherine Street | | | | Client No.: S0149 | | | Job No.: 57722-038 | | |
|---|---|---|---|---|---|---|---|---|---|---|---|---|---|---|---|---|
| Interior | Office & store room 1 | Walls | Fibre cement sheeting | Asbestos | 57722-038-001 | Negative | - | - | - | - | - | - | - | - | - | 1 |

**Photo 1.** Interior, ground level, office and store room 1, walls – non asbestos-containing fibre cement sheeting.

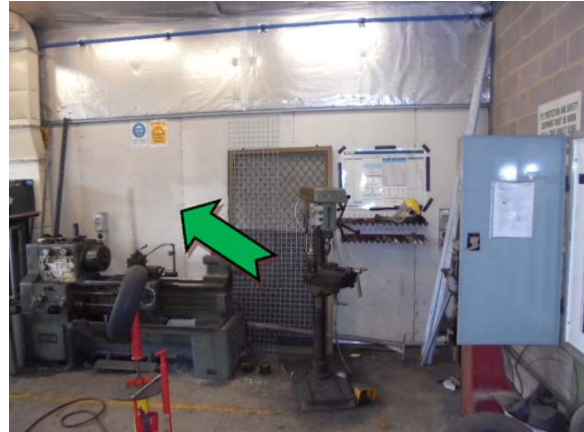
| Client: Inner West Council | | | Site Name: CID: 197 - Leichhardt Depot Mechanical Workshop | | | | Site Address: 229 Catherine Street | | | | Client No.: S0149 | | | Job No.: 57722-038 | | |
|---|---|---|---|---|---|---|---|---|---|---|---|---|---|---|---|---|
| Interior | Workshop | Walls | Fibre cement sheeting | Asbestos | 57722-038-002 | Negative | - | - | - | - | - | - | - | - | - | 2 |

**Photo 2.** Interior, ground level, workshop, walls – non asbestos-containing fibre cement sheeting.

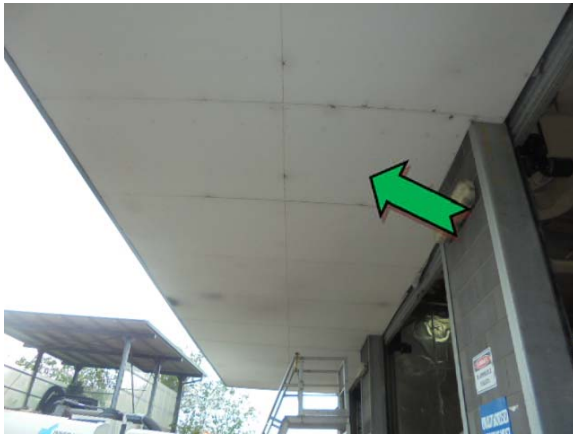
| Client: Inner West Council | | | Site Name: CID: 197 - Leichhardt Depot Mechanical Workshop | | | | Site Address: 229 Catherine Street | | | | Client No.: S0149 | | | Job No.: 57722-038 | | |
|---|---|---|---|---|---|---|---|---|---|---|---|---|---|---|---|---|
| Exterior | Front entrance | Awning | Fibre cement sheeting | Asbestos | 57722-038-003 | Negative | - | - | - | - | - | - | - | - | - | 3 |

**Photo 3.** Exterior, north elevation, awning – non asbestos-containing fibre cement sheeting.

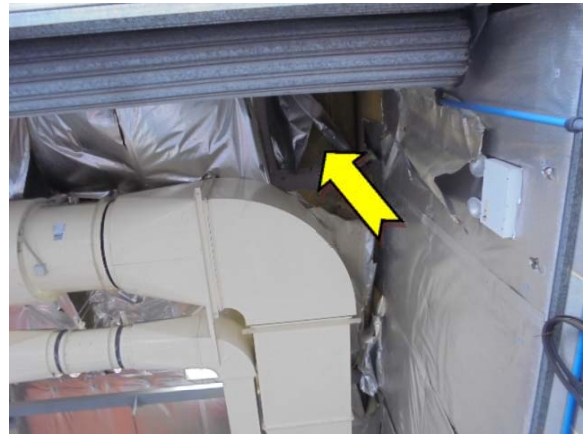
| Client: Inner West Council | | | Site Name: CID: 197 - Leichhardt Depot Mechanical Workshop | | | | Site Address: 229 Catherine Street | | | | Client No.: S0149 | | | Job No.: 57722-038 | | |
|---|---|---|---|---|---|---|---|---|---|---|---|---|---|---|---|---|
| Interior | Throughout | Ceiling, above SMF insulation | Fibre cement sheet | Asbestos | Not sampled: Height restrictions | Suspected Positive | Non-friable | Medium | Fair | Medium | 400 m <sup>2</sup> | Confirm status and maintain in current condition if to remain in-situ. Remove under controlled non-friable asbestos removal conditions prior to refurbishment or demolition works by a Class B (non-friable) licensed asbestos removal contractor. | | P4 | Mar-22 | 4 |

**Photo 4.** Interior, ground level, throughout, ceiling above SMF – suspected asbestos-containing fibre cement sheeting.

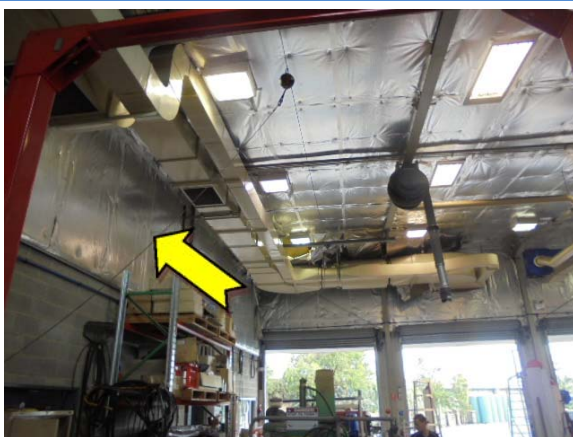
| Client: Inner West Council | | | Site Name: CID: 197 - Leichhardt Depot Mechanical Workshop | | | | Site Address: 229 Catherine Street | | | | Client No.: S0149 | | | Job No.: 57722-038 | | |
|---|---|---|---|---|---|---|---|---|---|---|---|---|---|---|---|---|
| Interior | Throughout | High level walls & ceiling | Sarking insulation | SMF | - | Suspected Positive | - | - | - | - | 400 m <sup>2</sup> | Maintain in current condition if to remain in-situ. Remove under controlled SMF conditions as per the Code of Practice for the Safe Use of Synthetic Mineral Fibres [NOHSC: 2006 (1990)]. | | - | - | 5 |

**Photo 5.** Interior, ground level, throughout ceiling and high level wall – suspected SMF sarking insulation.

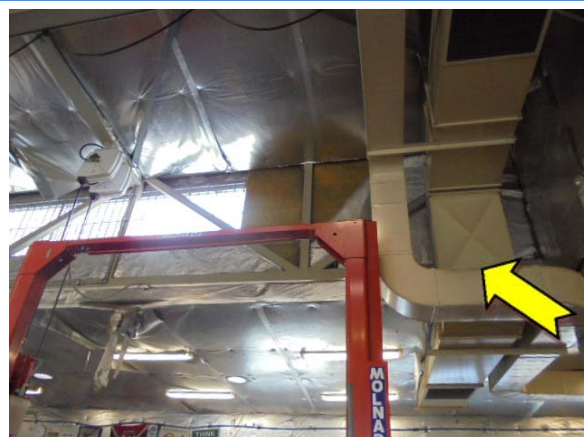
| Client: Inner West Council | | | Site Name: CID: 197 - Leichhardt Depot Mechanical Workshop | | | | Site Address: 229 Catherine Street | | | | Client No.: S0149 | | | Job No.: 57722-038 | | |
|---|---|---|---|---|---|---|---|---|---|---|---|---|---|---|---|---|
| Interior | Workshop | Duct | Insulation material - internal | SMF | - | Suspected Positive | - | - | - | - | 100 m <sup>2</sup> | Maintain in current condition if to remain in-situ. Remove under controlled SMF conditions as per the Code of Practice for the Safe Use of Synthetic Mineral Fibres [NOHSC: 2006 (1990)]. | | - | - | 6 |

**Photo 6.** Interior, ground level, workshop, ductwork – suspected SMF internal insulation.

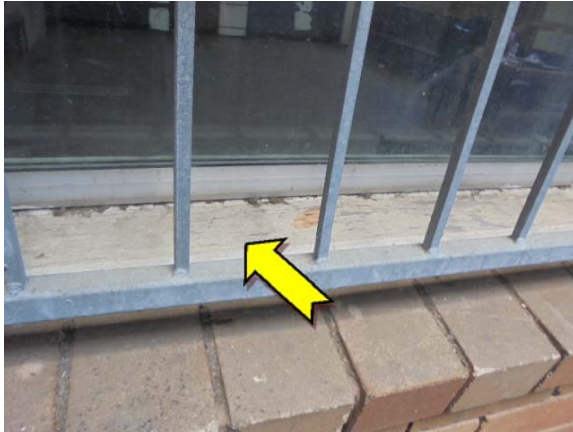
| Client: Inner West Council | | | Site Name: CID: 197 - Leichhardt Depot Mechanical Workshop | | | | Site Address: 229 Catherine Street | | | | Client No.: S0149 | | | Job No.: 57722-038 | | |
|---|---|---|---|---|---|---|---|---|---|---|---|---|---|---|---|---|
| Exterior | Throughout | Window frames | Cream - upper coloured paint system | Lead Paint - Swab | - | Suspected Positive | - | Low | Fair | Low | 25 m <sup>2</sup> | Confirm status by quantitative test method, maintain in current condition, over paint with a lead-free paint as part of ongoing maintenance. Remove under controlled conditions in accordance with AS 4361.2:2017 Guide to hazardous paint management prior to renovation or demolition works. | | - | - | 7 |

**Photo 7.** Exterior, throughout, window frames – suspected lead-containing cream upper paint system.

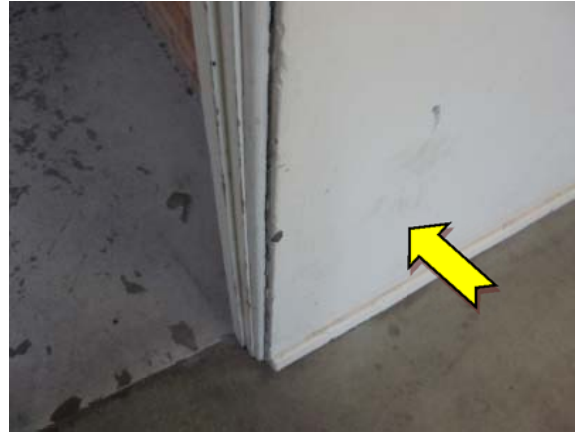
| Client: Inner West Council | | | Site Name: CID: 197 - Leichhardt Depot Mechanical Workshop | | | | Site Address: 229 Catherine Street | | | | Client No.: S0149 | | | Job No.: 57722-038 | | |
|---|---|---|---|---|---|---|---|---|---|---|---|---|---|---|---|---|
| Interior | Throughout | Walls - internal | White - upper coloured paint system | Lead Paint - Swab | - | Suspected Positive | - | Low | Fair | Low | 100 m <sup>2</sup> | Confirm status by quantitative test method, maintain in current condition, over paint with a lead-free paint as part of ongoing maintenance. Remove under controlled conditions in accordance with AS 4361.2:2017 Guide to hazardous paint management prior to renovation or demolition works. | | - | - | 8 |

**Photo 8.** Interior, throughout, walls – suspected lead-containing white upper paint system.
