Hazardous Building Materials Assessment

Leichhardt Depot Office

229 Catherine Street
Leichhardt NSW 2040

Inner West Council
March 2018

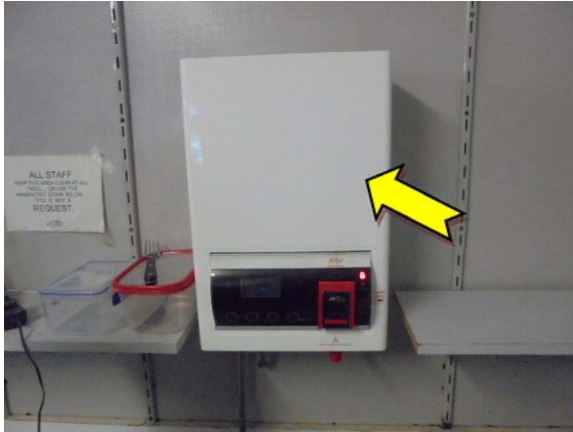
Photo Interior, ground level, kitchen, hot water heater – suspected SMF internal insulation.
1.

- Suspected SMF in the form of internal insulation within hot water heater in kitchen area.

- SMF materials that are likely to be disturbed during any proposed demolition/refurbishment works should be handled in accordance with the *Code of Practice for the Safe Use of Synthetic Mineral Fibres* [NOHSC:2006(1990)]. If these materials are impacted upon by accident or by pre-planned works, the Inner West Council must be informed via the contact detailed within Section 7: *Accidental Disturbance of Known or Suspected Hazardous Building Materials*. Following disturbance, inspection by a competent person should be undertaken.
