# Hazardous Building Materials Assessment Camdenville Park Amenities May & Council Street St Peters NSW 2044

Inner West Council  
March 2018

Job No.: 57722-014

Count ID: CID: 85

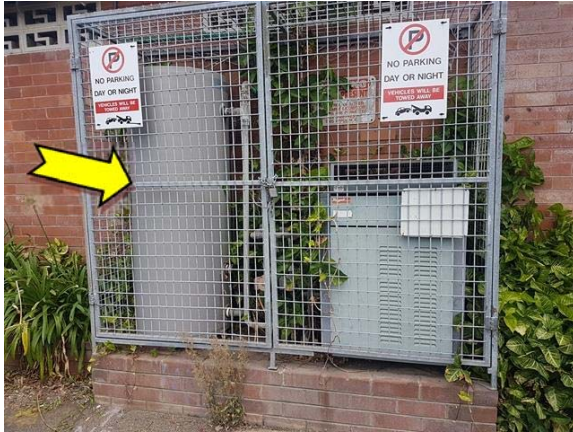
**Photo 1.** Exterior, north-east elevation, hot water heater – suspected SMF internal insulation.

- SMF internal insulation was suspected within the hot water heaters to the north-east exterior of the building.

- SMF materials that are likely to be disturbed during any proposed demolition/refurbishment works should be handled in accordance with the *Code of Practice for the Safe Use of Synthetic Mineral Fibres* [NOHSC:2006(1990)]. If these materials are impacted upon by accident or by pre-planned works, the Inner West Council must be informed via the contact detailed within Section 7: *Accidental Disturbance of Known or Suspected Hazardous Building Materials*. Following disturbance, inspection by a competent person should be undertaken.

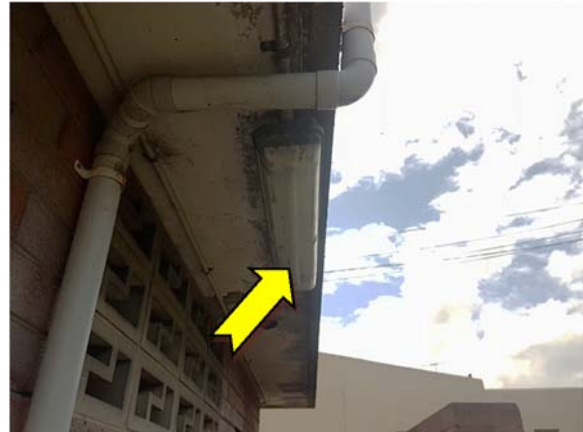
**Photo 2.** Exterior, throughout, double tube fluorescent light fitting – suspected PCB-containing capacitor.

- PCBs were suspected within the capacitors of the double tubed fluorescent light fittings located throughout the building.

- Electrical fittings suspected of containing PCB oil capacitors should be treated as containing PCB oils until such time as evidence suggest otherwise e.g. further assessed.
- Electrical fittings that contain or suspected to contain PCB oil-containing capacitors should be removed as hazardous/regulated waste under controlled working conditions prior to the demolition or refurbishment works in accordance with the *Polychlorinated Biphenyls Management Plan, Revised Edition April 2003*.

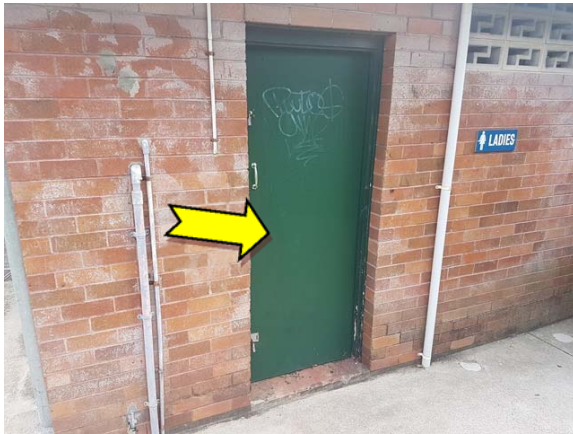
**Photo 3.** Exterior, throughout, doors and door frames – suspected lead-containing upper green paint system.

- LCP was suspected in the form of green upper paints to the doors and door frames throughout the building.

- The *LeadCheck* paint swab method can detect lead in paint at concentrations of 0.5% and above, and may indicate lead in some paint films as low as 0.2%. As paint with a lead content greater than 0.1% by dry weight is now considered to be lead-containing, Prensa recommends confirming status of suspected LCP identified during the assessment by quantitative test method.

- The safest method of dealing with LCP is to replace or remove the items in their entirety that have LCP on them and replace them with new items that do not contain lead. This allows the items to be disposed of as regular building or demolition unsegregated waste in accordance with the NSW Environment Protection Authority (EPA) *Waste Classification Guidelines 2014 Part 1 – Classifying Waste*. The advantage of this method is the reduction in labour requirements to remove the lead paint and also this reduces the risk to workers from exposure to lead dust or fumes. If the removal of the LCP or coatings is the preferred or required option this may generate significant amounts of potential hazardous waste. This waste must be removed, collected and disposed of by an appropriately licensed contractor under controlled conditions that minimises the release to air,
