Hazardous Building Materials Assessment Summer Hill Car Park Toilets Hardie Avenue Summer Hill NSW 2130

Inner West Council
March 2018

Job No.: 57722-012

Count ID: CID: 114

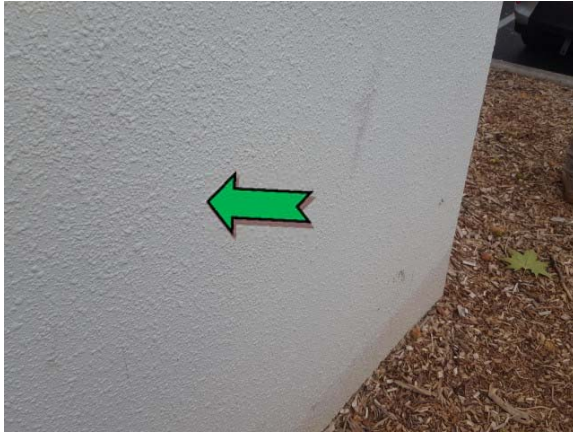
Photo 1. Exterior, throughout, walls – non asbestos-containing textured coating.

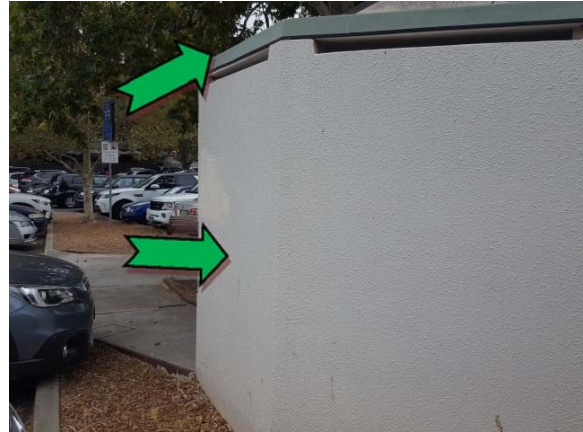
Photo 2. Exterior, throughout, walls and roof – suspected non lead-containing cream & green upper coloured paint systems.

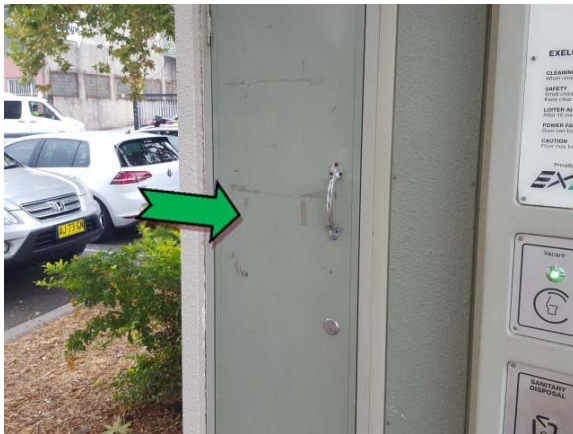
Exterior	Throughout	Door	Green - upper coloured paint system	Lead Paint - Swab	-	Suspected Negative	-	-	-	-	-	Data supplied by IWC shows building to have been constructed post 1997. Paint coatings suspected to be non lead containing (<0.1%W/W) as per Section 1.5 of AS 4361.2:2017 Guide to hazardous paint management.	-	-	3
Interior	Throughout	Ceiling	White - upper coloured paint system	Lead Paint - Swab	-	Suspected Negative	-	-	-	-	-	Data supplied by IWC shows building to have been constructed post 1997. Paint coatings suspected to be non lead containing (<0.1%W/W) as per Section 1.5 of AS 4361.2:2017 Guide to hazardous paint management.	-	-	4
Throughout	-	-	-	Ozone Depleting Substances	-	-	-	-	-	-	-	No suspect ODS's identified at the time of the assessment.	-	-	-

Photo 3. Exterior, throughout, doors – suspected non lead-containing green upper paint system.

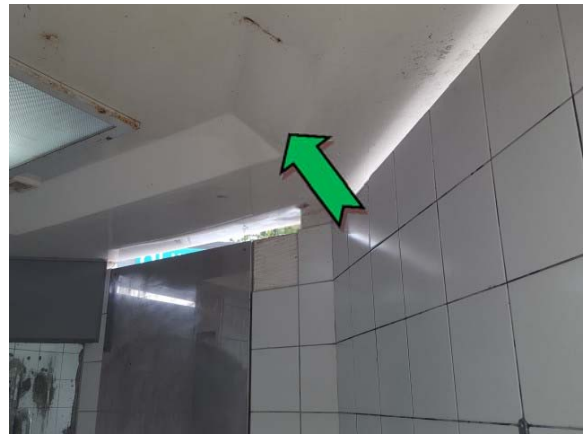
Photo 4. Interior, throughout, ceiling – suspected non lead-containing white upper paint system.
