Hazardous Building Materials Assessment

Balmain Occasional Care

370 Darling Street,
Balmain NSW 2041

Inner West Council
April 2018

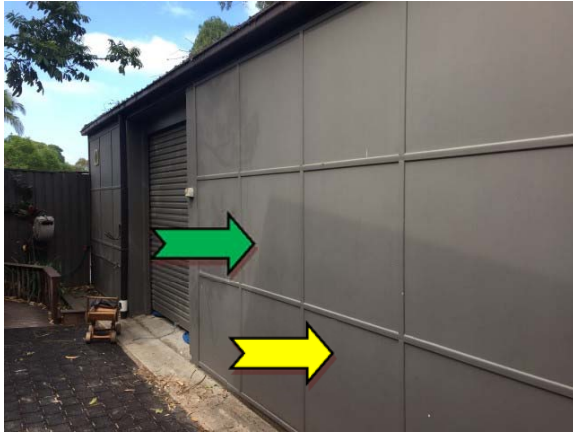
Photo 1. Exterior, east elevation, wall – non asbestos-containing fibre cement sheeting and suspected lead-containing grey upper paint systems.

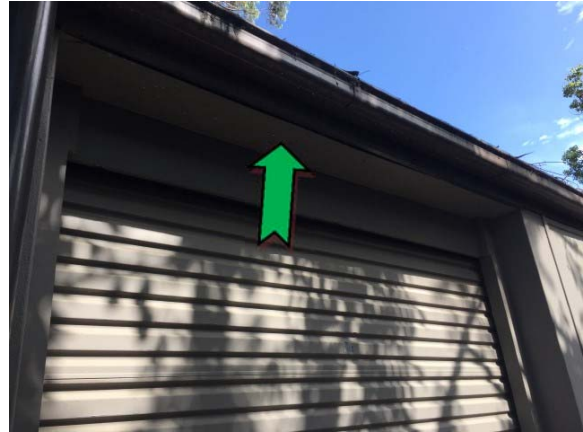
Photo 2. Exterior, eaves to shed – assumed non asbestos-containing fibre cement sheeting.

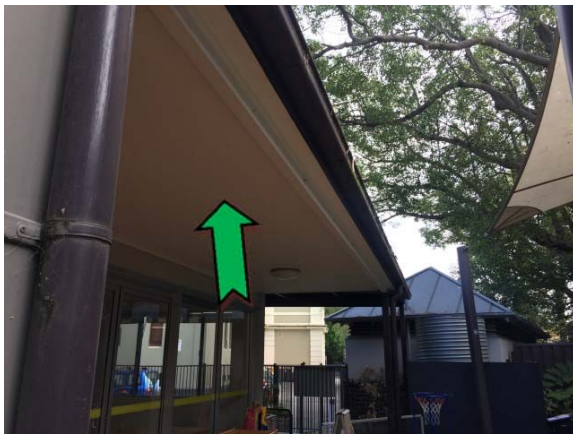
Photo 3. Exterior, awning – assumed non asbestos-containing fibre cement sheeting.

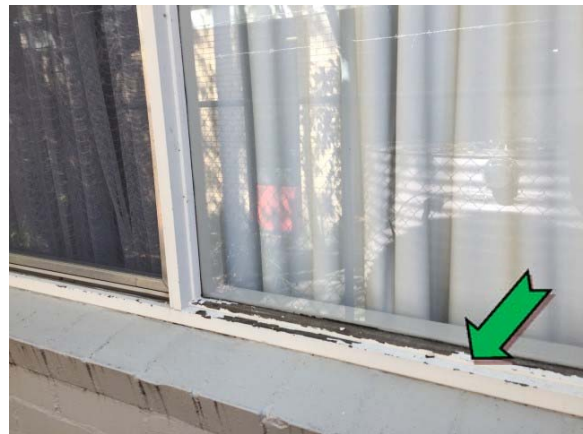
Photo 4. Exterior, southern elevation, window frames – non asbestos-containing window caulking.

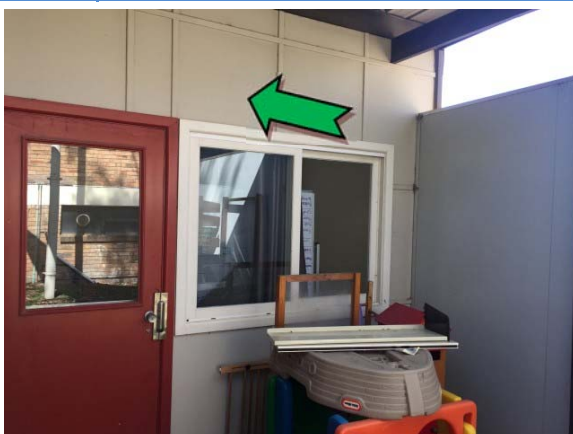
Photo 5. Exterior, southern elevation, wall – assumed non asbestos-containing fibre cement sheeting.

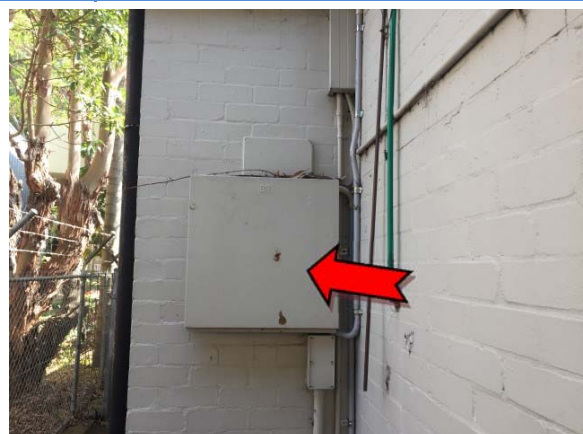
| Area / Level | Room & Location | Feature | Item Description | Hazard Type | Sample No. | Sample Status | Friability | Disturb. Potential | Condition | Risk Status | Approx. Quantity | Recommendations & Comments | Control Priority | Reinspect Date | Photo No. |
|---|---|---|---|---|---|---|---|---|---|---|---|--|---|---|---|
| Exterior | South-west corner | Electrical backing board | Bituminous backing board | Asbestos | Not sampled: electrical hazard | Suspected Positive | Non-friable | Low | Good | Low | 1 unit | Confirm status, label as containing asbestos and maintain in current condition if to remain in-situ. Remove under controlled non-friable asbestos removal conditions prior to refurbishment or demolition works by a Class B (non-friable) licensed asbestos removal contractor. | P4 | Feb-23 | 6 |

Photo 6. Exterior, south-west corner, electrical backing board – suspected asbestos-containing bituminous backing board.

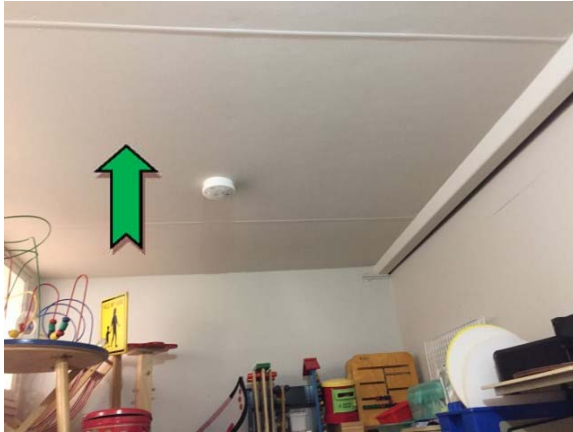
Photo 7. Interior, eastern store room, ceiling – non asbestos-containing fibre cement sheeting.

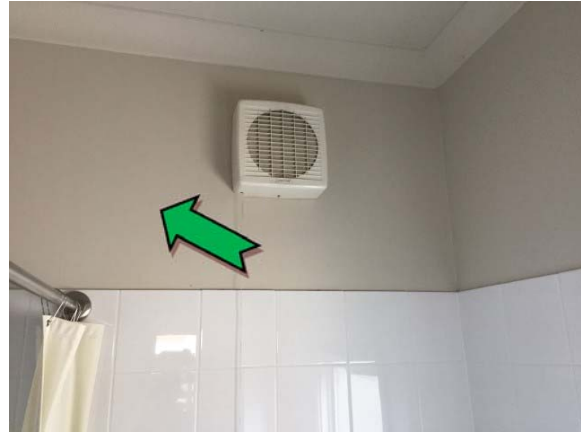
Photo 8. Interior, staff toilet, eastern elevation, wall – non asbestos-containing fibre cement sheeting.

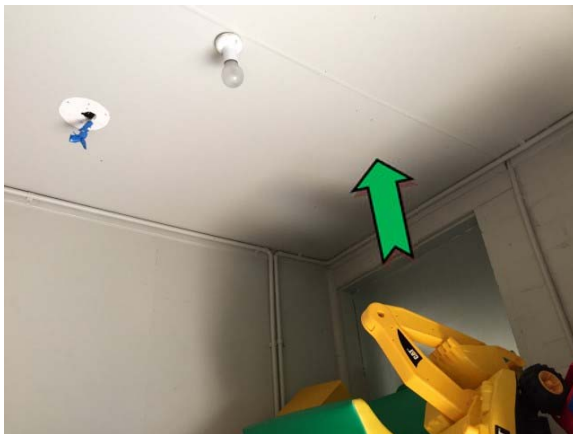
Photo 9. Interior, shed, ceiling – non asbestos-containing fibre cement sheeting.

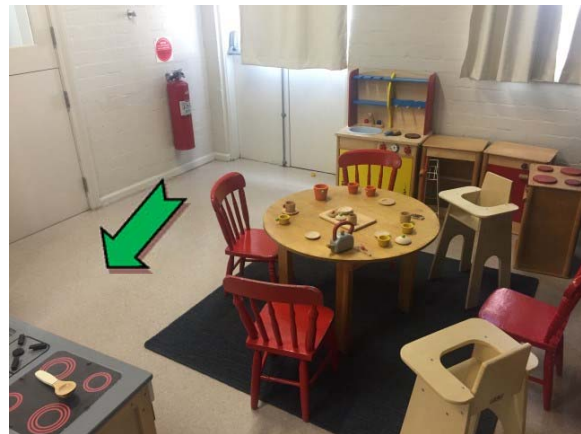
Photo 10. Interior, throughout, cream floor coverings – suspected non asbestos-containing sheet vinyl.

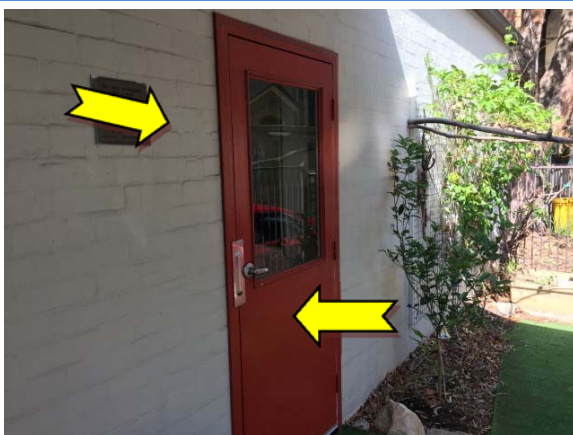
Photo 11. Exterior, throughout, walls and door – suspected lead-containing cream and red upper coloured paint systems.

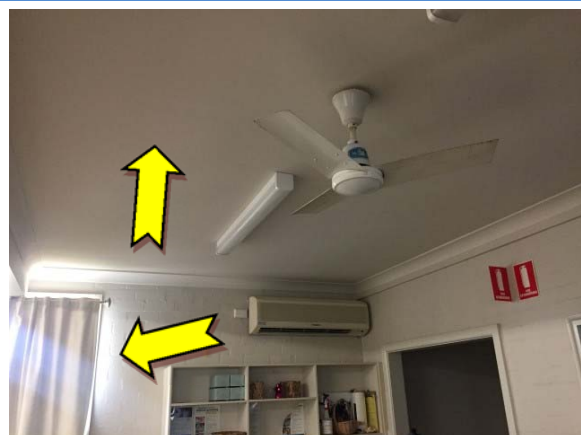
Photo 12. Interior, throughout, walls and ceiling – suspected lead-containing beige and white upper coloured paint systems.

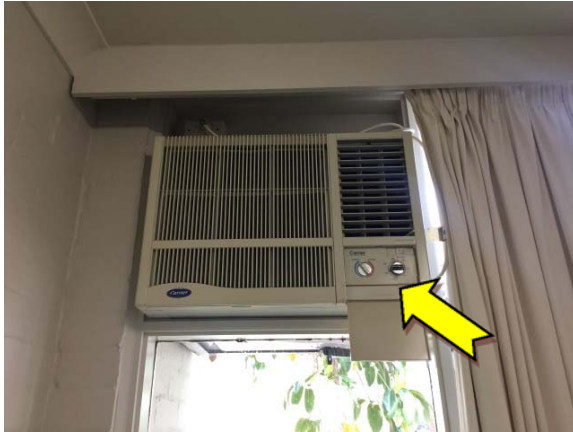
| Area / Level | Room & Location | Feature | Item Description | Hazard Type | Sample No. | Sample Status | Friability | Disturb. Potential | Condition | Risk Status | Approx. Quantity | Recommendations & Comments | Control Priority | Reinspect Date | Photo No. |
|---|---|---|--|---|---|---|---|---|---|---|---|---|---|---|---|
| Interior | Office | Air conditioning unit | Unknown refrigerant | Ozone Depleting Substances | - | Suspected Positive | - | Low | Good | Low | 1 unit | No data was visible at the time of the assessment. Confirm status of suspected ozone depleting substances identified in the assessment. | | | 13 |

Photo 13. Interior, office, air conditioning unit – suspected ODS-containing unknown refrigerant.

- If the ozone depleting substances identified on-site unit require removal they should be appropriately decanted and disposed of by a licensed contractor in accordance with the *Ozone Protection and Synthetic Greenhouse Gas Management Amendment Regulation 2017* as amended from time to time.
- In accordance with the Commonwealth Ozone Protection Legislation, Prensa recommends, in line with Australia's commitment to phase out ODS-containing substances that units which are required to be replaced due to their age, damage or functionality, have their ODS-containing refrigerants replaced with a non-ODS alternative such as R410A.
- It is important to note that, if a system which utilises ODS-refrigerants is in good working order, there is no need to transition to an alternative refrigerant/system (until 2029).

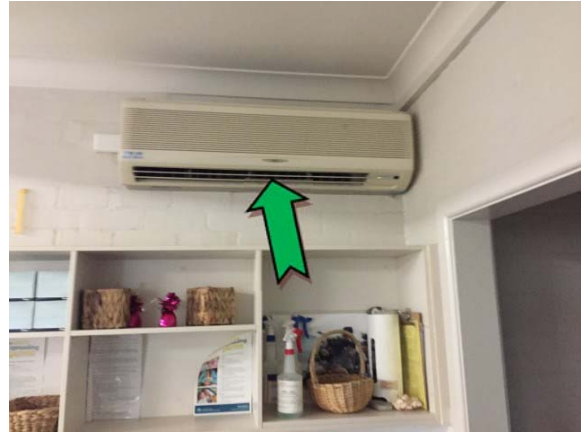
| Area / Level | Room & Location | Feature | Item Description | Hazard Type | Sample No. | Sample Status | Friability | Disturb. Potential | Condition | Risk Status | Approx. Quantity | Recommendations & Comments | Control Priority | Reinspect Date | Photo No. |
|---|---|---|--|---|---|---|---|---|---|---|---|---|---|---|---|
| Interior | Throughout | Sanyo air conditioning unit | Unknown refrigerant | Ozone Depleting Substances | - | Suspected Negative | - | - | - | - | 3 unit | Suspected negative due to age and appearance. | | | 14 |

Photo 14. Interior, throughout, Sanyo air conditioning unit – suspected non ODS-containing unknown refrigerant.

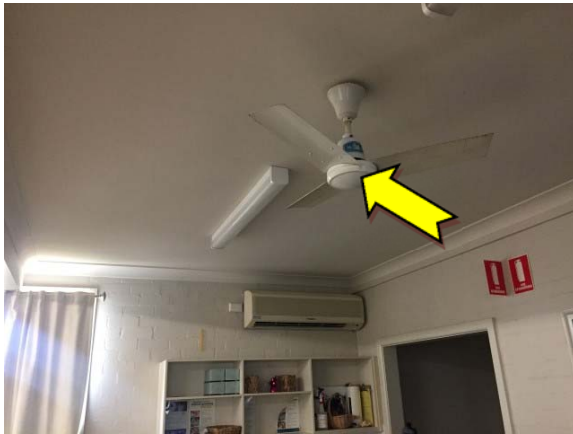
Photo 15. Interior, family room, ceiling fan – suspected PCB-containing capacitor.
