# Hazardous Building Materials Assessment Punch Park Tennis Clubhouse and Amenities Wortley Street Balmain NSW 2041

Inner West Council  
April 2018

Job No.: 57722-098

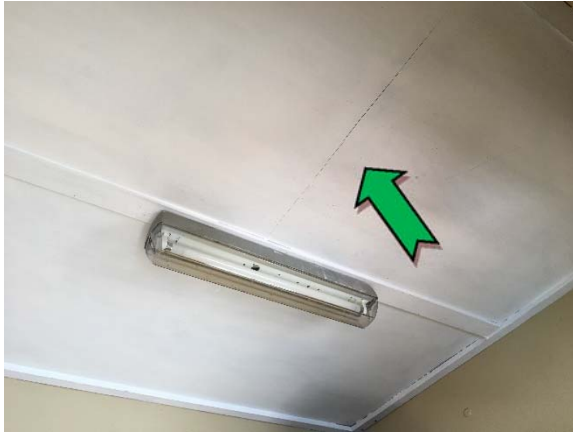
**Photo 1.** Interior, ground level, ceiling – non asbestos-containing fibre cement sheeting.

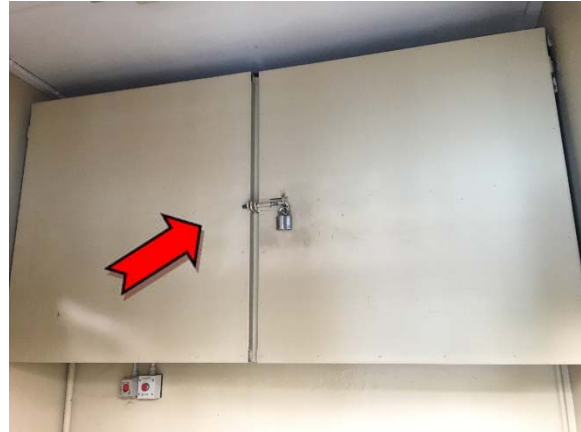
| Area / Level | Room & Location | Feature | Item Description | Hazard Type | Sample No. | Sample Status | Friability | Disturb. Potential | Condition | Risk Status | Approx. Quantity | Recommendations & Comments | Control Priority | Reinspect Date | Photo No. | |
|---|---|---|---|---|---|---|---|---|---|---|---|--|---|---|---|---|
| Interior | Ground level | Electrical backing board | Bituminous backing board | Asbestos | Not sampled: Locked | Suspected Positive | Non-friable | Low | Good | Low | 2 m <sup>2</sup> | Confirm status and maintain in current condition if to remain in-situ. Remove under controlled non-friable asbestos removal conditions prior to refurbishment or demolition works by a Class B (non-friable) licensed asbestos removal contractor. | P4 | Apr-23 | 2 | |

**Photo 2.** Interior, ground level, electrical backing board – suspected asbestos-containing bituminous backing board.

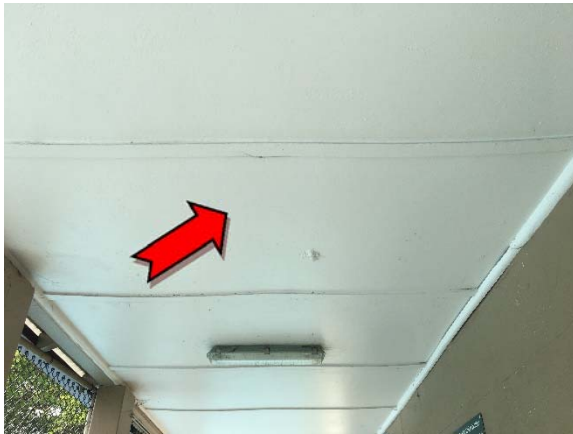
| Area / Level | Room & Location | Feature | Item Description | Hazard Type | Sample No. | Sample Status | Friability | Disturb. Potential | Condition | Risk Status | Approx. Quantity | Recommendations & Comments | Control Priority | Reinspect Date | Photo No. | |
|---|---|---|---|---|---|---|---|---|---|---|---|--|---|---|---|---|
| Exterior | Ground level | Awning | Fibre cement sheeting | Asbestos | 57722-098-002 | Positive | Non-friable | Low | Good | Low | 15 m <sup>2</sup> | Label as containing asbestos and maintain in current condition if to remain in-situ. Remove under controlled non-friable asbestos removal conditions prior to refurbishment or demolition works by a Class B (non-friable) licensed asbestos removal contractor. | P4 | Apr-23 | 3 | |

**Photo 3.** Exterior, ground level, awning – asbestos-containing fibre cement sheeting.

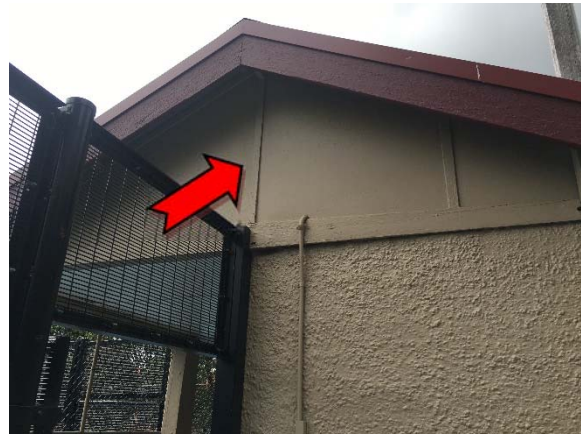
| Area / Level | Room & Location | Feature | Item Description | Hazard Type | Sample No. | Sample Status | Friability | Disturb. Potential | Condition | Risk Status | Approx. Quantity | Recommendations & Comments | Control Priority | Reinspect Date | Photo No. | |
|---|---|---|---|---|---|---|---|---|---|---|---|--|---|---|---|---|
| Exterior | Ground level, eastern elevation | Gable | Fibre cement sheeting | Asbestos | 57722-098-003 | Positive | Non-friable | Low | Good | Low | 4 m <sup>2</sup> | Label as containing asbestos and maintain in current condition if to remain in-situ. Remove under controlled non-friable asbestos removal conditions prior to refurbishment or demolition works by a Class B (non-friable) licensed asbestos removal contractor. | P4 | Apr-23 | 4 | |

**Photo 4.** Exterior, ground level, eastern elevation, gable – asbestos-containing fibre cement sheeting.

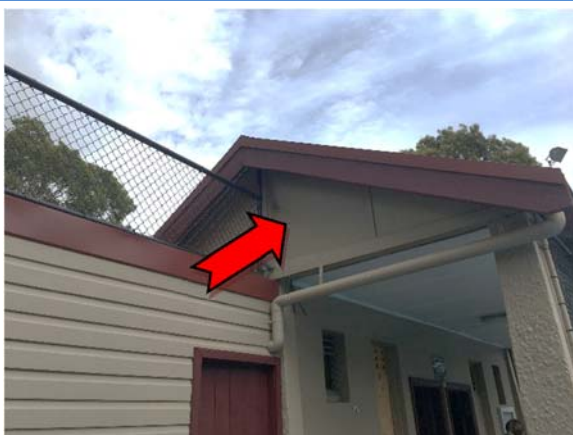
| Area / Level | Room & Location | Feature | Item Description | Hazard Type | Sample No. | Sample Status | Friability | Disturb. Potential | Condition | Risk Status | Approx. Quantity | Recommendations & Comments | Control Priority | Reinspect Date | Photo No. | |
|---|---|---|---|---|---|---|---|---|---|---|---|--|---|---|---|---|
| Exterior | Ground level, western elevation | Gable | Fibre cement sheeting | Asbestos | Same as 57722-098-003 | Assumed Positive | Non-friable | Low | Good | Low | 4 m <sup>2</sup> | Label as containing asbestos and maintain in current condition if to remain in-situ. Remove under controlled non-friable asbestos removal conditions prior to refurbishment or demolition works by a Class B (non-friable) licensed asbestos removal contractor. | P4 | Apr-23 | 5 | |

**Photo 5.** Exterior, ground level, western elevation, gable – assumed asbestos-containing fibre cement sheeting.

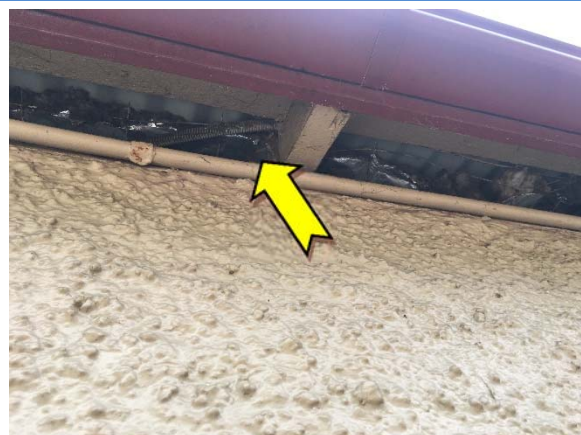
| Area / Level | Room & Location | Feature | Item Description | Hazard Type | Sample No. | Sample Status | Friability | Disturb. Potential | Condition | Risk Status | Approx. Quantity | Recommendations & Comments | Control Priority | Reinspect Date | Photo No. | |
|---|---|---|---|---|---|---|---|---|---|---|---|--|---|---|---|---|
| Interior | Ground level, roof space | Insulation | Sarking insulation | SMF | - | Suspected Positive | Bonded | Low | Fair | Low | 40 m <sup>2</sup> | Maintain in current condition if to remain in-situ. Remove under controlled SMF conditions as per the Code of Practice for the Safe Use of Synthetic Mineral Fibres [NOHSC: 2006 (1990)]. | - | - | 6 | |

**Photo 6.** Interior, ground level – suspected SMF sarking insulation.

- SMF materials that are likely to be disturbed during any proposed demolition/refurbishment works should be handled in accordance with the *Code of Practice for the Safe Use of Synthetic Mineral Fibres* [NOHSC:2006(1990)]. If these materials are impacted upon by accident or by pre-planned works, the Inner West Council must be informed via the contact detailed within Section 7: *Accidental Disturbance of Known or Suspected Hazardous Building Materials*. Following disturbance, inspection by a competent person should be undertaken.

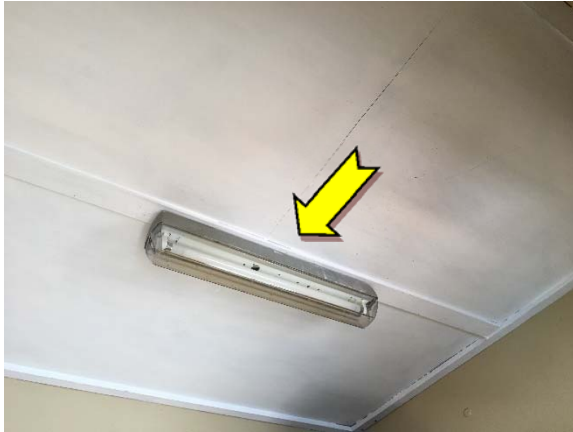
**Photo 7.** Interior, throughout, single tube fluorescent light fittings – suspected PCB containing capacitors.

- Electrical fittings suspected of containing PCB oil capacitors should be treated as containing PCB oils until such time as evidence suggest otherwise e.g. further assessed.
- Electrical fittings that contain or suspected to contain PCB oil-containing capacitors should be removed as hazardous/regulated waste under controlled working conditions prior to the demolition or refurbishment works in accordance with the *Polychlorinated Biphenyls Management Plan, Revised Edition April 2003*.

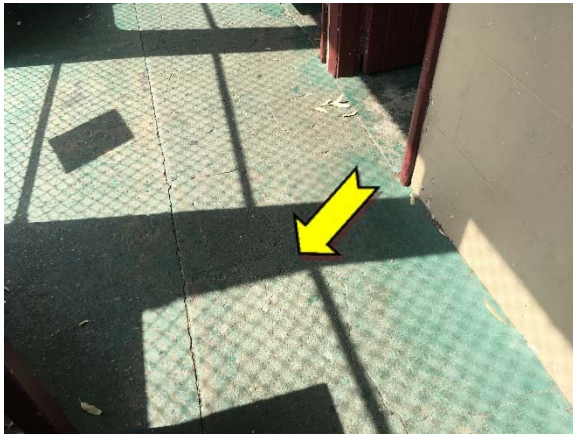
| Area / Level | Room & Location | Feature | Item Description | Hazard Type | Sample No. | Sample Status | Friability | Disturb. Potential | Condition | Risk Status | Approx. Quantity | Recommendations & Comments | Control Priority | Reinspect Date | Photo No. | |
|---|---|---|---|---|---|---|---|---|---|---|---|--|---|---|---|---|
| Interior | Ground level, throughout | Doors and door frames | Red - upper coloured paint system | Lead Paint - Swab | - | Suspected Positive | - | Low | Good | Low | 40m <sup>2</sup> | Confirm status by quantitative test method, maintain in current condition, over paint with a lead-free paint as part of ongoing maintenance. Remove under controlled conditions in accordance with AS 4361.2:2017 Guide to hazardous paint management prior to renovation or demolition works. | - | - | 9 | |

**Photo 9.** Exterior, throughout, floor – suspected lead-containing green paints system.
