# Hazardous Building Materials Assessment Portuguese Ethnographic Museum 24A Australia Street, Camperdown NSW 2050

Inner West Council

April 2018

Job No.: 57722-106

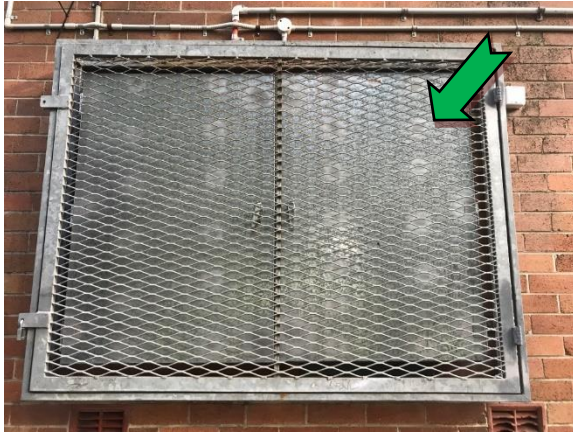
**Photo 1.** Exterior, south-east elevation, electrical backing board – suspected non-asbestos bituminous backing board.

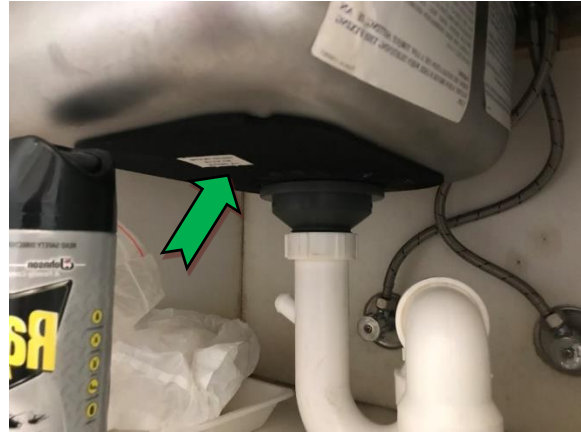
**Photo 2.** Interior, kitchen, under sink, sink pad – non asbestos-containing bituminous material.

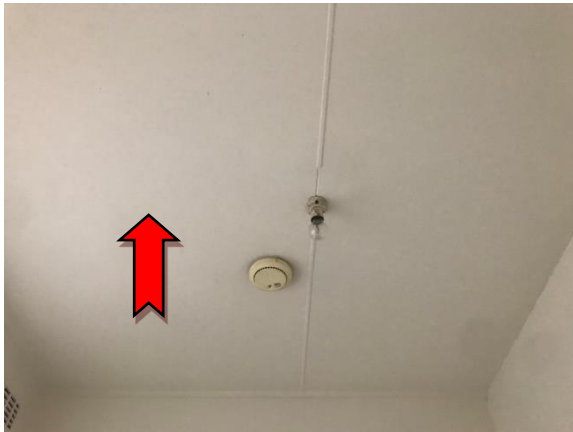
Area / Level	Room & Location	Feature	Item Description	Hazard Type	Sample No.	Sample Status	Friability	Disturb. Potential	Condition	Risk Status	Approx. Quantity	Recommendations & Comments	Control Priority	Reinspect Date	Photo No.
Exterior	South- east elevation	Electrical backing board	Bituminous backing board	Asbestos	Not sampled: electrical hazard	Suspected Negative	-	-	-	-	-	Suspected negative due to age and appearance. Informed that this was replace 6/7 years ago.	-	-	1
Interior, ground level	Kitchen, under sink	Sink pad	Bituminous material	Asbestos	57722-106-002	Negative	-	-	-	-	-	-	-	-	2
Interior, ground level	Kitchen	Ceiling	Fibre cement sheeting	Asbestos	57722-106-003	Positive	Non-friable	Low	Good	Low	6 m <sup>2</sup>	Maintain in current condition if to remain in-situ. Remove under controlled non-friable asbestos removal conditions prior to refurbishment or demolition works by a Class B (non-friable) licensed asbestos removal contractor.	P4	Feb-23	3

**Photo 3.** Interior, kitchen, ceiling – asbestos-containing fibre cement sheeting.

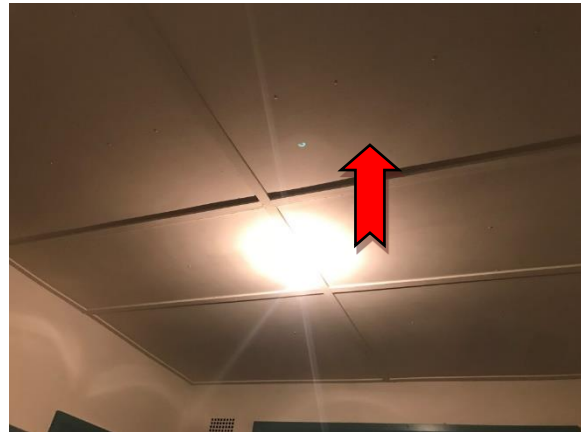
Interior, ground level	Lobby	Ceiling	Fibre cement sheeting	Asbestos	Refer to GETEX report 4729.09.ASMP	Assumed Positive	Non-friable	Low	Good	Low	24 m <sup>2</sup>	Sample noted to be positive for asbestos content by GETEX report 4729.09.ASMP. Not identified at the time of Prensa inspection, label false ceiling as containing asbestos and maintain in current condition if to remain in-situ. Remove under controlled non-friable asbestos removal conditions prior to refurbishment or demolition works by a Class B (non-friable) licensed asbestos removal contractor.	P4	Feb-23	-
Interior, ground level	Store	Ceiling	Fibre cement sheeting	Asbestos	Same as 57722-106-003	Assumed Positive	Non-friable	Low	Good	Low	12 m <sup>2</sup>	Maintain in current condition if to remain in-situ. Remove under controlled non-friable asbestos removal conditions prior to refurbishment or demolition works by a Class B (non-friable) licensed asbestos removal contractor.	P4	Feb-23	4

**Photo 4.** Interior, store, ceiling – assumed asbestos-containing fibre cement sheeting.

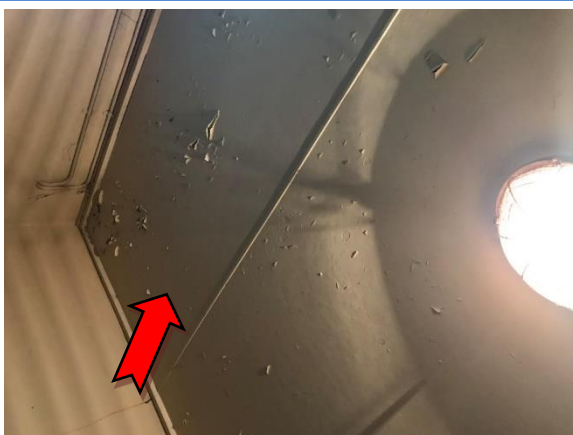
Interior, basement	Store room	Ceiling	Cream - upper coloured paint system	Lead Paint - Swab	-	Suspected Positive	-	Low	Fair	Low	30 m <sup>2</sup>	Confirm status by quantitative test method, maintain in current condition, over paint with a lead-free paint as part of ongoing maintenance. Remove under controlled conditions in accordance with AS 4361.2:2017 Guide to hazardous paint management prior to renovation or demolition works.	-	-	5

**Photo 5.** Interior, basement level, store room, ceiling – asbestos-containing fibre cement sheeting and suspected lead-containing cream upper paint system.

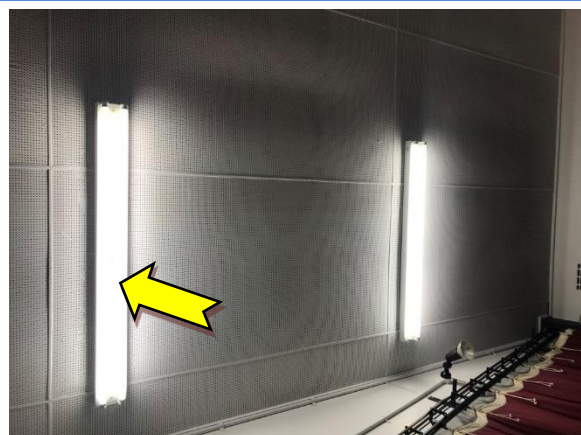
**Photo 6.** Interior, throughout, double tubed fluorescent light fittings – suspected PCB-containing capacitors.

- Electrical fittings suspected of containing PCB oil capacitors should be treated as containing PCB oils until such time as evidence suggest otherwise e.g. further assessed.
- Electrical fittings that contain or suspected to contain PCB oil-containing capacitors should be removed as hazardous/regulated waste under controlled working conditions prior to the demolition or refurbishment works in accordance with the *Polychlorinated Biphenyls Management Plan, Revised Edition April 2003*.

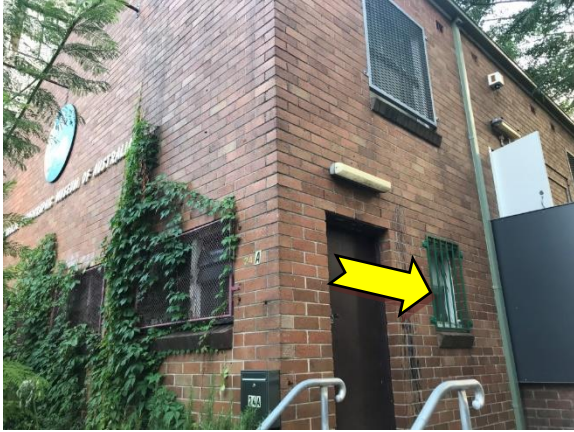
Interior	Throughout	Fluorescent light fitting - double tube	Capacitor	PCBs	Not sampled: electrical hazard	Suspected Positive	-	-	-	-	11 units	PCB-containing capacitors are suspected due to age & appearance of electrical fittings. Remove and dispose of in accordance with the Polychlorinated Biphenyls Management Plan, Revised Edition April 2003.	-	-	6
Exterior	Throughout	Window frames	White - upper coloured paint system	Lead Paint - Swab	-	Positive	-	Low	Poor	Medium	8 m	Remove flaking sections and over paint with a lead-free paint. Remove under controlled conditions in accordance with AS 4361.2:2017 Guide to hazardous paint management prior to renovation or demolition works.	-	-	7
Exterior	Throughout	Window frames	Yellow (light) - lower coloured paint system	Lead Paint - Swab	-	Positive	-	Low	Poor	Medium	8 m	Remove flaking sections and over paint with a lead-free paint. Remove under controlled conditions in accordance with AS 4361.2:2017 Guide to hazardous paint management prior to renovation or demolition works.	-	-	7

**Photo 7.** Exterior, throughout, window frames – suspected lead-containing white upper and light yellow lower coloured paint systems.

- Remove flaking lead containing paint to window surrounds throughout the property in accordance with AS4361.2-2017 Guide to Hazardous Paint Management and relevant legislation.

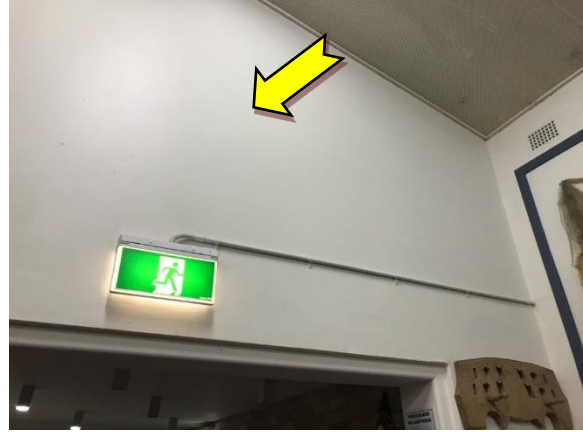
Area / Level	Room & Location	Feature	Item Description	Hazard Type	Sample No.	Sample Status	Friability	Disturb. Potential	Condition	Risk Status	Approx. Quantity	Recommendations & Comments	Control Priority	Reinspect Date	Photo No.
Interior, basement	Store room	Walls	Yellow (light) - upper coloured paint system	Lead Paint - Swab	-	Suspected Positive	-	Low	Fair	Low	70 m <sup>2</sup>	Confirm status by quantitative test method, maintain in current condition, over paint with a lead-free paint as part of ongoing maintenance. Remove under controlled conditions in accordance with AS 4361.2:2017 Guide to hazardous paint management prior to renovation or demolition works.	-	-	-
Interior, ground level	Museum, throughout	Walls	White - upper coloured paint system	Lead Paint - Swab	-	Suspected Positive	-	Low	Good	Low	300 m <sup>2</sup>	Confirm status by quantitative test method, maintain in current condition, over paint with a lead-free paint as part of ongoing maintenance. Remove under controlled conditions in accordance with AS 4361.2:2017 Guide to hazardous paint management prior to renovation or demolition works.	-	-	8

**Photo 8.** Interior, throughout, walls – suspected lead-containing white upper paint systems.
