Hazardous Building Materials Assessment Camperdown Park – Electrical Control Room Australia Street, Camperdown NSW 2050

Inner West Council
April 2018

Job No.: 57722-080

Count ID: CID: 90

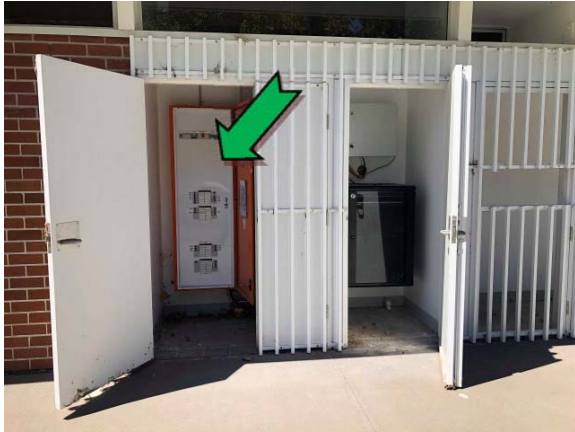
Photo Interior, electrical backing board – suspected
1. non asbestos-containing bituminous backing board.
