# Hazardous Building Materials Assessment Camperdown Commons Mallett Street, Camperdown NSW 2050

Inner West Council  
April 2018

Job No.: 57722-104

# Executive Summary

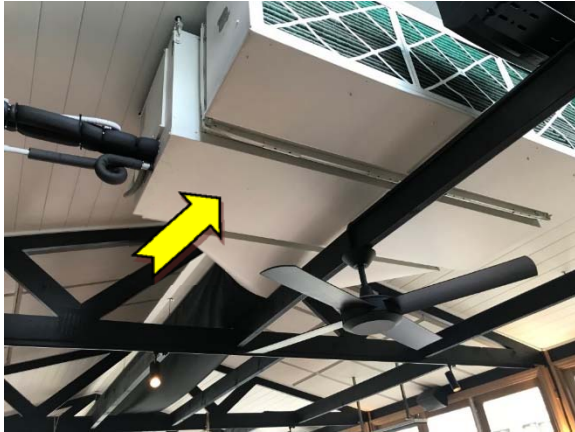
**Photo 1.** Interior, throughout, duct work – suspected SMF internal insulation.

- SMF internal insulation was suspected within the ductwork throughout the building.
- SMF compressed ceiling tiles was suspected throughout the ceiling in the community room.

- SMF materials that are likely to be disturbed during any proposed demolition/refurbishment works should be handled in accordance with the *Code of Practice for the Safe Use of Synthetic Mineral Fibres* [NOHSC:2006(1990)]. If these materials are impacted upon by accident or by pre-planned works, the Inner West Council must be informed via the contact detailed within Section 7: *Accidental Disturbance of Known or Suspected Hazardous Building Materials*. Following disturbance, inspection by a competent person should be undertaken.

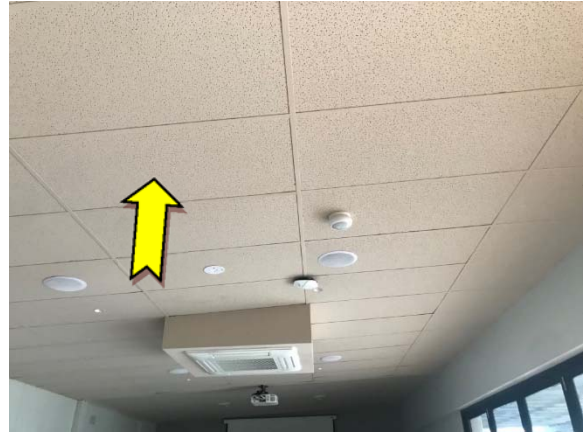
**Photo 2.** Interior, community room, ceiling – suspected SMF-containing compressed ceiling tiles.

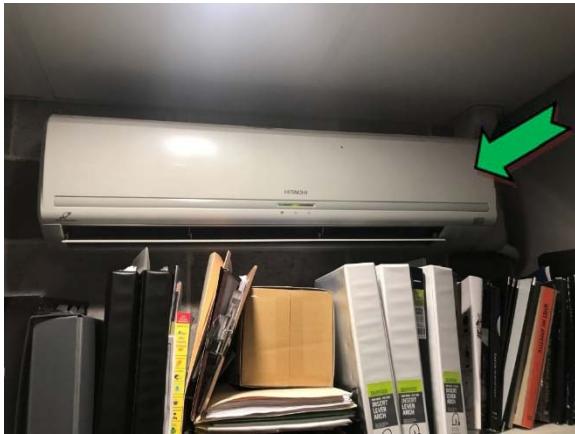
**Photo 3.** Interior, office, air conditioning unit, unknown refrigerant – suspected non ODS-containing refrigerant.

- No ODS-containing air conditioning units were identified or suspected during the Assessment.
