Hazardous Building Materials Assessment Lambert Park – Turnstile Building Marion Street Leichhardt NSW 2040

Inner West Council
April 2018

Job No.: 57722-065

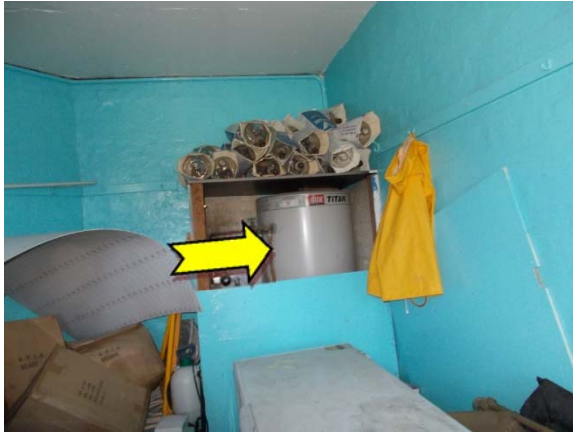
Photo 1. Interior, store room, hot water heater – suspected SMF internal insulation.

- SMF internal insulation was suspected within the hot water heater located in the store room.

- SMF materials that are likely to be disturbed during any proposed demolition/refurbishment works should be handled in accordance with the *Code of Practice for the Safe Use of Synthetic Mineral Fibres* [NOHSC:2006(1990)]. If these materials are impacted upon by accident or by pre-planned works, the Inner West Council must be informed via the contact detailed within Section 7: *Accidental Disturbance of Known or Suspected Hazardous Building Materials*. Following disturbance, inspection by a competent person should be undertaken.

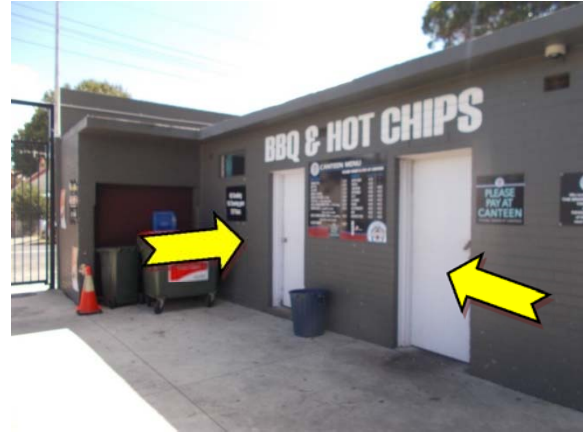
Exterior, ground level	Throughout	Door	White - upper coloured paint system	Lead Paint - Swab	-	Suspected Positive	-	Low	Good	Low	6 m ²	Confirm status by quantitative test method, maintain in current condition, over paint with a lead-free paint as part of ongoing maintenance. Remove under controlled conditions in accordance with AS 4361.2:2017 Guide to hazardous paint management prior to renovation or demolition works.	-	-	2
Interior, ground level	Throughout	Ceiling	White - upper coloured paint system	Lead Paint - Swab	-	Suspected Positive	-	Low	Good	Low	25 m ²	Confirm status by quantitative test method, maintain in current condition, over paint with a lead-free paint as part of ongoing maintenance. Remove under controlled conditions in accordance with AS 4361.2:2017 Guide to hazardous paint management prior to renovation or demolition works.	-	-	3
Interior, ground level	Throughout	Walls	Blue - upper coloured paint system	Lead Paint - Swab	-	Suspected Positive	-	Low	Good	Low	35 m ²	Confirm status by quantitative test method, maintain in current condition, over paint with a lead-free paint as part of ongoing maintenance. Remove under controlled conditions in accordance with AS 4361.2:2017 Guide to hazardous paint management prior to renovation or demolition works.	-	-	3

Photo 2. Exterior, throughout, walls and doors – suspected lead-containing grey and white upper coloured paint systems.

- The *LeadCheck* paint swab method can detect lead in paint at concentrations of 0.5% and above, and may indicate lead in some paint films as low as 0.2%. As paint with a lead content greater than 0.1% by dry weight is now considered to be lead-containing, Prensa recommends confirming status of suspected LCP identified during the Assessment by quantitative test method.

- The safest method of dealing with LCP is to replace or remove the items in their entirety that have LCP on them and replace them with new items that do not contain lead. This allows the items to be disposed of as regular building or demolition unsegregated waste in accordance with the NSW Environment Protection Authority (EPA) *Waste Classification Guidelines 2014 Part 1 – Classifying Waste*. The advantage of this method is the reduction in labour requirements to remove the lead paint and also this reduces the risk to workers from exposure to lead dust or fumes. If the removal of the LCP or coatings is the preferred or required option this may generate significant amounts of potential hazardous waste. This waste must be removed, collected and disposed of by an appropriately licensed contractor under controlled conditions that minimises the release to air, water and soil. Disposal of lead waste must be disposed of as hazardous waste at an approved waste facility.

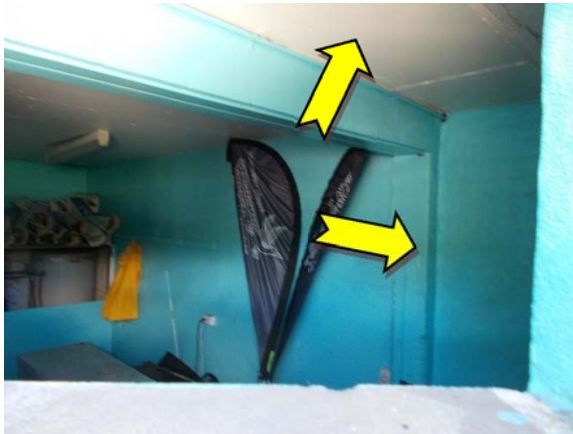
Photo 3. Interior, throughout, ceiling and walls – suspected lead-containing white and light blue upper paint systems.

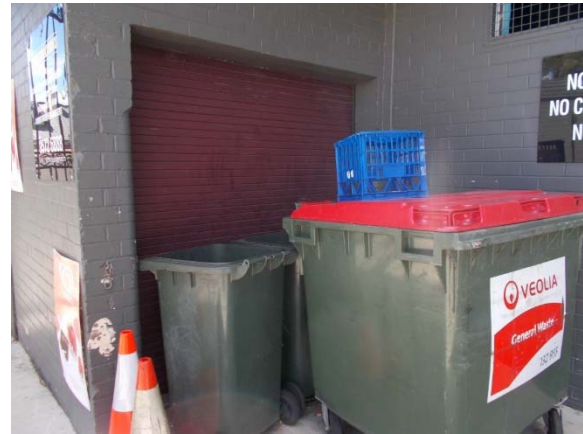
Throughout	-	-	-	Ozone Depleting Substances	-	-	-	-	-	-	-	No suspect ODS's identified at the time of the assessment.	-	-	-
Interior, ground level	Garage	-	-	-	-	-	-	-	-	-	-	No access at the time of the assessment.	-	-	4

Photo 4. No access to garage at the time of Assessment.
