# Hazardous Building Materials Assessment

## Addison Road Early Learning Centre

142 Addison Road  
Marrickville NSW 2204

Inner West Council  
April 2018

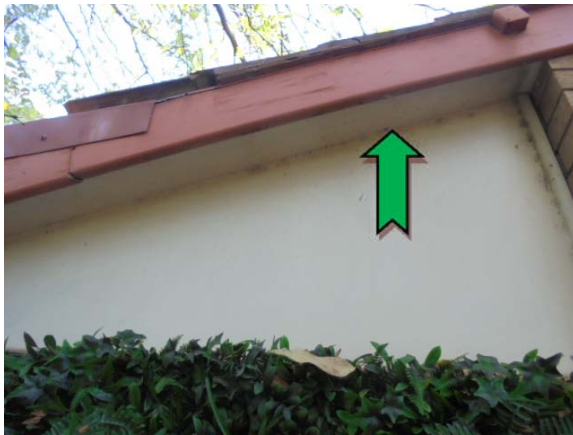
| Client: Inner West Council | | | Site Name: CID: 003, Addison Road Ealry Learning Centre | | | | Site Address: 142 Addison Road Marrickville 2204 | | | | | Client No.: S0149 | | Job No.: 57722-083 | |
|---|---|---|---|---|---|---|---|---|---|---|---|---|---|---|---|
| Exterior | Throughout | Eaves | Fibre cement sheeting | Asbestos | 57722-083-001 | Negative | - | - | - | - | - | - | - | - | 1 |

**Photo 1.** Exterior, throughout, eaves – non asbestos-containing fibre cement sheeting.

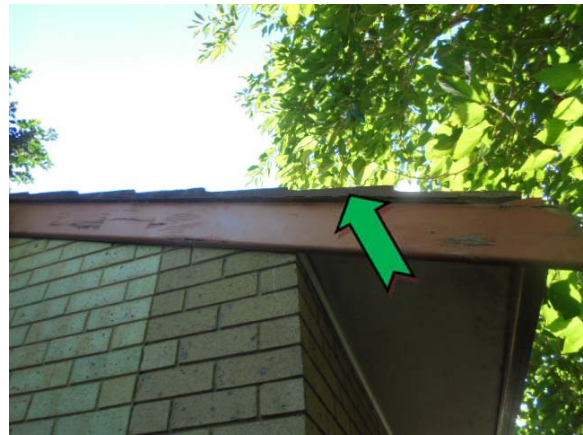
| Client: Inner West Council | | | Site Name: CID: 003, Addison Road Ealry Learning Centre | | | | Site Address: 142 Addison Road Marrickville 2204 | | | | | Client No.: S0149 | | Job No.: 57722-083 | |
|---|---|---|---|---|---|---|---|---|---|---|---|---|---|---|---|
| Exterior | Throughout | Undercloaking | Fibre cement sheeting | Asbestos | 57722-083-002 | Negative | - | - | - | - | - | - | - | - | 2 |

**Photo 2.** Exterior, throughout, under cloaking – non asbestos-containing fibre cement sheeting.

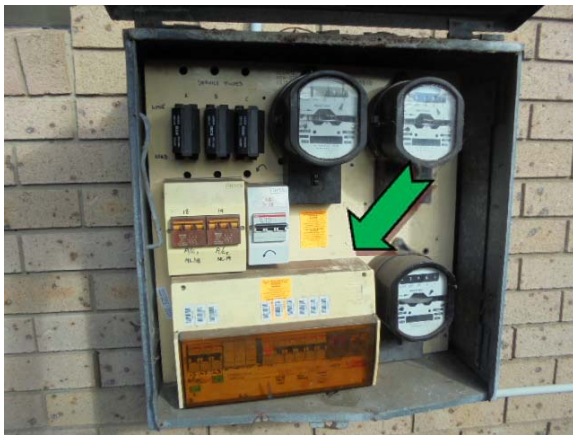
| Client: Inner West Council | | | Site Name: CID: 003, Addison Road Ealry Learning Centre | | | | Site Address: 142 Addison Road Marrickville 2204 | | | | | Client No.: S0149 | | Job No.: 57722-083 | |
|---|---|---|---|---|---|---|---|---|---|---|---|---|---|---|---|
| Exterior | Southern wall | Electrical backing board | Fibre cement sheeting | Asbestos | 57722-083-003 | Negative | - | - | - | - | - | - | - | - | 3 |

**Photo 3.** Exterior, southern wall, electrical backing board – non asbestos-containing fibre cement sheeting.

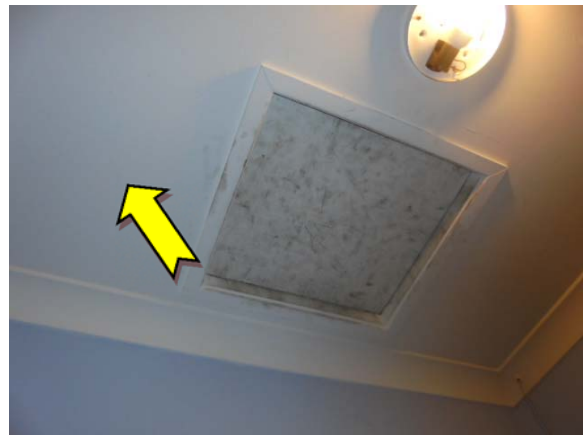
| Client: Inner West Council | | | Site Name: CID: 003, Addison Road Ealry Learning Centre | | | | Site Address: 142 Addison Road Marrickville 2204 | | | | | Client No.: S0149 | | Job No.: 57722-083 | |
|---|---|---|---|---|---|---|---|---|---|---|---|---|---|---|---|
| Interior | Throughout | Ceiling | White - lower coloured paint system | Lead Paint - Swab | - | - | - | Low | Good | Low | 80 m <sup>2</sup> | Confirm status by quantitative test method, maintain in current condition, over paint with a lead-free paint as part of ongoing maintenance. Remove under controlled conditions in accordance with AS 4361.2:2017 Guide to hazardous paint management prior to renovation or demolition works. | - | - | 4 |

**Photo 4.** Interior, throughout, ceiling – suspected lead-containing white upper paint system.
