# Hazardous Building Materials Assessment Mackey Park Pump Room Carrington Road & Richardsons Crescent Marrickville, NSW 2204

Inner West Council  
April 2018

Job No.: 57722-052

Count ID: CID: 250

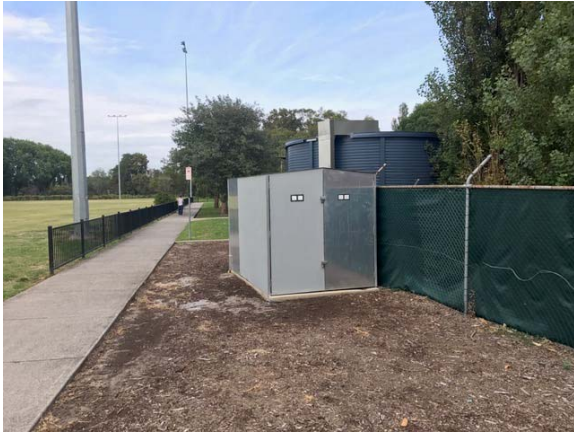
**Photo 1.** No hazardous materials identified or suspected at time of the Assessment.
