# Hazardous Building Materials Assessment Henson Park Scoreboard, Kiosk and Toilets 22 Centennial Street Marrickville NSW 2204

Inner West Council  
April 2018

Job No.: 57722-160

Count ID: 166

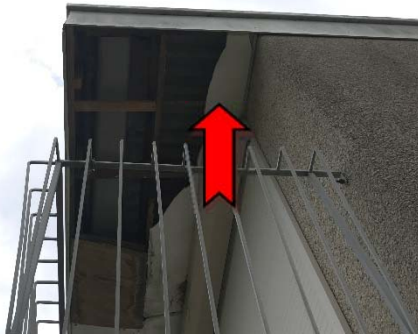
| Area / Level | Room & Location | Feature | Item Description | Hazard Type | Sample No. | Sample Status | Friability | Disturb. Potential | Condition | Risk Status | Approx. Quantity | Recommendations & Comments | Control Priority | Reinspect Date | Photo No. |
|---|---|---|---|---|---|---|---|---|---|---|---|--|---|---|---|
| Exterior | Throughout | Eaves | Fibre cement sheeting | Asbestos | 57722-160-001 | Positive | Non-friable | Medium | Poor | Medium | 20 m <sup>2</sup> | Eaves extensively damaged. Remove and replace under controlled non-friable asbestos removal conditions by a Class B (non-friable) licensed asbestos removal contractor as a matter of priority | P2 | Dec-18 | 1 |

**Photo 1.** Exterior, throughout, eaves – asbestos-containing fibre cement sheeting.

- Exterior eaves are noted to be in poor condition with extensive damage throughout. Remove under controlled non-friable asbestos removal conditions by a Class B (non-friable) licensed asbestos removal contractor.

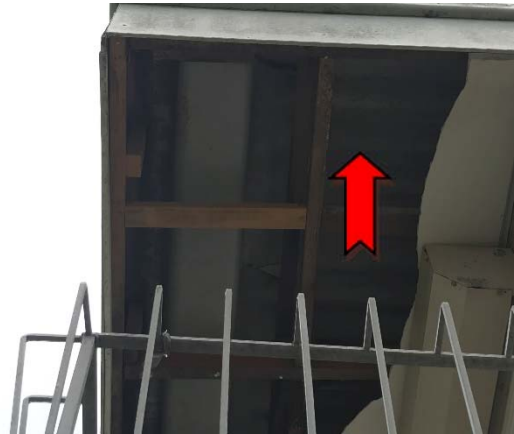
| Area / Level | Room & Location | Feature | Item Description | Hazard Type | Sample No. | Sample Status | Friability | Disturb. Potential | Condition | Risk Status | Approx. Quantity | Recommendations & Comments | Control Priority | Reinspect Date | Photo No. |
|---|---|---|---|---|---|---|---|---|---|---|---|--|---|---|---|
| Exterior | Throughout | Roof | Fibre cement sheeting | Asbestos | Not sampled: Height restrictions | Suspected Positive | Non-friable | Low | Good | Low | 50 m <sup>2</sup> | Confirm status, label as containing asbestos and maintain in current condition if to remain in-situ. Remove under controlled non-friable asbestos removal conditions prior to refurbishment or demolition works by a Class B (non-friable) licensed asbestos removal contractor. | P4 | Feb-23 | 2 |

**Photo 2.** Exterior, throughout, roof – suspected asbestos-containing fibre cement sheeting.

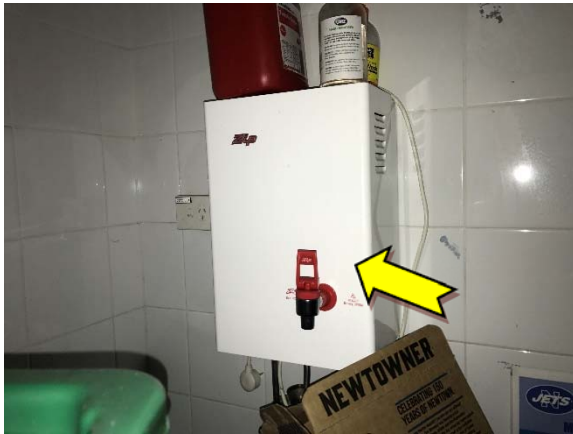
| Area / Level | Room & Location | Feature | Item Description | Hazard Type | Sample No. | Sample Status | Friability | Disturb. Potential | Condition | Risk Status | Approx. Quantity | Recommendations & Comments | Control Priority | Reinspect Date | Photo No. |
|---|---|---|---|---|---|---|---|---|---|---|---|--|---|---|---|
| Ground level | Kiosk | Hot water heater | Insulation material - internal | SMF | | Suspected Positive | - | - | - | - | 1 units | Maintain in current condition if to remain in-situ. Remove under controlled SMF conditions as per the Code of Practice for the Safe Use of Synthetic Mineral Fibres [NOHSC: 2006 (1990)]. | - | - | 3 |

**Photo 3.** Interior, ground level, kiosk, hot water heater – suspected SMF internal insulation.

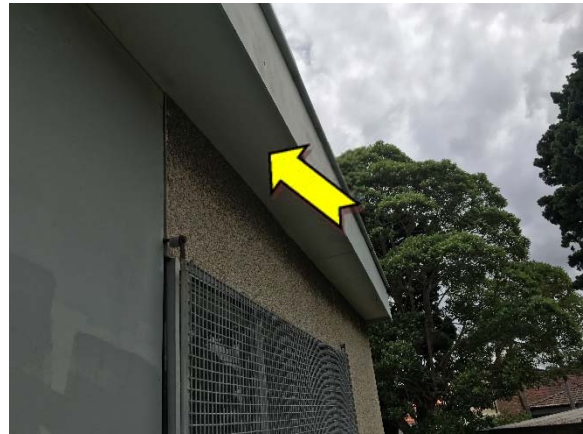
| Area / Level | Room & Location | Feature | Item Description | Hazard Type | Sample No. | Sample Status | Friability | Disturb. Potential | Condition | Risk Status | Approx. Quantity | Recommendations & Comments | Control Priority | Reinspect Date | Photo No. |
|---|---|---|---|---|---|---|---|---|---|---|---|--|---|---|---|
| Exterior | Throughout | Eaves | White - upper coloured paint system | Lead paint | - | Suspected Positive | - | Low | Good | Low | 16 m <sup>2</sup> | Confirm status by quantitative test method, maintain in current condition, over paint with a lead-free paint as part of ongoing maintenance. Remove under controlled conditions in accordance with AS 4361.2:2017 Guide to hazardous paint management prior to renovation or demolition works. | - | - | 4 |

**Photo 4.** Exterior, throughout, eaves – suspected lead-containing white upper paint system.
