Hazardous Building Materials Assessment Johnson Park Toilets Constitution Road Marrickville NSW 2204

Inner West Council
April 2018

Job No.: 57722-087

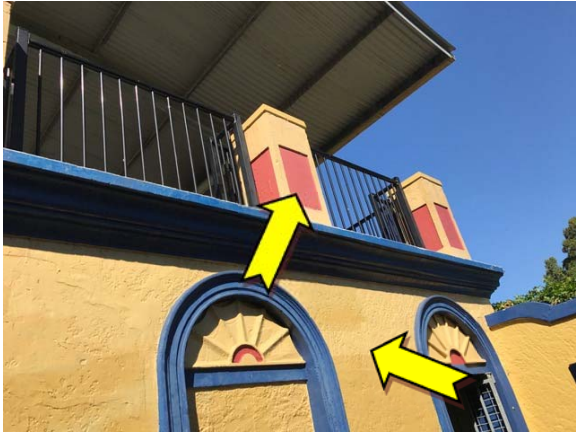
Exterior, ground level	Throughout	Wall	Yellow - upper coloured paint system	Lead Paint - Swab	-	Suspected Positive	-	Low	Good	Low	100 m ²	Confirm status by quantitative test method, remove flaking sections and over paint with a lead-free paint. Remove under controlled conditions in accordance with AS 4361.2:2017 Guide to hazardous paint management prior to renovation or demolition works.	-	-	1
Throughout	-	-	-	Ozone Depleting Substances	-	-	-	-	-	-	-	No suspect ODS's identified at the time of the assessment.	-	-	-

Photo 1. Exterior, ground level, wall - suspected lead-containing yellow and red upper paint systems.

- LCP was suspected in the yellow and red upper coloured paint systems to the exterior of the site.

- The *LeadCheck* paint swab method can detect lead in paint at concentrations of 0.5% and above, and may indicate lead in some paint films as low as 0.2%. As paint with a lead content greater than 0.1% by dry weight is now considered to be lead-containing, Prensa recommends confirming status of suspected LCP identified during the Assessment by quantitative test method.

- The safest method of dealing with LCP is to replace or remove the items in their entirety that have LCP on them and replace them with new items that do not contain lead. This allows the items to be disposed of as regular building or demolition unsegregated waste in accordance with the NSW Environment Protection Authority (EPA) *Waste Classification Guidelines 2014 Part 1 – Classifying Waste*. The advantage of this method is the reduction in labour requirements to remove the lead paint and also this reduces the risk to workers from exposure to lead dust or fumes. If the removal of the LCP or coatings is the preferred or required option this may generate significant amounts of potential hazardous waste. This waste must be removed, collected and disposed of by an appropriately licensed contractor under controlled conditions that minimises the release to air, water and soil. Disposal of lead waste must be disposed of as hazardous waste at an approved waste facility.
