Hazardous Building Materials Assessment

Steel Park Amenities

531-565 Illawarra Road
Marrickville NSW 2204

Inner West Council
April 2018

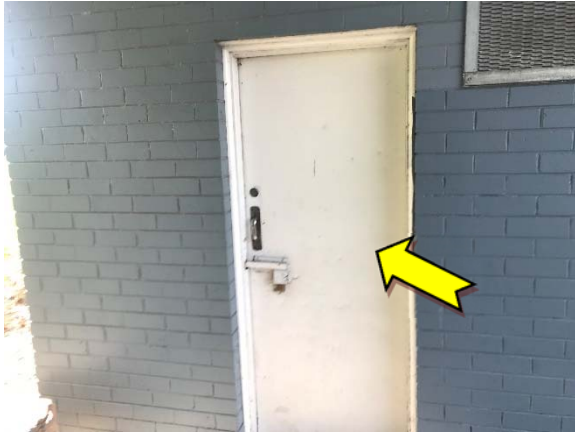
| Area / Level | Room & Location | Feature | Item Description | Hazard Type | Sample No. | Sample Status | Friability | Disturb. Potential | Condition | Risk Status | Approx. Quantity | Recommendations & Comments | Control Priority | Reinspect Date | Photo No. |
|---|---|---|---|---|---|---|---|---|---|---|---|--|---|---|---|
| Exterior | Throughout | Door & frames | White - upper coloured paint system | Lead Paint - Swab | - | Suspected Positive | - | Low | Good | Low | 35 m ² | Confirm status by quantitative test method, maintain in current condition, over paint with a lead-free paint as part of ongoing maintenance. Remove under controlled conditions in accordance with AS 4361.2:2017 Guide to hazardous paint management prior to renovation or demolition works. | - | - | 1 |

Photo 1. Exterior, throughout, doors and window frames – suspected lead-containing white upper paint system.

- LCP was suspected in the form of white and grey coloured upper paint systems to the exterior of the building.

- The *LeadCheck* paint swab method can detect lead in paint at concentrations of 0.5% and above, and may indicate lead in some paint films as low as 0.2%. As paint with a lead content greater than 0.1% by dry weight is now considered to be lead-containing, Prensa recommends confirming status of suspected LCP identified during the Assessment by quantitative test method.

- The safest method of dealing with LCP is to replace or remove the items in their entirety that have LCP on them and replace them with new items that do not contain lead. This allows the items to be disposed of as regular building or demolition unsegregated waste in accordance with the NSW Environment Protection Authority (EPA) *Waste Classification Guidelines 2014 Part 1 – Classifying Waste*. The advantage of this method is the reduction in labour requirements to remove the lead paint and also this reduces the risk to workers from exposure to lead dust or fumes. If the removal of the LCP or coatings is the preferred or required option this may generate significant amounts of potential hazardous waste. This waste must be removed, collected and disposed of by an appropriately licensed contractor under controlled conditions that minimises the release to air, water and soil. Disposal of lead waste must be disposed of as hazardous waste at an approved waste facility.

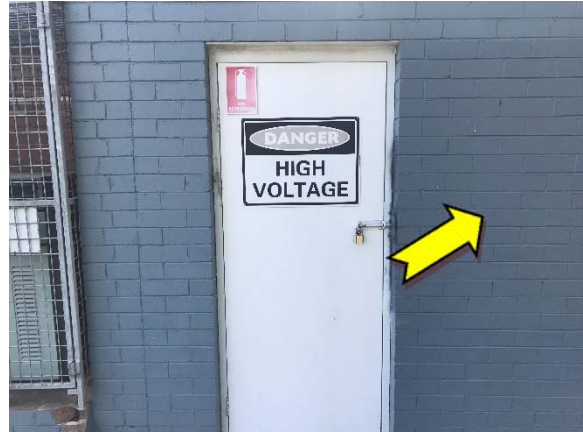
| Area / Level | Room & Location | Feature | Item Description | Hazard Type | Sample No. | Sample Status | Friability | Disturb. Potential | Condition | Risk Status | Approx. Quantity | Recommendations & Comments | Control Priority | Reinspect Date | Photo No. |
|---|---|---|---|---|---|---|---|---|---|---|---|--|---|---|---|
| Exterior | Throughout | Walls | Grey - upper coloured paint system | Lead Paint - Swab | - | Suspected Positive | - | Low | Good | Low | 150 m ² | Confirm status by quantitative test method, maintain in current condition, over paint with a lead-free paint as part of ongoing maintenance. Remove under controlled conditions in accordance with AS 4361.2:2017 Guide to hazardous paint management prior to renovation or demolition works. | - | - | 2 |

Photo 2. Exterior, throughout, wall – suspected lead-containing grey upper paint system.
