Hazardous Building Materials Assessment

Tillman Park Toilets

Unwins Bridge Road,
Tempe NSW 2044

Inner West Council
April 2018

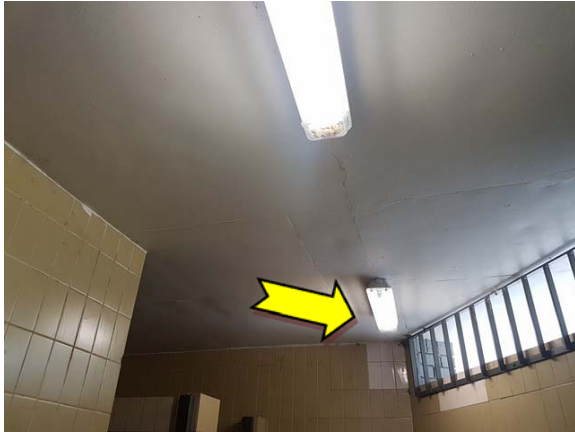
Photo 1. Interior, throughout, single tube fluorescent light fitting – suspected non PCB-containing capacitors.

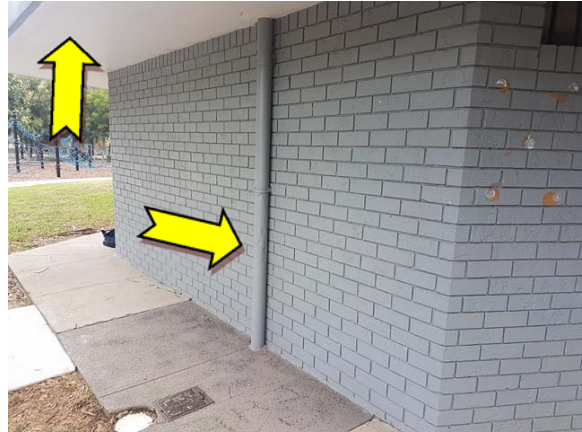
Exterior	Throughout	Eaves	White - upper coloured paint system	Lead Paint - Swab	-	Suspected Positive	-	Low	Good	Low	20 m ²	Confirm status by quantitative test method, maintain in current condition, over paint with a lead-free paint as part of ongoing maintenance. Remove under controlled conditions in accordance with AS 4361.2:2017 Guide to hazardous paint management prior to renovation or demolition works.	-	-	2
Exterior	Throughout	Walls	Green - lower coloured paint system	Lead Paint - Swab	-	Suspected Positive	-	Low	Good	Low	50 m ²	Confirm status by quantitative test method, maintain in current condition, over paint with a lead-free paint as part of ongoing maintenance. Remove under controlled conditions in accordance with AS 4361.2:2017 Guide to hazardous paint management prior to renovation or demolition works.	-	-	-
Exterior	Throughout	Walls	Red - lower coloured paint system	Lead Paint - Swab	-	Suspected Positive	-	Low	Good	Low	50 m ²	Confirm status by quantitative test method, maintain in current condition, over paint with a lead-free paint as part of ongoing maintenance. Remove under controlled conditions in accordance with AS 4361.2:2017 Guide to hazardous paint management prior to renovation or demolition works.	-	-	-

Exterior	Throughout	Walls	Cream - lower coloured paint system	Lead Paint - Swab	-	Suspected Positive	-	Low	Good	Low	50 m ²	Confirm status by quantitative test method, maintain in current condition, over paint with a lead-free paint as part of ongoing maintenance. Remove under controlled conditions in accordance with AS 4361.2:2017 Guide to hazardous paint management prior to renovation or demolition works.	-	-	-
Throughout	-	-	-	Ozone Depleting Substances	-	-	-	-	-	-	-	No suspect ODS's identified at the time of the assessment.	-	-	-

Photo 2. Exterior, walls and eaves – suspected lead-containing grey and white upper coloured paint systems.

- LCP was suspected in the form of grey and white upper coloured paint systems to the exterior of the building.
- LCP was suspected in the form of green, red and cream lower coloured paint systems to the external walls.

- The *LeadCheck* paint swab method can detect lead in paint at concentrations of 0.5% and above, and may indicate lead in some paint films as low as 0.2%. As paint with a lead content greater than 0.1% by dry weight is now considered to be lead-containing, Prensa recommends confirming status of suspected LCP identified during the Assessment by quantitative test method.

- The safest method of dealing with LCP is to replace or remove the items in their entirety that have LCP on them and replace them with new items that do not contain lead. This allows the items to be disposed of as regular building or demolition unsegregated waste in accordance with the NSW Environment Protection Authority (EPA) *Waste Classification Guidelines 2014 Part 1 – Classifying Waste*. The advantage of this method is the reduction in labour requirements to remove the lead paint and also this reduces the risk to workers from exposure to lead dust or fumes. If the removal of the LCP or coatings is the preferred or required option this may generate significant amounts of potential hazardous waste. This waste must be removed, collected and disposed of by an appropriately licensed contractor under controlled conditions that minimises the release to air, water and soil. Disposal of lead waste must be disposed of as hazardous waste at an approved waste facility.
