Date: 4th July 2022 Ref: 2205\_c\_ 67-73 Lords Road, Leichhardt, NSW Arboricultural Assessment.

Phase: Council Submission - Planning Proposal.

67-73 Lords Road, Leichhardt, NSW 2040 Consulting Arboricultural Assessment Report.

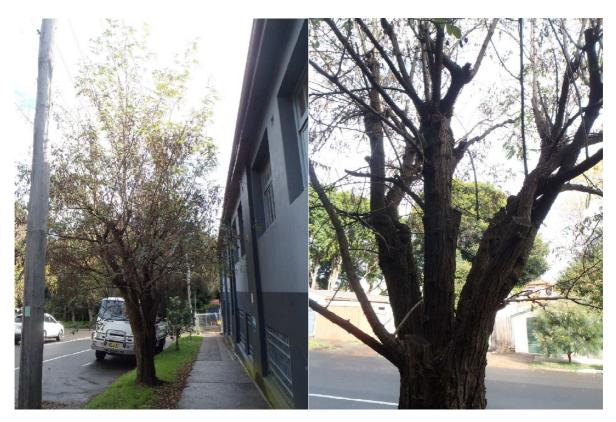
Figure 4. Photo showing T16, Robinia street tree. The pruning and thorns on epicormic shoots are visible.

- 6.11 The proposed removal of T16, a *Robinia pseudoacacia* (False Robinia) located within the street verge of Lords Road whilst not hinging or contingent on this planning proposal, is proposed as it is seen as an opportunity for replacement to a more suitable, and native tree planting along the street verge of Lords Road. This would be considered a more beneficial outcome for both parties (council and adjacent site owner).

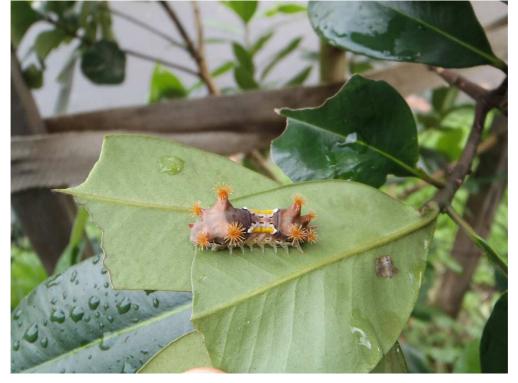
Figure 5. Photo showing The Doratifera vulnerans (Mottled cup moth caterpillar – venomous and native) on T17 and T18, new Tristaniopsis laurina (Water Gum) juvenile street trees.

- 6.12 T17 and T18 are both newly planted *Tristaniopsis laurina* (Water Gum). These juvenile street verge plantings are proposed for retention and protection with tree protection fencing during construction. It should be noted that the presence of *Doratifera vulnerans* (Mottled cup moth caterpillar venomous and native) and their pupae were present and browsing on the leaves. Provided the trees receive good water, soil nutrition and suitable protection including protection of the soil during any development, it is believed that the trees will be able to naturally overcome the cup moth caterpillar outbreak as they grow and mature. (*Refer to Figure 5 and 6, Chapter 8 below*).

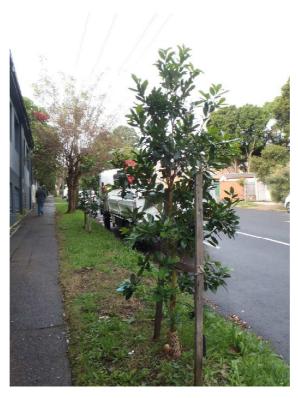
Figure 6. Photo showing The cup moth on T17 and T18, new Tristaniopsis laurina (Water Gum) juvenile street trees. T16 is in the background. Overhead powerlines just visible above these trees.

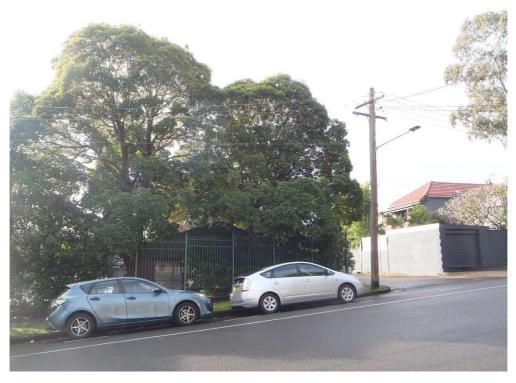
Figure 7. Photo from Lords Rd towards T3 and T4 (south western corner). Davies lane is also visible in the photo

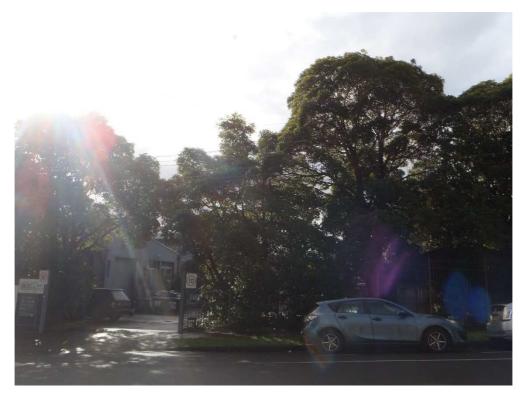
Figure 8. Photo from Lords Rd towards T1 (left of driveway) and T2 (right of driveway) with T3 and T4 far right.

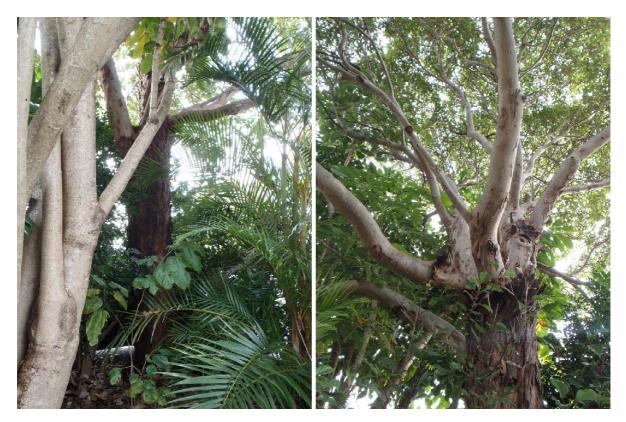
Figure 9. T1, Brush box with Schefflera growing close to it (photo on the left). Photo on the right shows T1 has previously been lopped/topped at approximately 4m high with the new branches growing from one node.

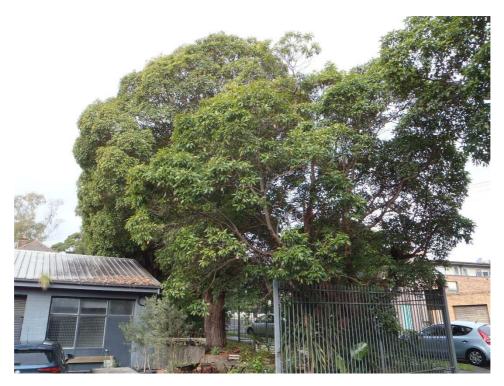
Figure 10. Photo T2 behind entry fence and T3 closer to building

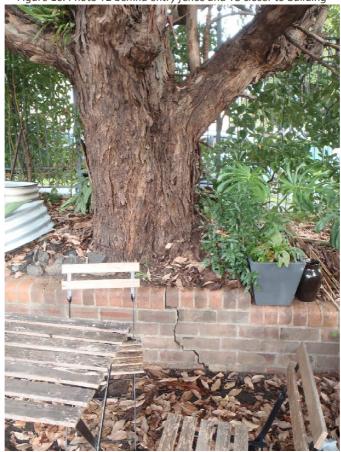
Figure 11. Photo T2. View looking south. Crack in brick wall. Hard pave surface where table/chairs are placed.

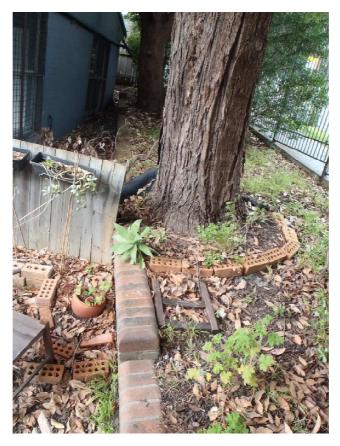
Figure 12. Photo T3. Wall to the north of T3. Lords Rd footpath in background on right. T4 in background.

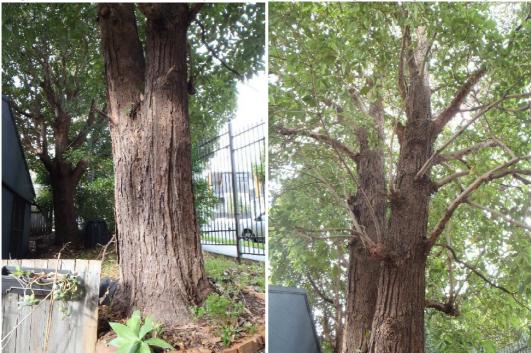
Figure 13. Photo T3 – co-dominant form

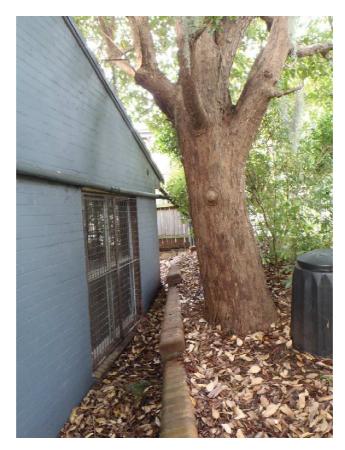
Figure 14. Photo T4. Brick wall displacement visible in photo.

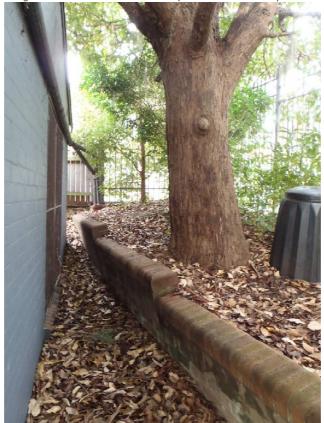
Figure 15. Photo T4. Brick wall displacement visible in photo.

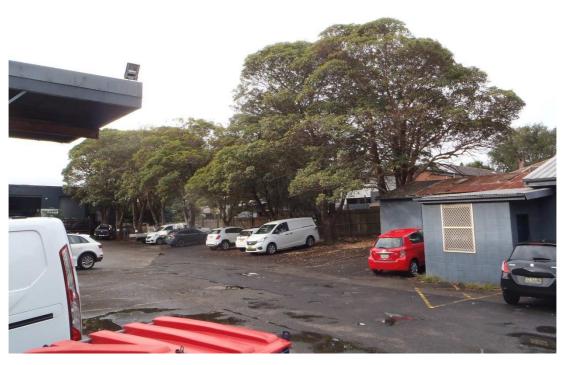
Figure 16. Trees 7 (right – near red car) through to T15 (far left)

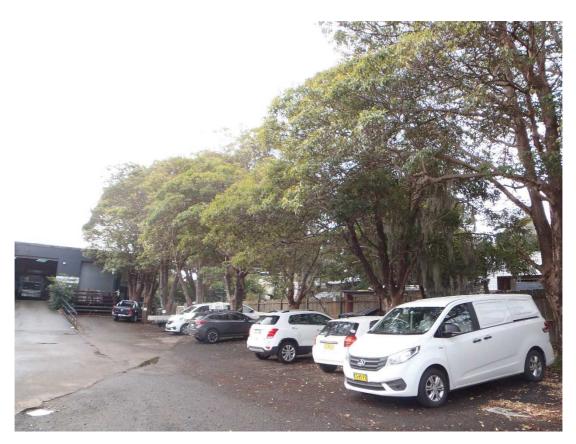
Figure 17. Trees 7 (right – near white van) through to T15 (far left)

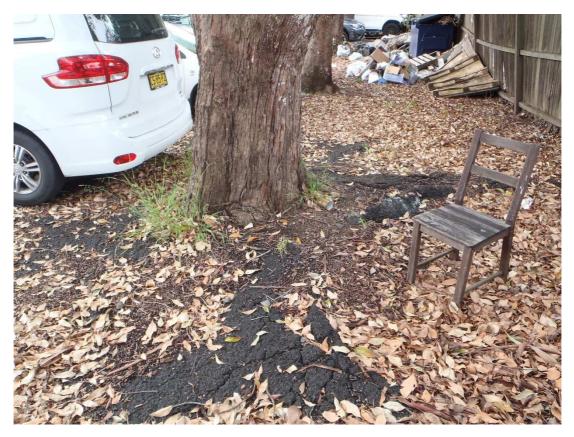
Figure 18. Trees 7-15 all within asphalt. Much displacement of the hard pave around the root crown base, rubbish dumped and cars parking.

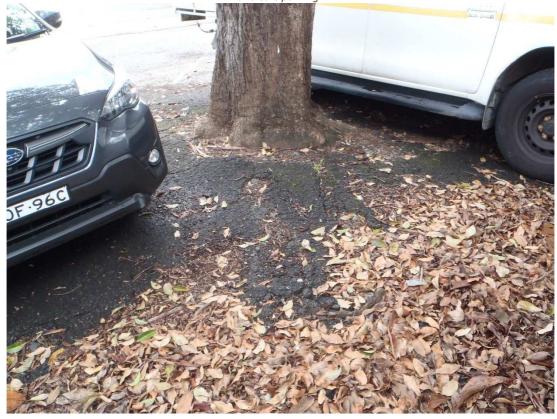
Figure 19. Trees 7-15 all within asphalt. Much displacement of the hard pave around the root crown base, rubbish dumped and cars parking.

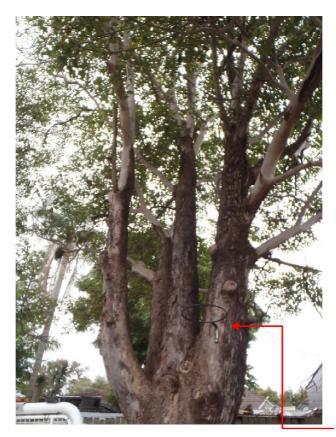
Figure 20. Trees T11 with netball hoop drilled into the tree (at red arrow)

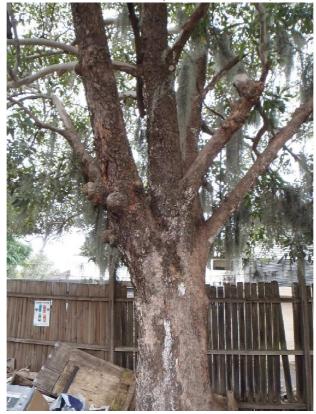
Figure 21. Tree T9. Slight stunting to tree. Rubbish dumped at base. Davies Lane in background. Tillandsia growing on limbs.

Fungal mycelia present on trunk. Vertical split in trunk (refer next photo)

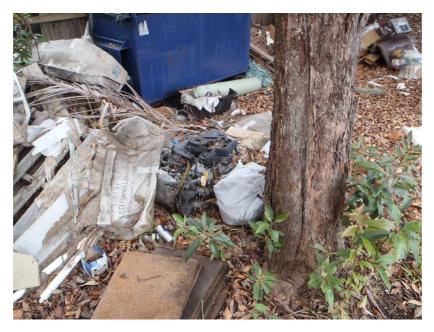
Figure 22. Tree T9. Slight stunting to tree. Rubbish dumped at base. Davies Lane in background. Tillandsia growing on limbs.

Fungal mycelia present on trunk. Vertical split in trunk.

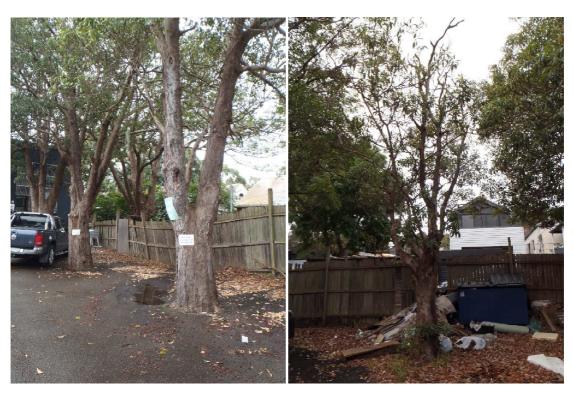
Figure 23. Tree T13 with two signs nailed into trunk and hard pave up to base of T13, T14, and T15 in background. Photo on right is T10 in very poor form

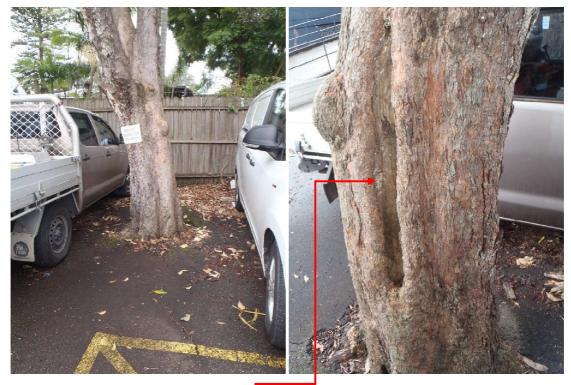
Figure 24. Tree 12 with decay on both sides of trunk. Asphalt up to base of tree and car parking either side.

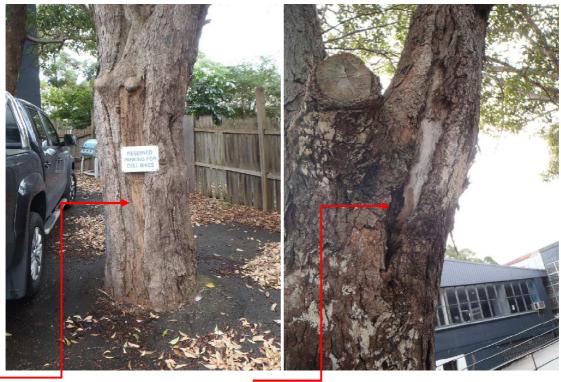
Figure 25. Tree 14 with decay on trunk and sign and asphalt up to base of tree and car parking either side.

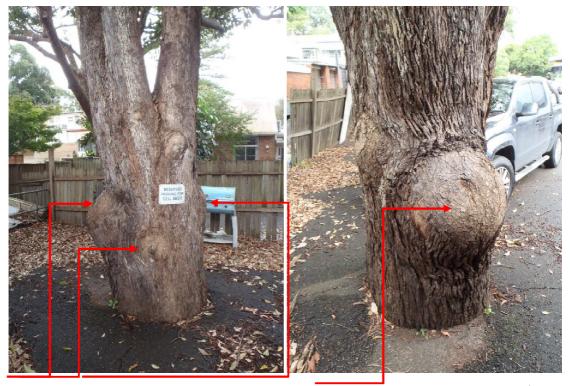
Figure 26. Tree 15 with several large limb scars at 1m above asphalt. It is suspected that this tree was lopped /topped at this height and the remaining trunks regrew. There is a lack of root crown base taper at the collar where asphalt has been laid of the trunk, indicating higher ground level than was existing.
