FENWICK'S STONE BUILDING
2-8 WESTON STREET
BALMAIN NSW 2041

CONSERVATION MANAGEMENT PLAN

JANUARY 2009

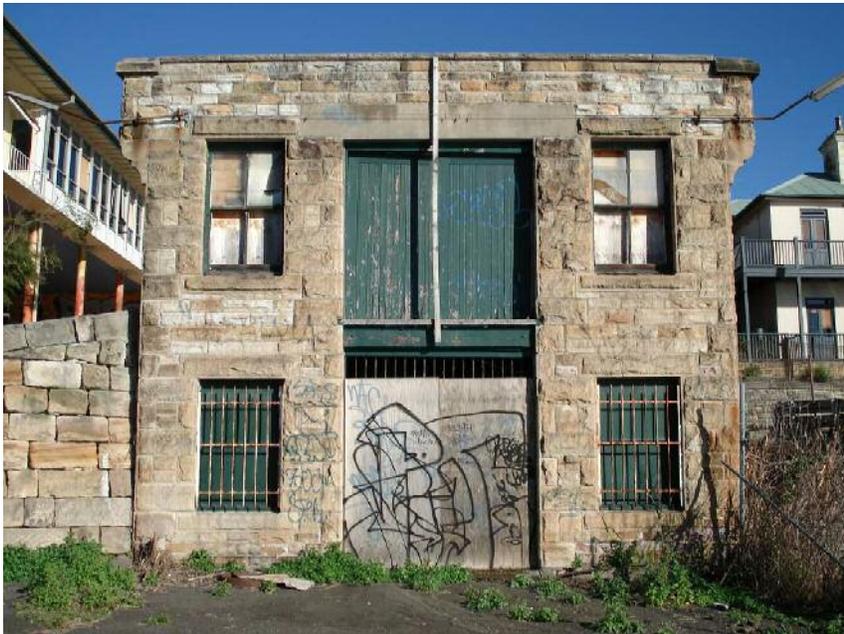
The eastern façade facing the water is the principal façade. It was modified in 1963. In its modified form the ashlar sandstone facade is two storeys high, parapeted with corbels with four windows symmetrical around double timber ledged and framed doors at each level. This is the only façade with ashlarwork instead of rubble stonework and has rock-faced lintels over the windows and quoins. The arch above the central doors has been removed along with the upper part of the gable and the voussoir stones of the arch replaced with a flat concrete lintel. The parapet ashlarwork above the lintel is comprised of smaller stone units than the rest of the wall. A slate damp proof course is evident on the exterior of the building.

The stone retaining wall and ramp of 1963 abuts the north-eastern corner of the building. Intrusive elements include steel grilles on windows and two fluorescent luminaires fixed on steel poles to the parapet. The windows are double hung timber sashes each with two panes divided vertically. They are in poor condition. The doors do not appear to be original and are likely to be replacements of the 1880s originals. A *Ficus* spp. weed is growing at the foot of the wall.

Figure 14 Photograph - view of the building's eastern façade. NBRSPartners (WDW), 2007.

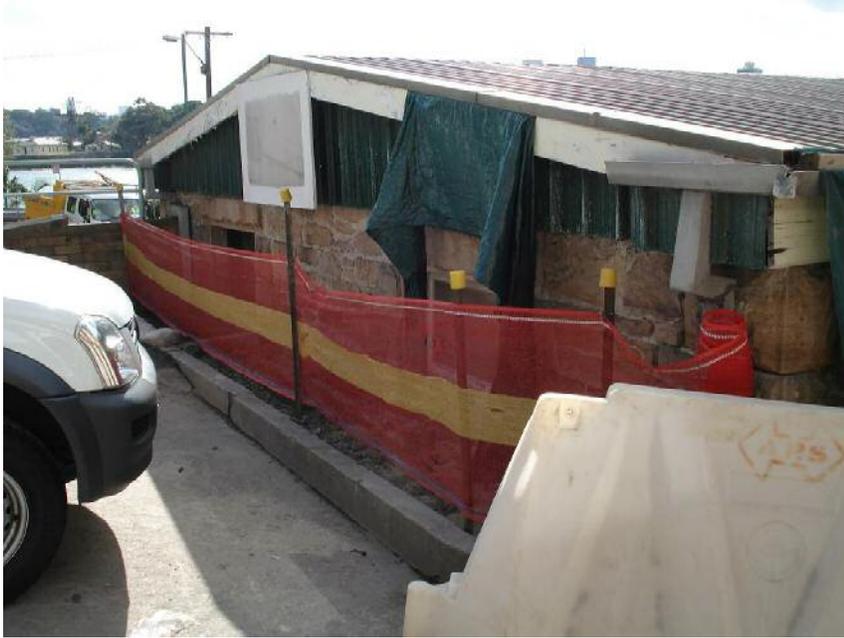
The western façade is not visible from the key views from the south-east through to the north. It was substantially modified in 1963 not only by the removal and replacement of the roof but by increasing the ground level. The rubble wall has two windows. Both have rock-faced stone lintels and appear to be original openings. The window frame and sash of the northern window appear to be original or early - it is a four pane window. A concrete kerb - presumably from 1963 - has been placed in front of this window making a pit for water in addition to the hydrostatic pressure and water ingress from the earth. The southern window frame, sash and concrete sill appear to date from 1963. The window comprises a single pane of wired glass in a timber frame. Clearly the ground level was raised somewhat in 1963 but the height of the early window whose sill is higher than that on the northern wall indicates that the first constructed ground level may have been quite high up the building in this location in any case. There is a deep crack through the stonework near the south-western corner of the wall.

Figure 19 Photograph - view of the western elevation of the building with some protection in place during works to the seawall. NBRSPartners (WDW), 2008.

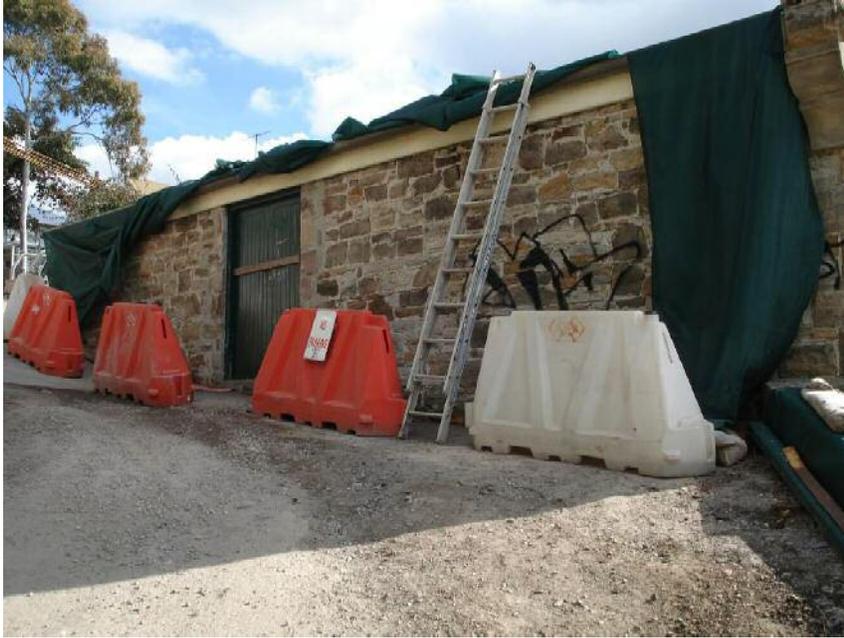
The southern façade is visible from some views from the south and south-east. There is no physical or documentary evidence that the wall had any openings in it before the vehicular ramp was constructed in 1963. The roughly central opening has been cut into the rubble wall and re-pointed using hard cement mortar in contrast to the original sand mortar of the rubblework. The opening has a concrete threshold. The framed and ledged double doors may date from 1963 or may have been reused from elsewhere on the site. The ground level has been considerably raised along this wall. A system of cracks is evident near the south-western corner.

Figure 23 Photograph - view of the southern wall adjacent to the ramp with some protection in place during works to the seawall. NBRSPartners (WDW), 2008.

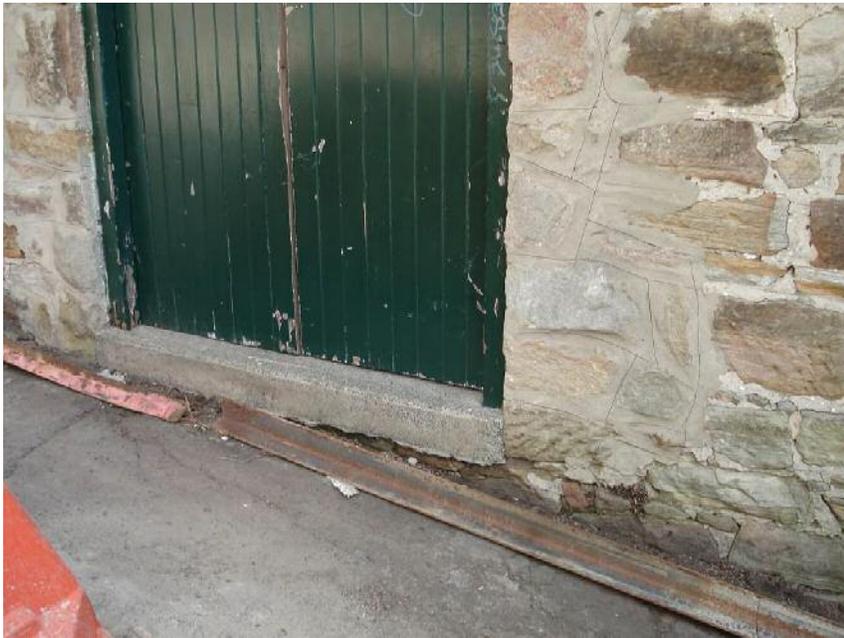
Figure 24 Photograph - the opening and door in the southern wall showing alterations using hard Portland cement render and a new concrete threshold. NBRSPartners (WDW), 2008.

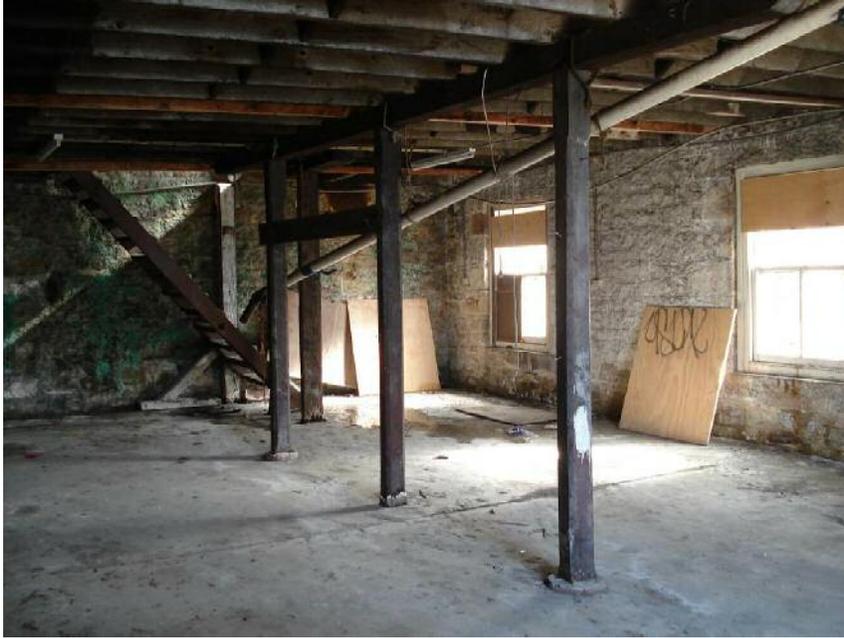
The walls are un-rendered sandstone rubble walls. There are serious damp issues particularly in the western and southern walls which retain the ground on the other side of the wall at least to the height of the first floor. Geotechnical investigations indicate that near the southern wall, rock can be found at 1.4 metres above ground floor level. The nature and condition of the outer side of the walls and their interface with the natural foundations has not been investigated and is unknown.

Figure 26 Photograph - The ground floor interior looking to the north-west. NBRSPartners (WDW), 2007/2008.

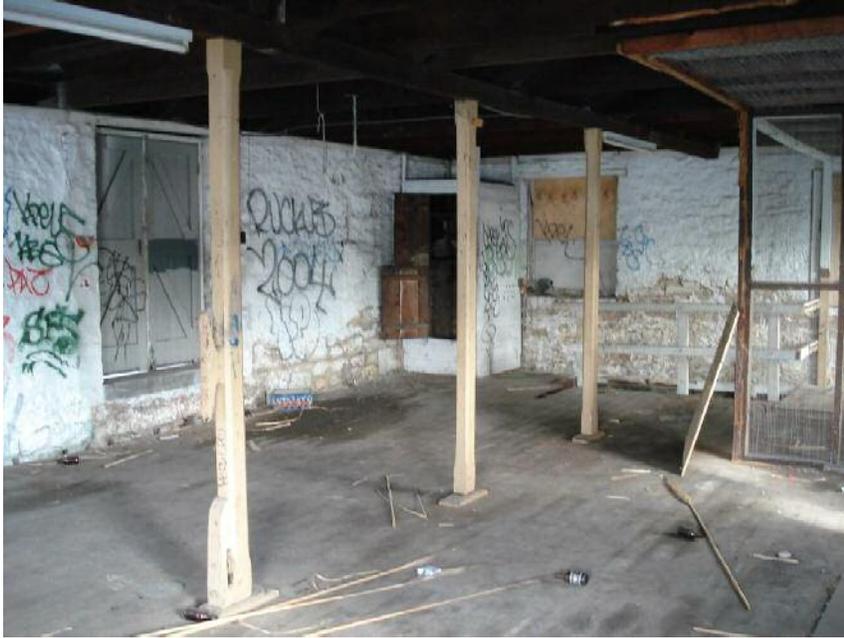
The floor is a timber floor comprising 140mm x 30mm tongue and groove boards laid east-west on timber joists (290mm x 50mm). The joists are partly supported from below on a beam carried by the ground floor posts. Joist pockets hold some of the ends of the joists but many joist ends have rotted or been effected by white-ant activity and have come away from the pockets. This is most evident along the southern wall where the floor has sunk. The floor is stiffened in parts with herring-bone strutting. Seven of the 26 joists have been replaced with glued laminated timber and it is these newer 'glu-lam' beams which show some of the most serious damage due to white-ants.

Figure 31 Photograph - The first floor interior looking to the south-west.
NBRS+Partners (WDW), 2008.

Recommendation 17 The building should be treated immediately for termites and a program of regular inspections should be established.
