HABERFIELD MAIN STREET STUDY 1993

Address: 75 - 77 Dalhousie Street Item No Page No 37 3/6 Name of Building:

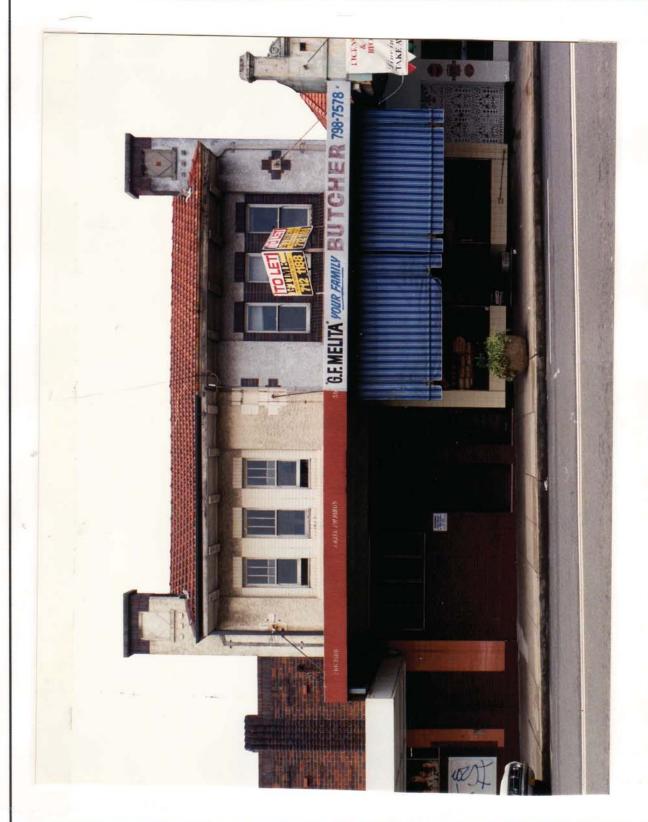
1993 PHOTOGRAPH

imitation mullion treatment. The end piers of the facade continue above the eaves line and have brick tops. There are decorative accents of brick and stucco. The suspended awning is of steel construction. Below this, the shopfront of No. 75 appears to retain its original form with a central ingo. No. 77 has been altered but still has a side entrance, alongside which is the entry to the upstairs occupancy.

Modifications: The awning appears to be of fairly recent construction. The shopfront of No. 77 has been largely filled in by brickwork and tiling. The top sashes of No. 75 have been altered to single panes.

| Item No. | Page 1 | No. | Addres | s: | 7: | 5 - 77 Da | alhous | sie Street | | | |
|---|---|---|---|---|---|---|---|---|---|---|---|
| Recommenda (a) Immedia | ate: | | | | | me for th | ne foor | ade above t | he awning. If | the n | aint |
| car | inot be | remo | oved from | face | brickwor | k it shou | ld be | overpainted | to match the | brick | colour. |
| (b) Medium Un | | rolle | r blind tr | eatme | nt and sig | gnage. | | | | | |
| (c) Long Te | erm: build th | e sho | opfront o | f No. | 77 to be 0 | compatit | ole wit | th that of N | o. 75. | | |
