DEVELOPMENT ASSESSMENT REPORT		
Application No. D/2018/672		
Address	147 Darling Street, Balmain	
Proposal	Removal of a Casuarina glauca (Swamp She-Oak) tree located	
	at rear of a heritage listed site.	
Date of Lodgement	20 December 2018	
Applicant	Carlene York	
Owner	Carlene York	
Number of Submissions	One (1)	
Value of works	\$2000.00	
Reason for determination at	t Partial demolition of heritage item (tree removal only)	
Planning Panel		
Main Issues Nil		
Recommendation	Recommendation Approval	
Attachment A	Recommended Conditions of Consent	
Attachment B	Statement of Environmental Effects	
Attachment C	Arborist Report	
Attachment D	Statement of Significance (Heritage Item)	
Attachment E	Statement of Significance (Waterview Estate)

Arboriculture Risk Assessment and Assessment for Damage. Date: 12<sup>th</sup> September 2018. Site: 147 Darling Street, Balmain

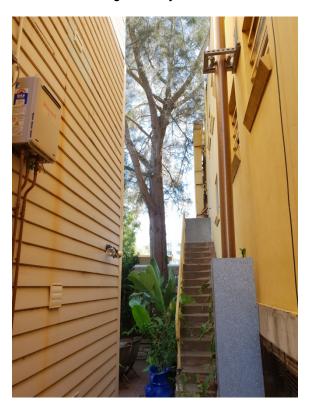
Image 4: Subject Swamp She-Oak tree (side setback)

- The height and canopy spread of the specimen was estimated to be 15 x 11m.
- At the time of inspection the specimen appeared to be in good health and vigour.
  No significant structural defects could be seen from ground level however a
  previously removed branch of 150mm in diameter at approximately 6.5m in
  height was noted from the southern aspect of the canopy.

- Several tree roots identified to be originating from the subject tree were observed to be extending through the raised garden bed and travelling beneath brick paving in the rear of the site for several metres.

- Evidence of root damage could be seen on the northern aspect of the base of the tree. The roots were observed to have been cut in line with recent paving for a pathway. The diameter of the roots were measured to be 60mm in diameter.

- A masonry garden shed was measured to be 170mm from the N/W face of the specimen however, the trunk could be seen to be visibly touching and callousing over the roof facing of the shed at 2.2m. A visible crack in the brick work could be seen directly adjacent to the base of the tree.

- Further cracking of brickwork was observed on the opposite side of the shed, indicating movement.

Replacement planting with minimum of 1  $\times$  200 litre size additional tree, which will attain a minimum mature height of 8 metres, shall be planted in a more suitable location within the property at a minimum of 1.5 metres from any boundary or structure.

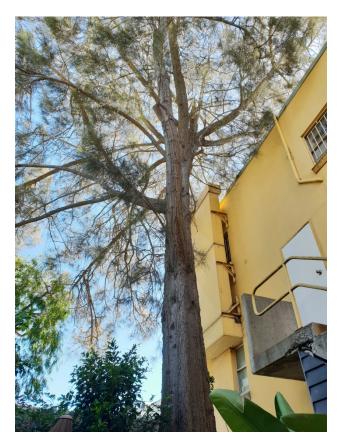
Image 5: Subject Swamp She-Oak tree (rear yard)

This assertion is supported as it is considered that the majority of the structural root system was restricted to the confines of the garden bed. The specimen has potential to become destabilized in its current location without the support of the external wall of the shed and retaining wall requiring repair.

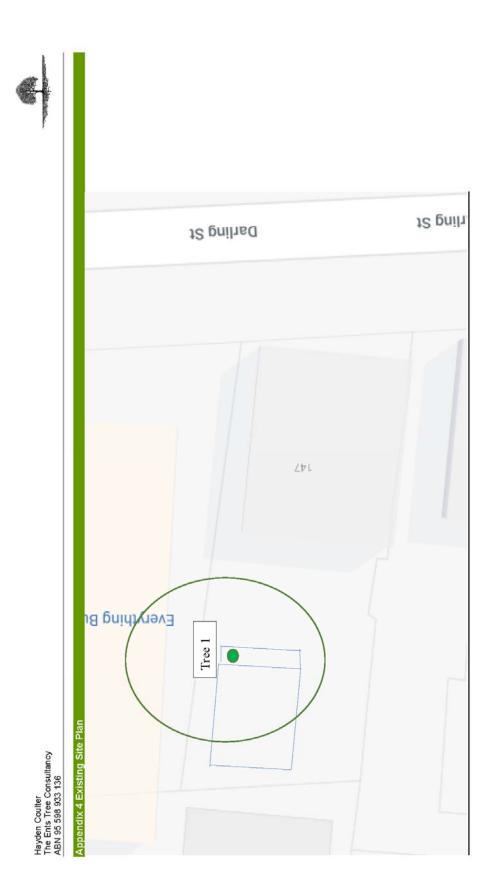
Appendix 3 Images of

- 4.3 Tree 1 is a mature tree that has average health, average vigour and below average form for this species. The tree has lost apical dominance. The tree has a low level of deadwood, a low level of dieback, a low amount of epicormic growth with reasonable average vitality at the time of the inspection. The tree has some dieback in its crown and tree has some included branch unions with previous failures evident. The tree has no significant defects within the trees structure that would warrant its immediate removal.

- 4.5 The structural root zone (SRZ) of the tree is calculated at 3.05m and the pruning of structural roots 50mm+ is not recommended within or at the edge of this area. This means that the options for pruning roots are limited and will not be effective in stopping the damage to the building wall. The tree will continue to cause damages to the surrounding structures. The damages to the paving and the retaining wall may be possible, however due to the position of the tree and the trees growth potential, options for repairing the damage to the wall and retaining the tree are not likely. The client has requested to remove the tree and replace it with a better specimen that will offer better amenity and function for the site. The replacement tree will replace the canopy cover lost and could improve the canopy cover for the area.

- 5.1 Tree 1 is a mature tree that has average health, average vigour and below average form for the species. The tree has a risk potential that is deemed to be a low risk to people and a low risk to property.
- 5.2 Due to the position of the tree, the existing damages and the trees growth potential it is not likely that the damages could be repaired effectively and the tree retained. The client would like to remove the tree to repair the damages that are present. This appears to be a reasonable request.
- 5.3 If the tree is removed it should be replaced with a better specimen it a more suitable position replacing the canopy cover lost.
