DEVELOPMENT ASSESSMENT R	
Application No.	DA/2020/0671
Address	Callan Park
	Glover Street LILYFIELD NSW 2040
Proposal	Demolition of building 508, tree removal, fence replacement and
	potential remediation of land
Date of Lodgement	18 August 2020
Applicant	Megan Parker
Owner	Health Administration Corporation
Number of Submissions	2 submissions received
Value of works	\$80,000.00
Reason for determination at	Complete demolition of a building at heritage listed site
Planning Panel	
Main Issues	Nil
Recommendation	Approved with Conditions
Attachment A	Recommended conditions of consent
Attachment B	Statement of Environment Effects
Attachment C	Statement of Heritage Significance
Attachment D	Ministerial Waiver and Heritage Exemptions Letters
Attachment E	Structural Condition Assessment Report
LOCALITY MAP Subject Site	Objectors N
Notified Area	Supporters
Note: Due to scale of map, not all o	bjectors could be shown.

Building 508 demolition, tree removal and fence replacement

Condition Assessment Report

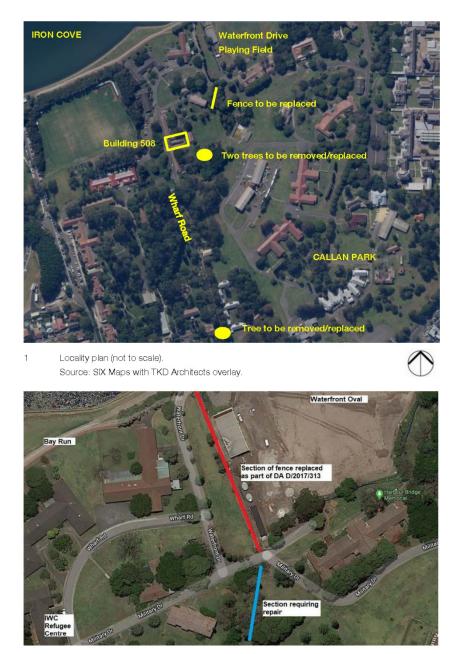
2 Location of fencing to be replaced. This section of fencing is highlighted in blue. Source: National Parks & Wildlife Service.

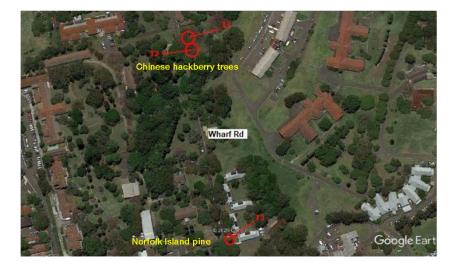
Location of trees to be removed and replaced.
 Source: National Parks & Wildlife Service.
