19 September 2023

Our ref: 23WOL4937

Cook to Cove Greenway – Compensatory Microbat Habitat Installation

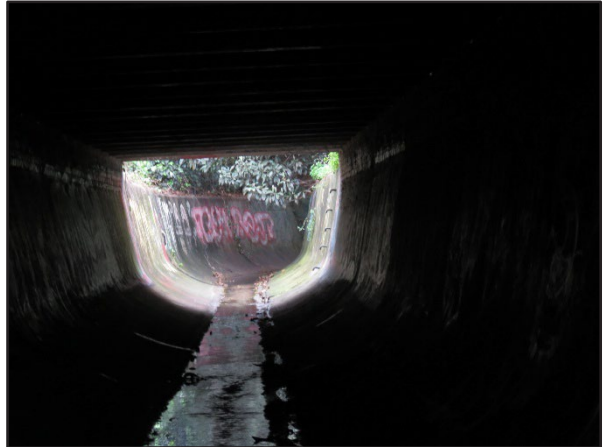
Culvert showing light intrusion

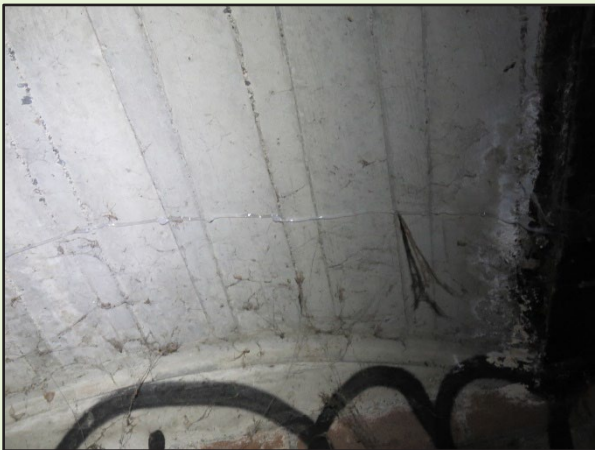
Roof of culvert with compensatory silicone habitat installed.

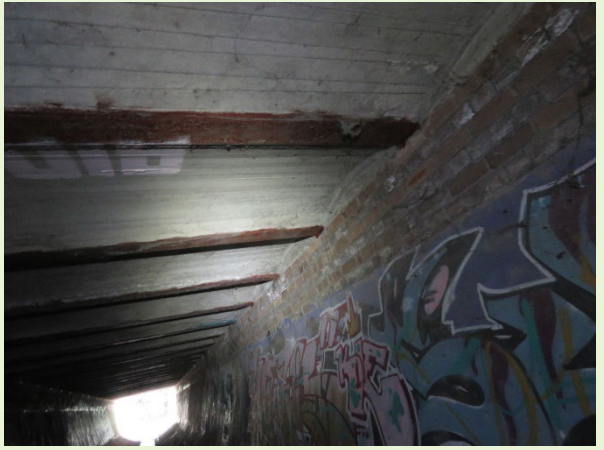
Roof of culvert showing cobwebs and existing potential habitat

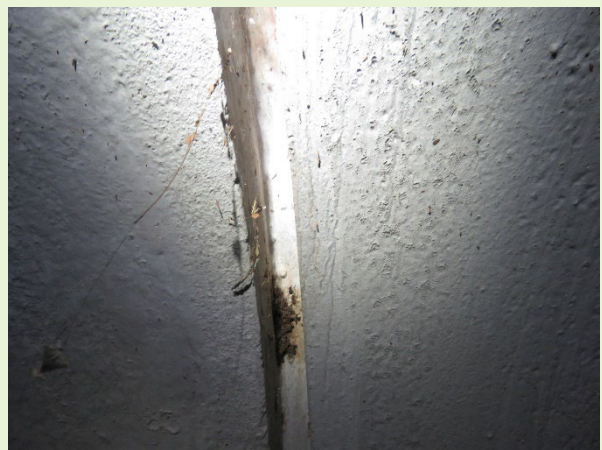
Roof of culvert showing discolouration

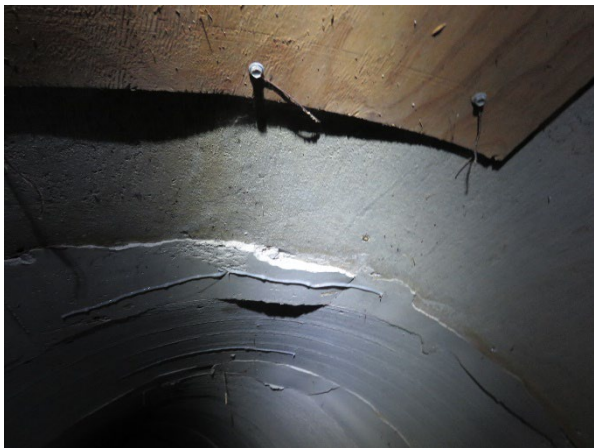
Compensatory silicone habitat and potential existing habitat

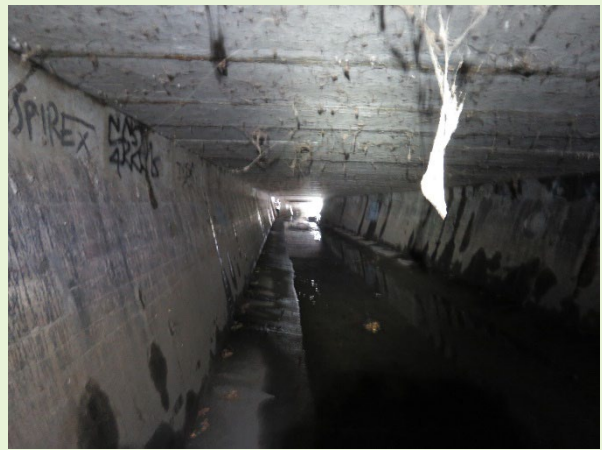
Cobwebs indicating lack of current use

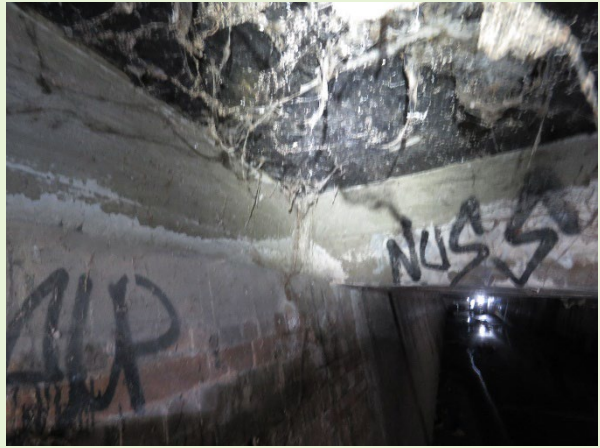
Cobwebs indicating lack of current use

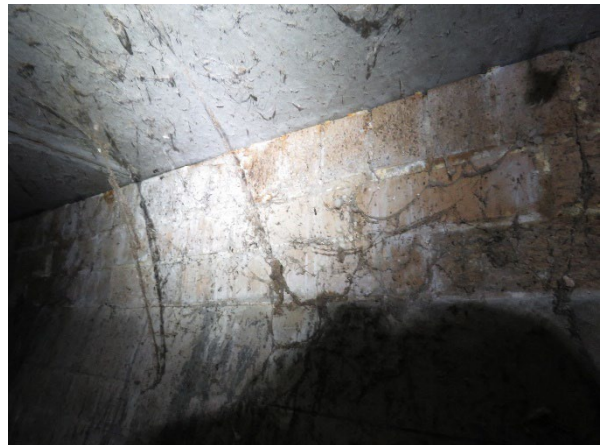
Cobwebs indicating limited current microbat use

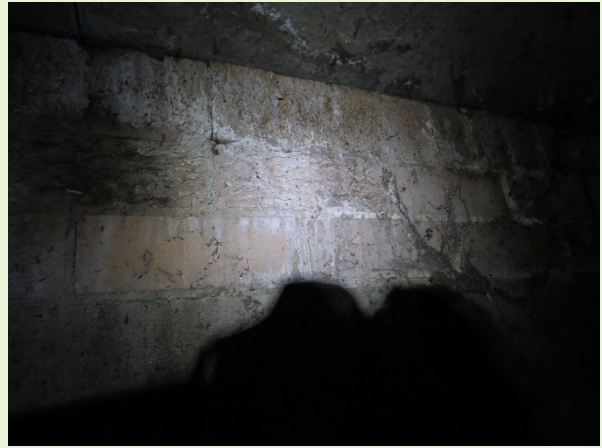
Cobwebs indicating limited current microbat use
