DEVELOPMENT ASSESSMENT REPORT

<b>Application No.</b>	REV/2022/0026
<b>Address</b>	5 Farleigh Street ASHFIELD NSW 2131
<b>Proposal</b>	S8.2 Review application of DA/2022/0244 that approved tree pruning. The review seeks tree removal and pruning.
<b>Date of Lodgement</b>	13 September 2022
<b>Applicant</b>	Mrs Joanne M Herron
<b>Owner</b>	Mr Adam J Herron Mrs Joanne M Herron
<b>Number of Submissions</b>	One (1)
<b>Value of works</b>	\$12,000.00
<b>Reason for determination at Planning Panel</b>	Refusal of S8.2 Review
<b>Main Issues</b>	Removal of healthy tree
<b>Recommendation</b>	Refusal
<b>Attachment A</b>	Reasons for refusal
<b>Attachment B</b>	Arborist's report
<b>Attachment C</b>	Conditions of consent (in the event of approval)

<b>ABN</b> <b>97 363 034 490</b>	PRELIMINARY TREE ASSESSMENT FOR A TREE LOCATED IN 5 FARLEIGH STREET, ASHFIELD
Phone 0405 626 970  Email majbruce@hotmail.com

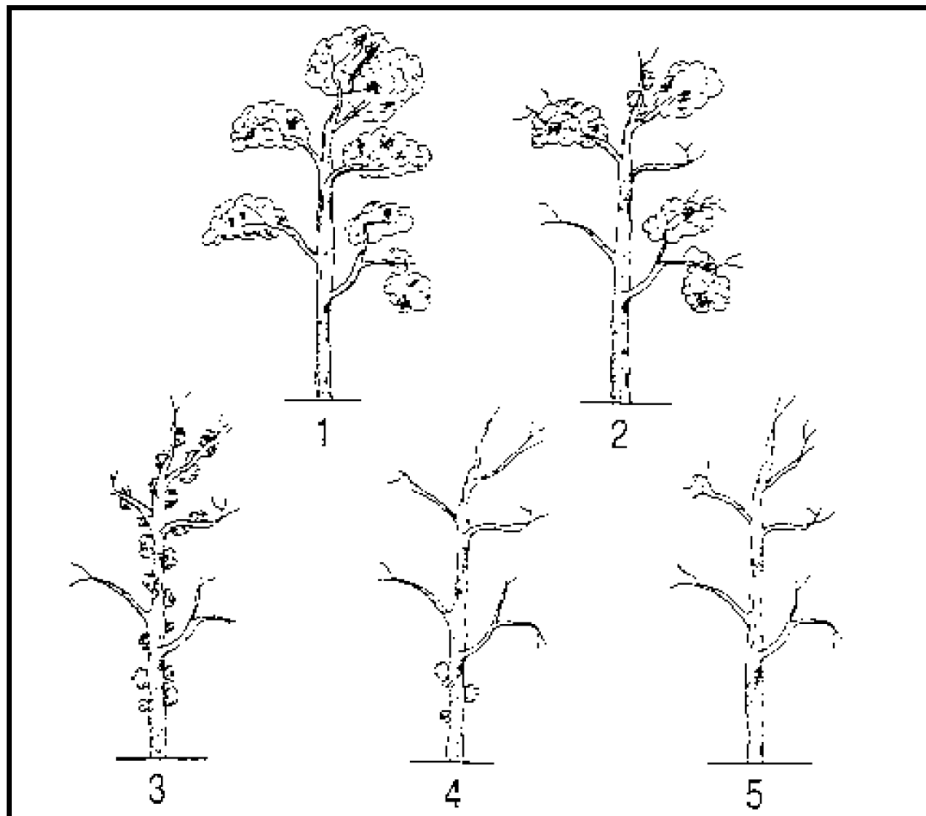
Figure 2: Crown decline

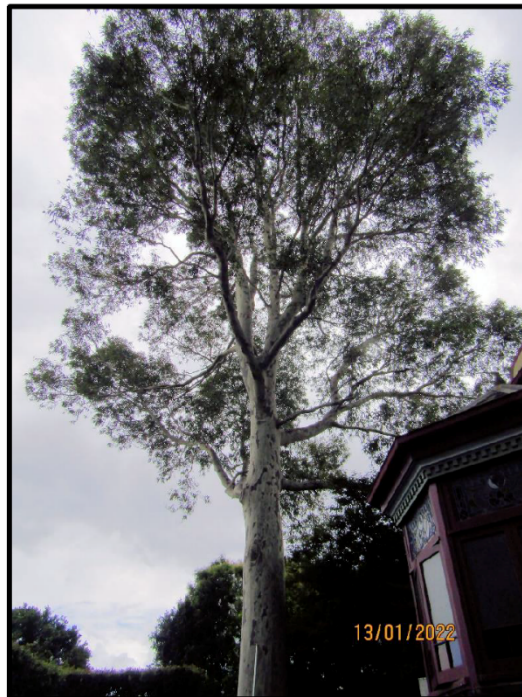
- 5.1 Tree 1 is a mature *Corymbia maculata* (Spotted Gum). (See Figure 4) This is visible in the 1975 historic aerial photograph, as a small sized tree and but is not present in the 1971 historic aerial photograph. (See DCS 2020) This suggests that the Spotted Gum is between 47 and 50 years old. The Spotted Gum is in very good condition. The tree is a moderately sized Spotted Gum, with a height nearly 20 metres, a Tree Protection Zone (TPZ) of 11 metres and a Structural Root Zone (SRZ) of 3.5 metres. (See Table 3) There is swimming pool located 2.22 metres from the Spotted Gum's trunk, placing the pool within the SRZ. (See Figure 5) The problem with the Spotted Gum is the potential size that this tree may reach. Eucalid (2022) describes Spotted Gum as a "tree to 45 metres tall, forming a lignotuber". The local soil is described by OEH ESspade V2 (2022) as Blacktown Soil Landscape. Chapman and Murphy (1989) P.38 describe these soils as with "General fertility is low to moderate. Soil materials have low to moderate available water capacity." This suggests that this Spotted Gum will not reach 45 metres but may grow to between 35 and 40 metres in height. This suggests that the Structural Root Zone (SRZ) may be as large as 4 metres;

Figure 4: The *Corymbia maculata*

- 6.1 The Spotted Gum should be removed, as this tree has reached a size where damage to the allotment's infrastructure will increase and the buttress roots will become a dangerous trip hazard. If the tree is removed, replacement with a species suitable for the size of the area will be required;
- 6.2 The Sydney Blue Gum will require remedial pruning to rebalance the crown.

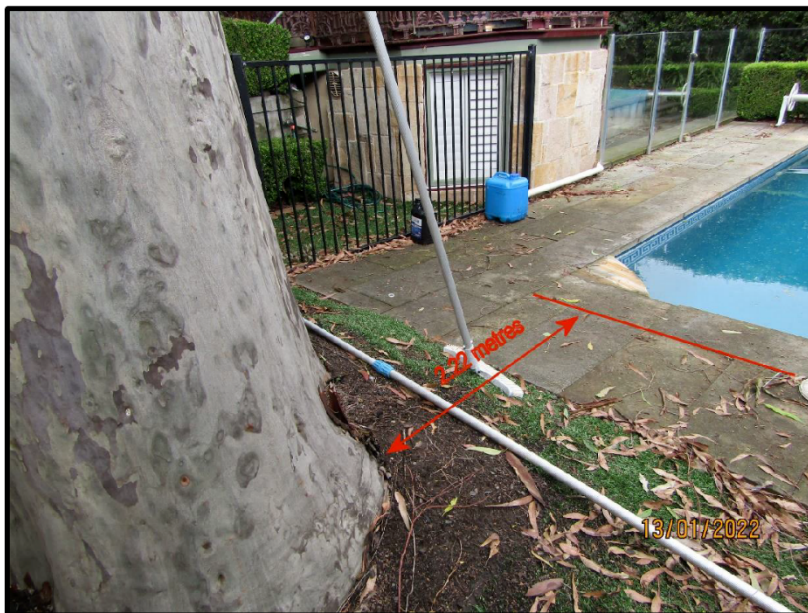
Figure 5: Showing the proximity of the *Corymbia maculata* to the pool wall

- 5.2 The Spotted Gums structural roots are highly likely to be pressing against the wall of the swimming pool. This pressure will increase as the tree gets bigger. There is the potential that the Spotted Gum will eventually cause the development of vertical cracks in the fabric of the swimming pool wall. Mattheck et al (2003), P.758 states "As far as the interaction with buildings is concerned, the small fatigue strength of the brickwork against the fatigue loads introduced by the root also plays a major role. Even small roots may cause damage to the building by fatigue load." and "Against a wall pressing roots (lateral force) can cause different crack formations" (See Figure 7 and Figure 13) There is the potential for the swimming pool wall to fail from compression forces generated by the Spotted Gum's structural roots and amplified by strong winds. The Spotted Gum has already started to buttress, and the structural root are beginning to disturb the soil surface and artificial turf, as they expand in dimension, and the roots are becoming a trip hazard. (See Figure 9) There are structural roots starting to lift the pool safety fence. (See Figure 10) Further, there is a large crack developing in a nearby retaining wall. (See Figure 11) The cracks pattern is similar to the pattern described by Mattheck et al (2003), P.758, (See Figure 12) with the crack appearing to be larger at the top with the top of the wall curving up at the top of the crack. This Spotted Gum will continue to damage surrounding structures, with the potential to cause damage to the heritage listed dwelling. Unfortunately, the Spotted Gum is too large for the location and should be removed;

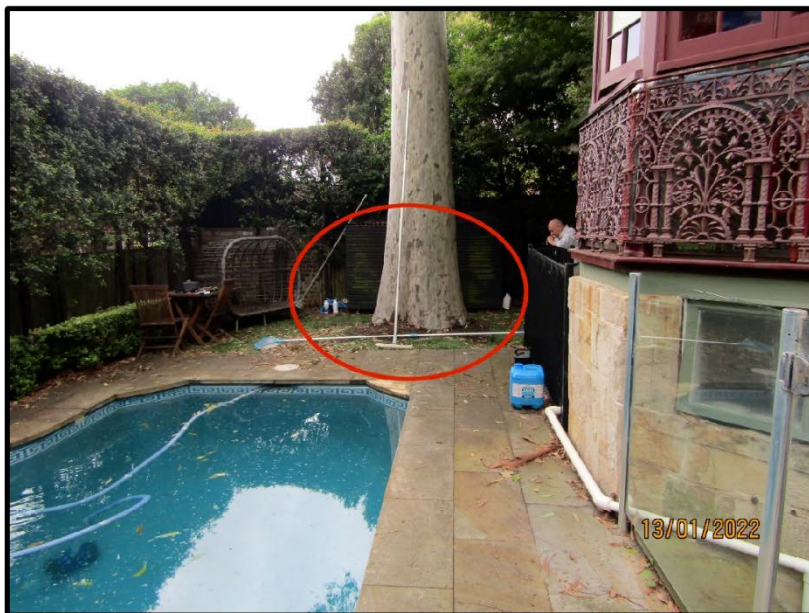
Figure 8: Showing the developing buttress on the Spotted Gum

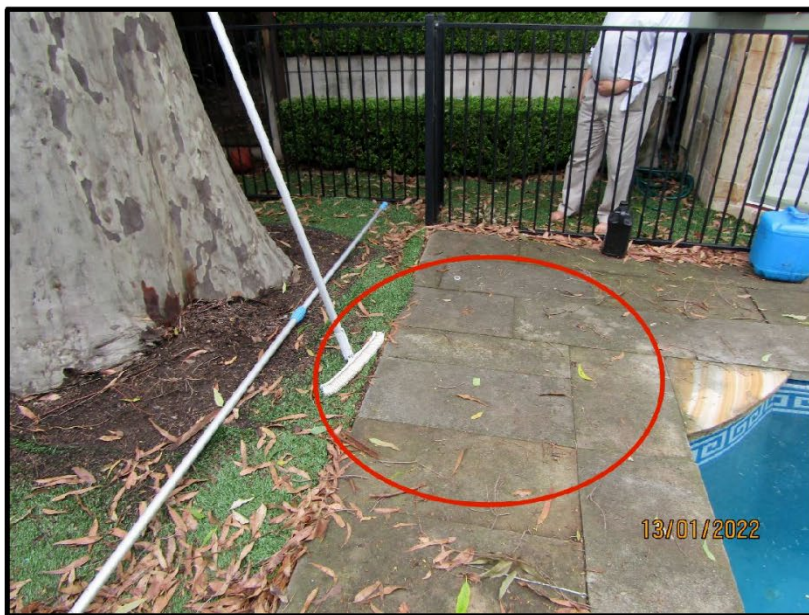
Figure 9: Spotted Gum's structural roots lifting the flag stones around the swimming pool edge

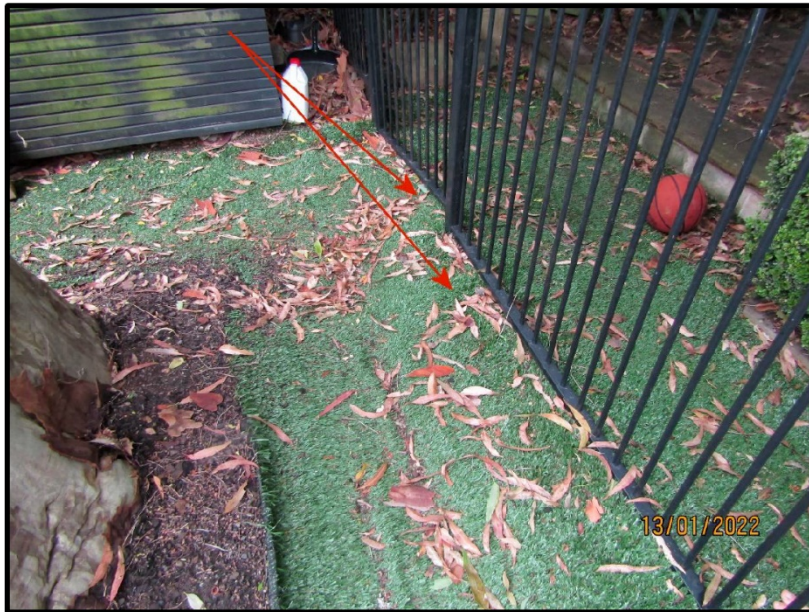
Figure 10: Showing the Spotted Gum's structural roots starting to lift the pool safety fence and interfering with the operation of the gate.

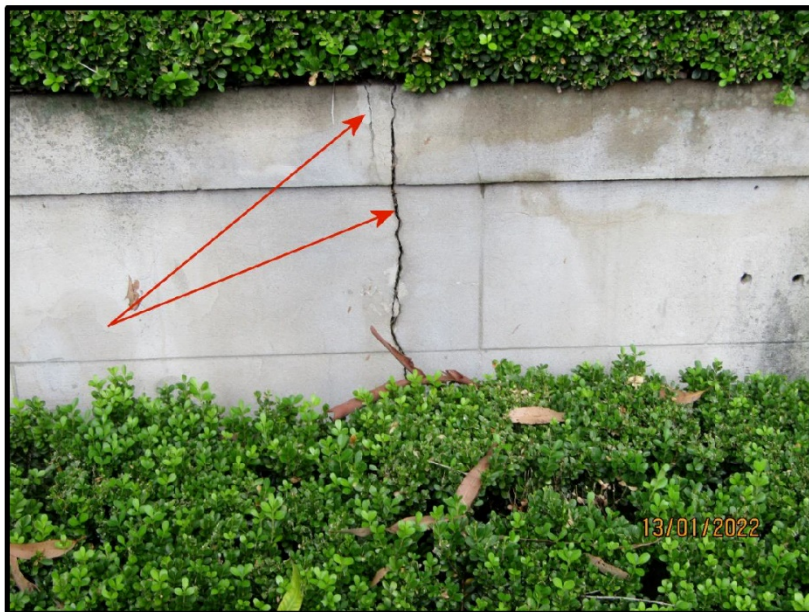
Figure 11: Showing the crack in the retaining wall with the crack larger nearer the top of the wall and a second crack developing near the top as the top of the wall starts to separate

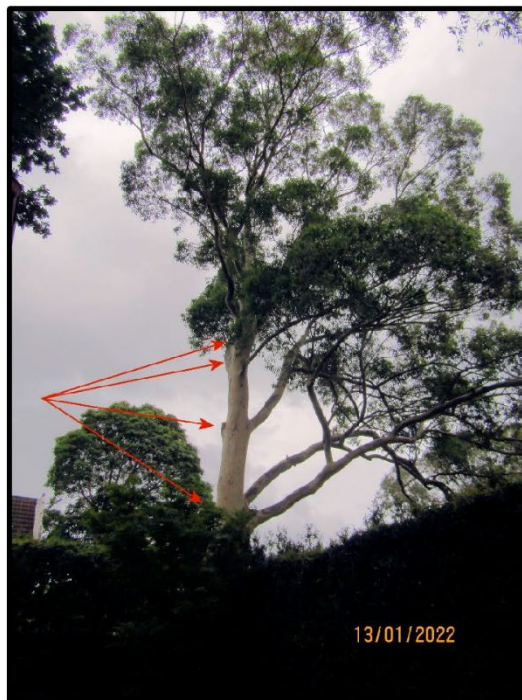
The review application seeks pruning additional to that approved under DA/2022/0244. It is noted that a number of large diameter first order branches have previously been removed to south along the shared boundary line, inconsistent with Australian Standard 4373—Pruning of amenity trees: The tree has an asymmetrical crown.

- 5.3 Tree 2 is a *Eucalyptus saligna* (Sydney Blue Gum). The tree is same age as the Spotted Gum (Tree 1). This tree was not measured or subjected to a complete Visual Tree Assessment (VTA) (Mattheck & Breloer 1994). The tree has been heavily crown reduced on the eastern and south-eastern sides of the trunk with at least three large first order branches having been removed, effectively crown lifting the tree. (See Figure 13) This has left the Sydney Blue Gum with an unbalanced crown. Fielding (1967) suggests that the effect of an unbalanced crown will cause a corresponding inequality in the width of growth ring around the trunk. This is supported by Mattheck (2007) P. 67, where he describes a tree "which will put on less and less radial increment from the top down". Mattheck, also, implies that the loss of the lower first order branches will reduce root growth, resulting in a smaller root plate. There is considerable weight of crown with several large first order branches over 22 Clissold Street. The branch architecture arising from these first order branches is very crowded and should be thinned. (See Figure 14) The weight of the crown must be redistributed and the crown pruned to a more symmetrical form. This may require the removal of some lower order branches and a reduction in the length of the first order branches.

Figure 13: Showing the Sydney Blue Gum and where the first order branches were removed indicated with arrows

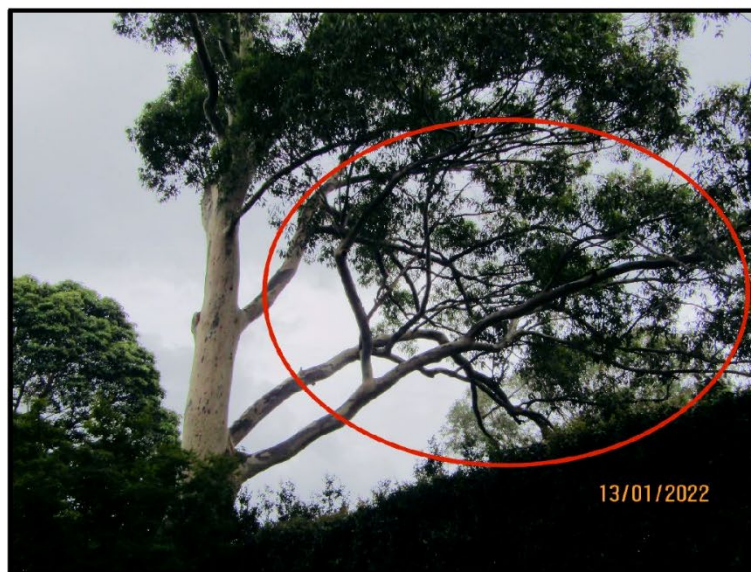
The proposed additional pruning to the lower lateral branches is considered excessive as extensive pruning can be hazardous to a tree and pre-dispose branches to become more susceptible to failure.

Figure 14: Showing the crowded lower branch architecture that needs to be thinned and shortened
