HCA 3 Petersham North Heritage Conservation Area

Figure 3.1 HCA 3 Petersham North Heritage Conservation Area

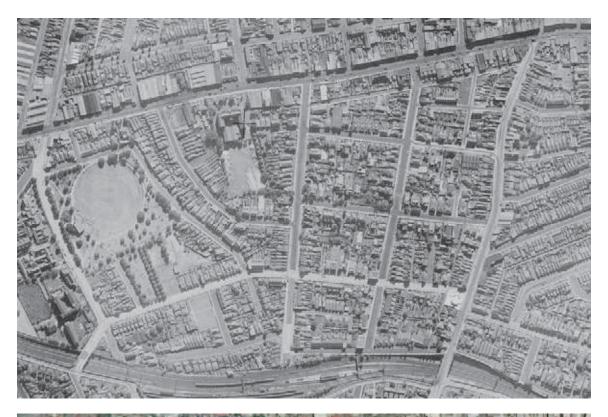
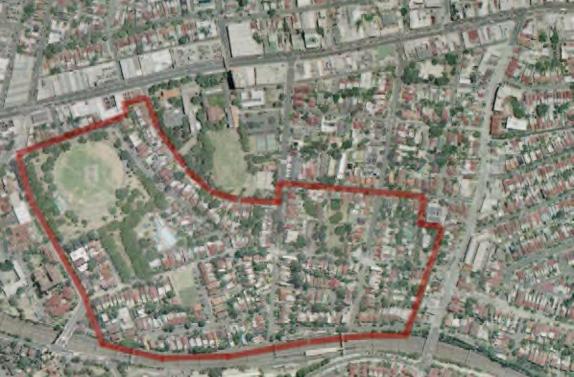
Figure 3.2 The Area in 1943 and 2009 (source: NSW Lands Department SIX Viewer)

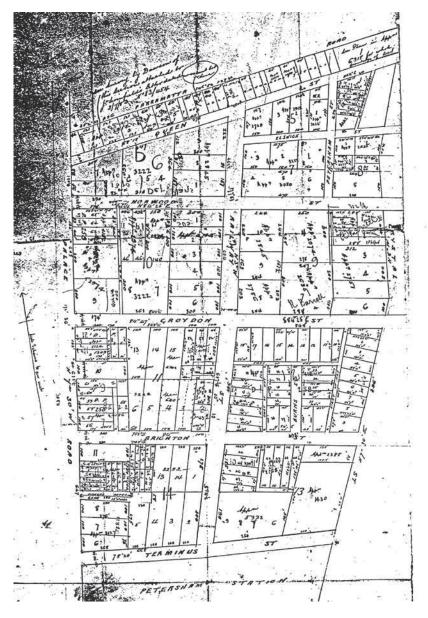
Figure 3.3 The Area has been subjected to many successive subdivisions – the original Petersham Estate was divided along the line now followed by Palace Street; with the eastern section becoming known as the Sydenham Estate. Each was then re-subdivided into successively smaller parcels leading to today's somewhat erratic subdivision pattern.

The subdivision patterns are irregular and demonstrate the effects of successive layers of infill subdivision of the early villa allotments created from the Petersham and Sydenham Estates. There is no formal laneway system, with many properties not having rear access. This reflects the piecemeal nature of the infill subdivisions in the area.
