HCA 4 Railway Street (Petersham) Heritage Conservation Area

4.1 LOCATION

4.2 DESCRIPTION

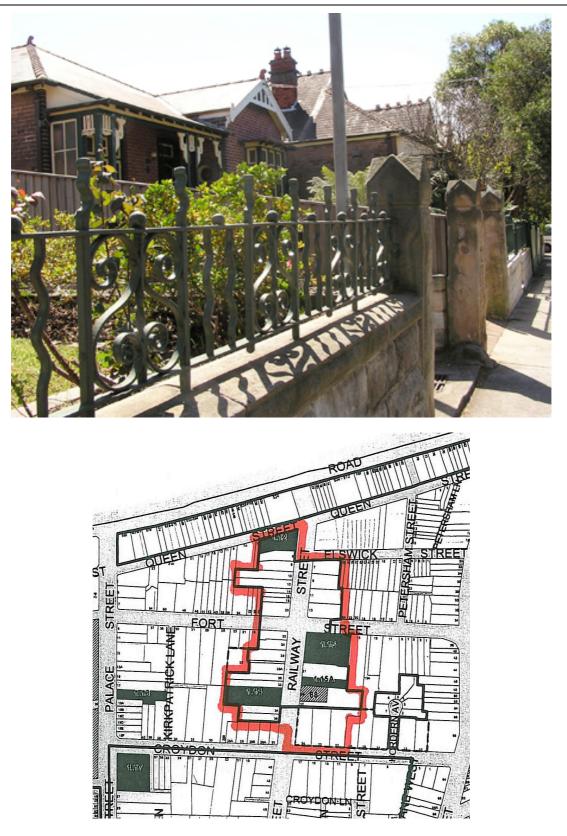
Figure 4.1 HCA 4 Railway Street Heritage Conservation Area

The Railway Street Heritage Conservation Area is located in north Petersham between Parramatta Road and Croydon Street; and between Palace and Crystal Streets.

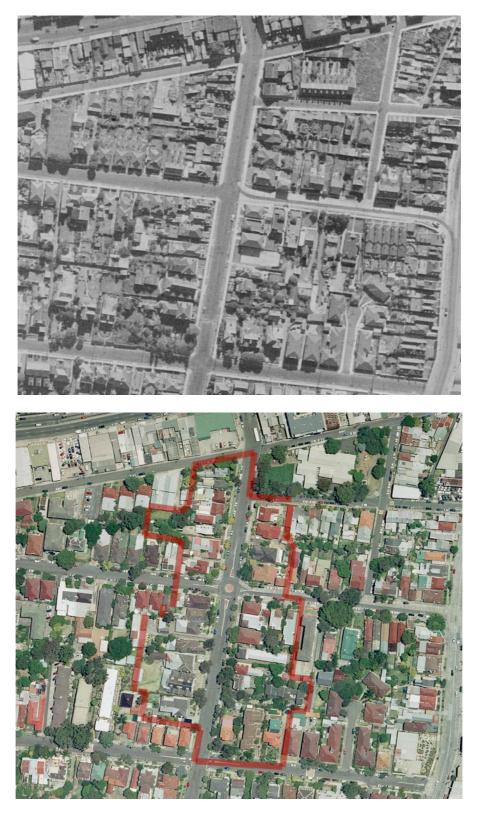
Figure 4.2 The Area in 1943 and 2009 (source: NSW Lands Department SIX Viewer)

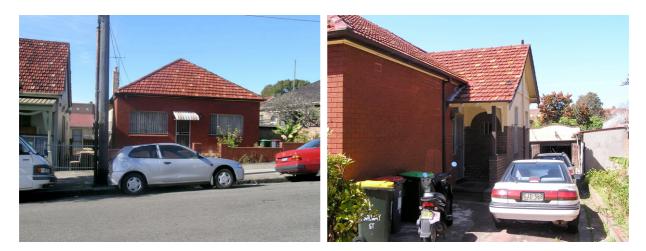
Figure 4.9 and Figure 4.10 This cottage has been layered by the addition of a red texture brick facade in the post-war years. The original Federation cottage can still be seen behind the addition.
