HCA 7 Kingston West Heritage Conservation Area

7.1 LOCATION

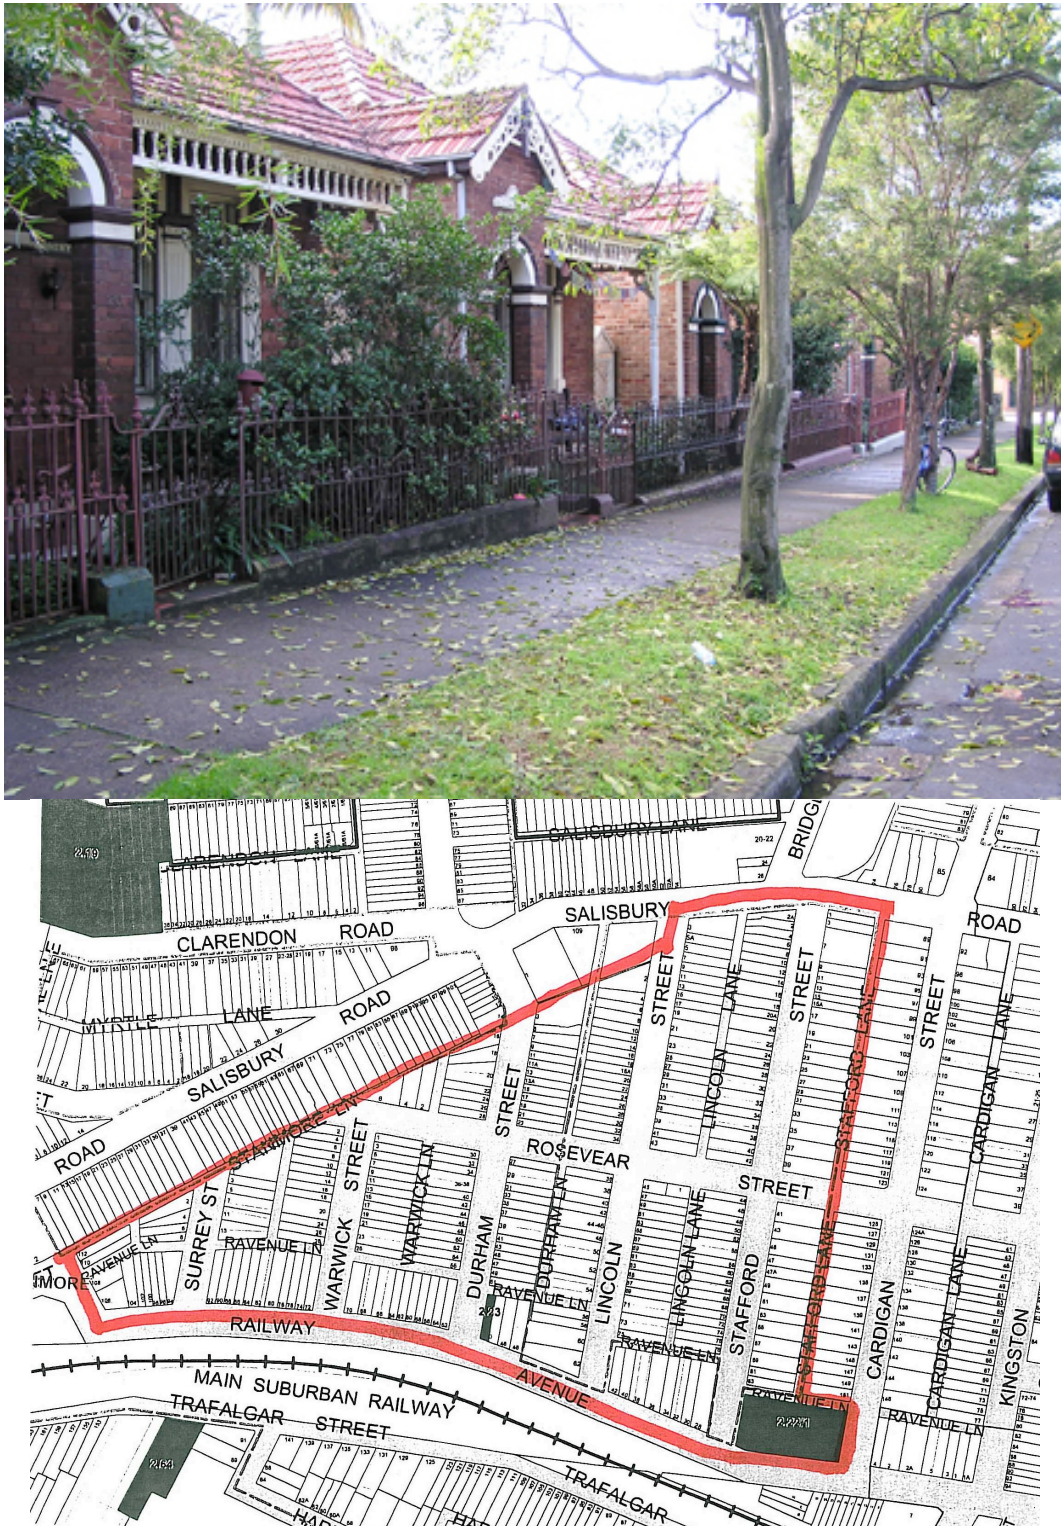
Figure 7.1 HCA 7 Kingston West Heritage Conservation Area

The Kingston West Heritage Conservation Area is located in Stanmore between Salisbury Road and the main western railway line.

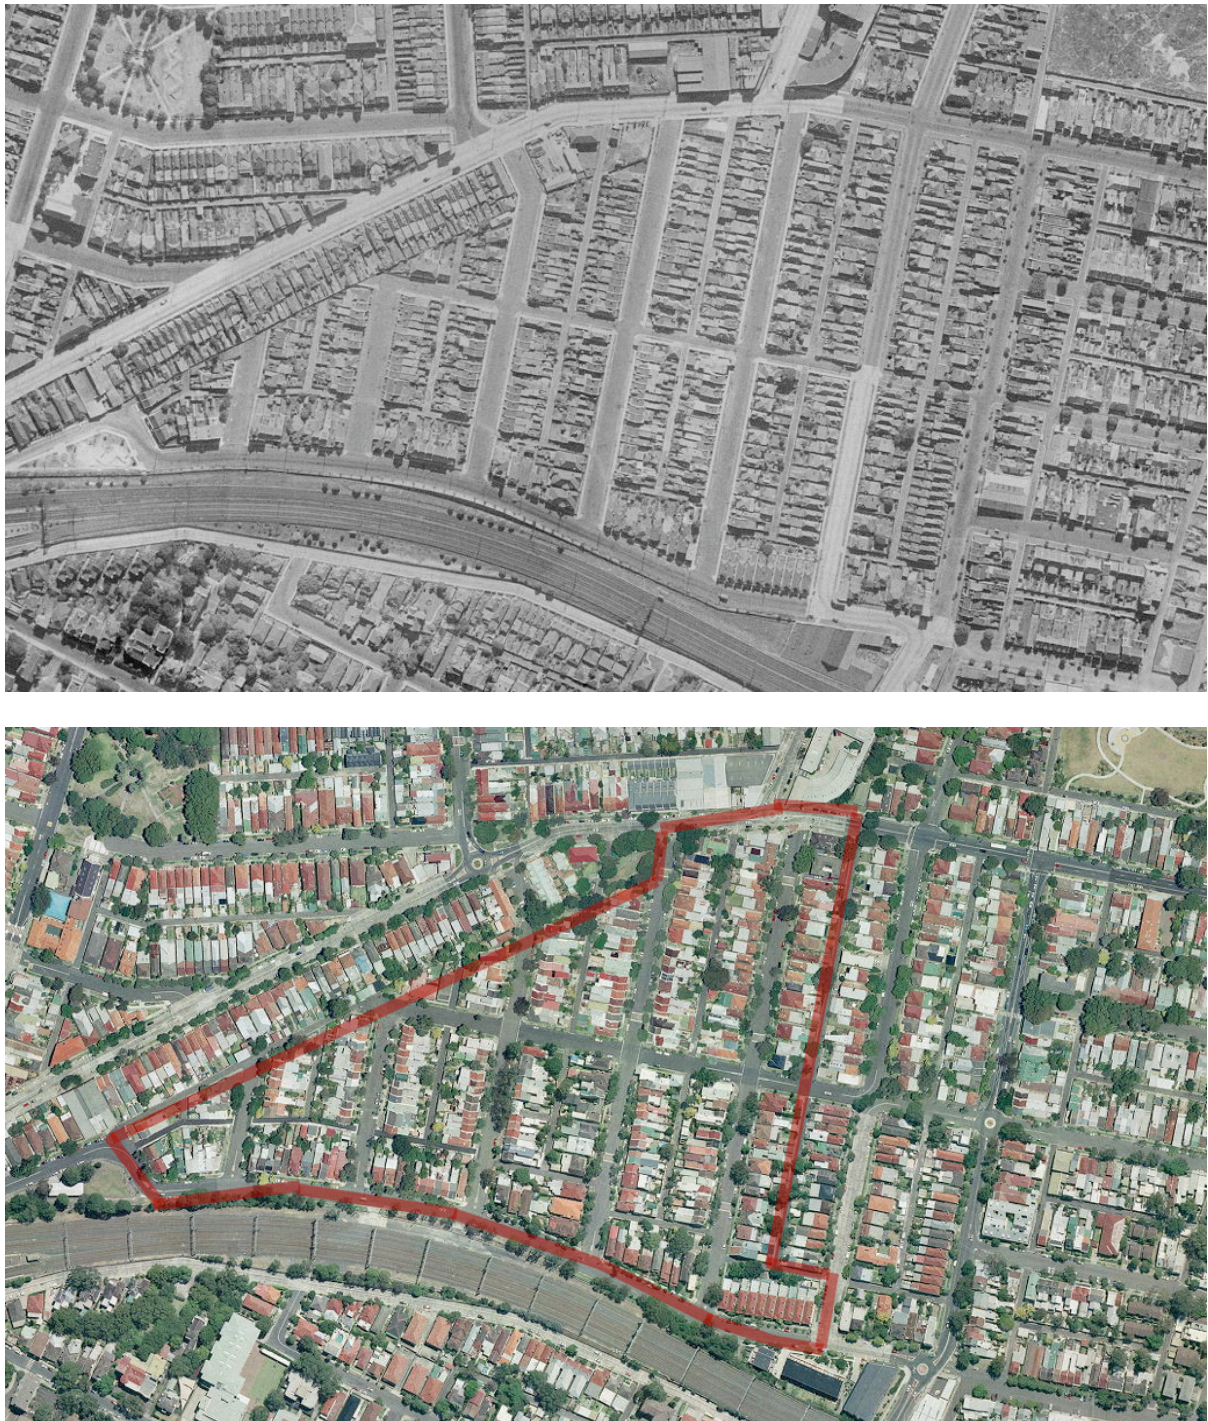
Figure 7.2 The Area in 1943 and 2009 (source: NSW Lands Department SIX Viewer)

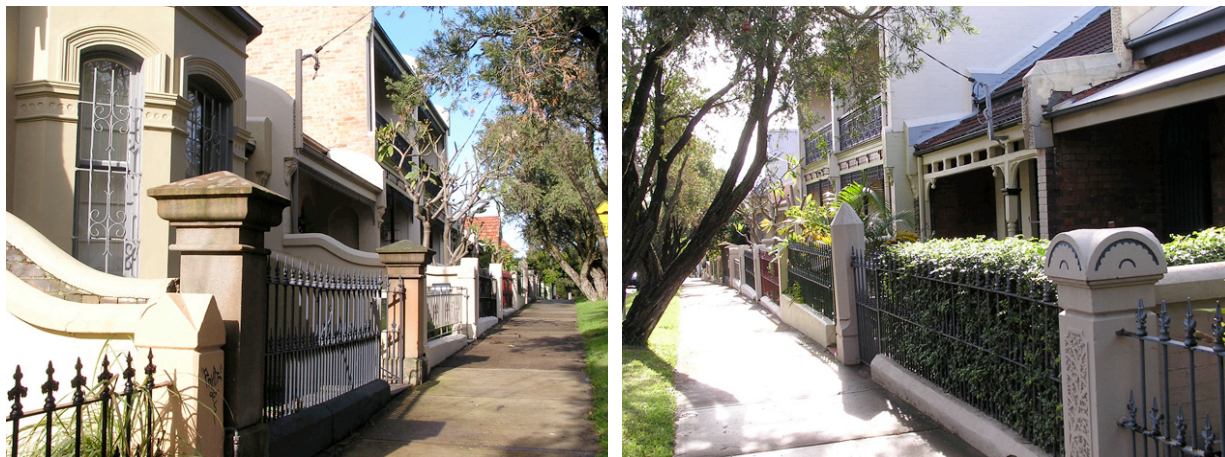
Figure 7.3 and 7.4 The consistent setbacks, fences and terraced built forms have resulted in highly cohesive streetscape throughout the area, including some very good individual examples.

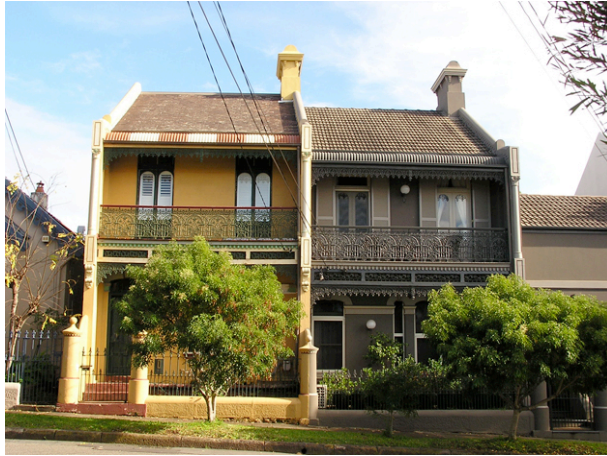
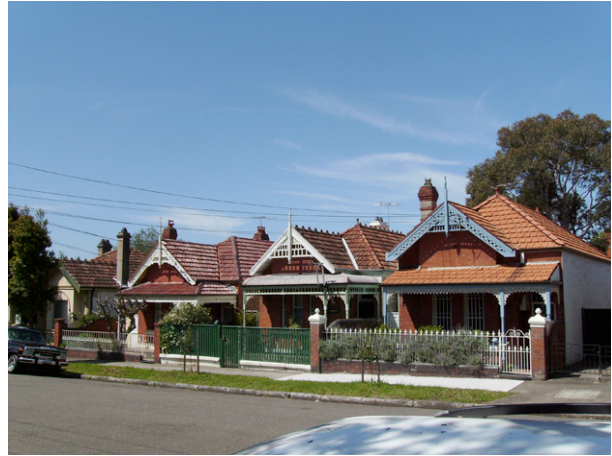
Figure 7.5 and 7.6 The area includes both substantial two-storey terraces and modest Federation cottages. The consistent subdivision patterns have ensured a rhythmical streetscape character, emphasised by the groups of identical dwellings which create a strongly expressed roofscape and contribute to the aesthetic significance of the area.

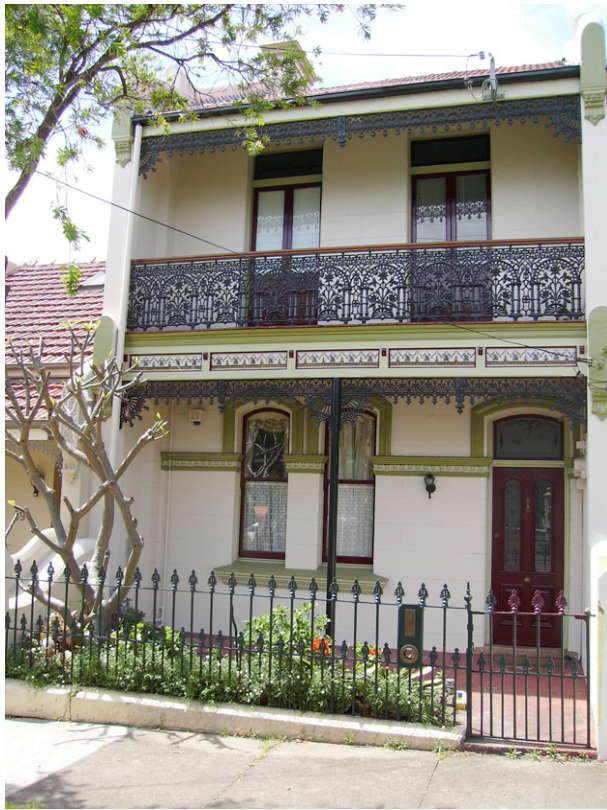
Figure 7.7. A typical terrace with iron palisade fence

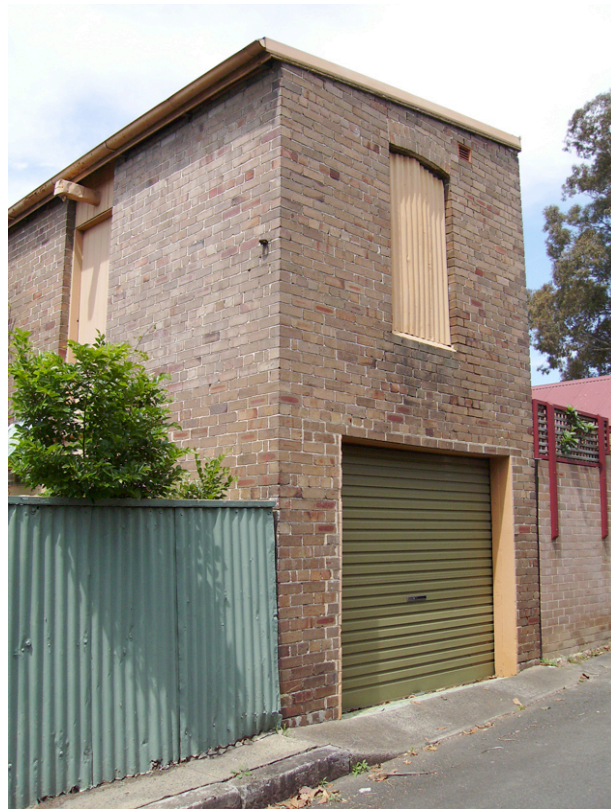
Figure 7.8. The original stable and store at the rear of this property has been converted to a garage. Its form is simple and unadorned using common brickwork.

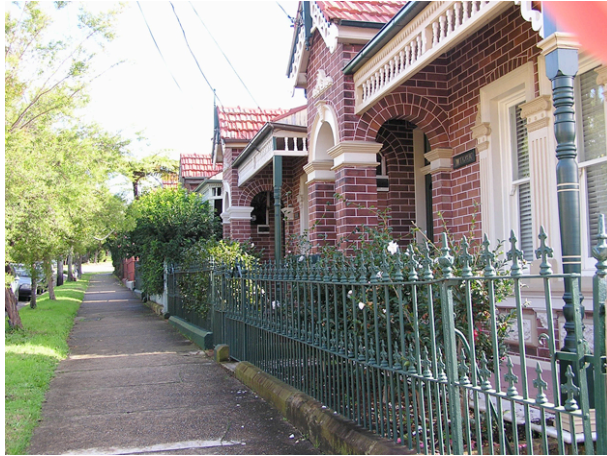
Figure 7.9. This group of modest Federation terraces facing Railway Parade is substantially intact and continues to demonstrate many of the finer details of Federation cottage design which is often lost through subsequent redevelopment. These include tradesmen's gates as well as the pedestrian gate, lattice screens to side passages and fine detailing to the façade.

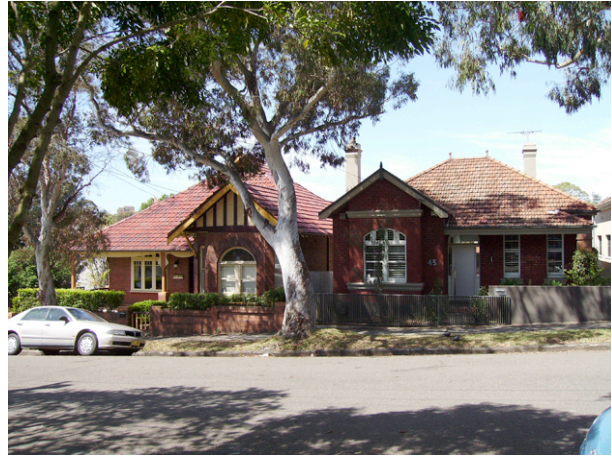
Figure 7.10. The area also includes good examples of the Federation style as it was built in the Marrickville area.

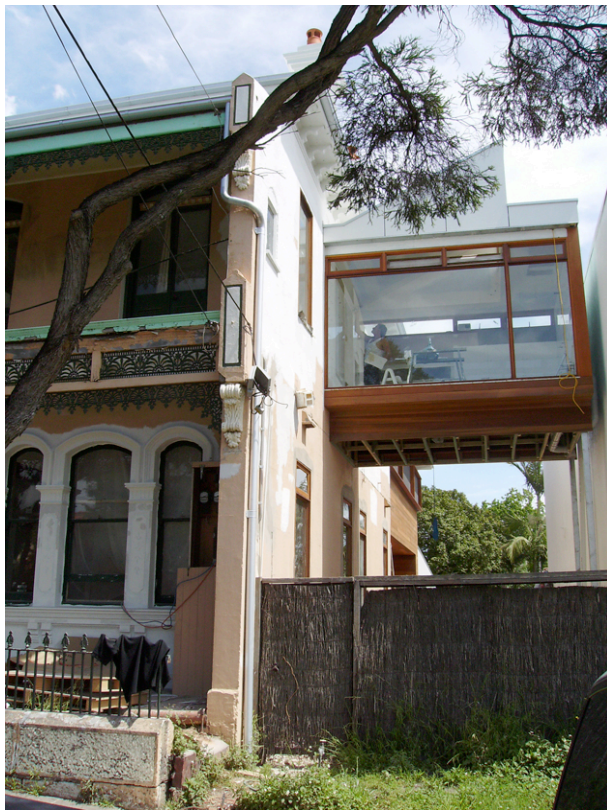
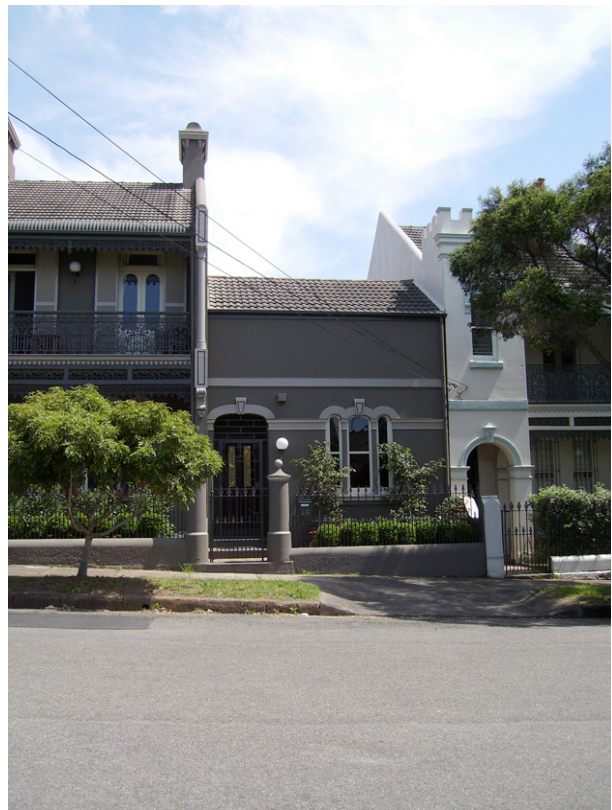
Figure 7.11 and 7.12. The area also demonstrates some contemporary solutions to alterations and additions. These range from the original to the traditional in approach.

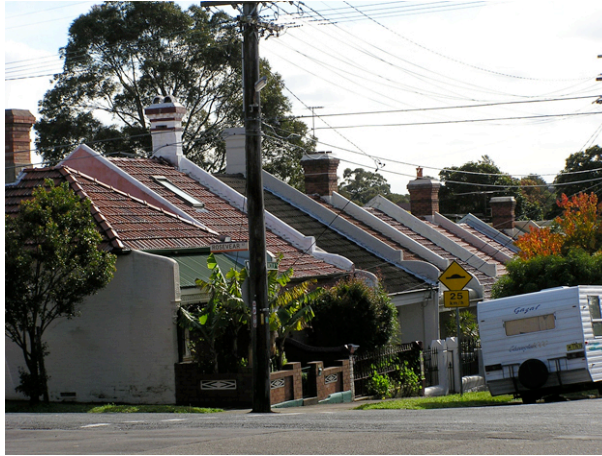
Figure 7.13. Streetscape view. The dividing walls and chimneys are an important element of the roovescape as it steps down the hill towards Salisbury Road.

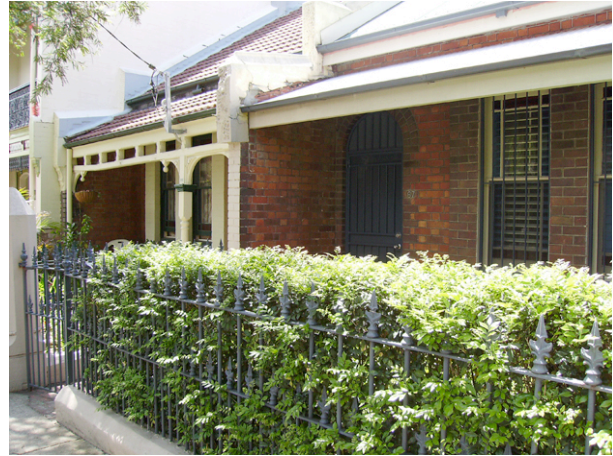
Figure 7.14. Detail of the facade of modest Federation era terraces demonstrating duochrome brickwork. Simple security bars painted a dark colour help to minimise their visual impact on the streetscape.

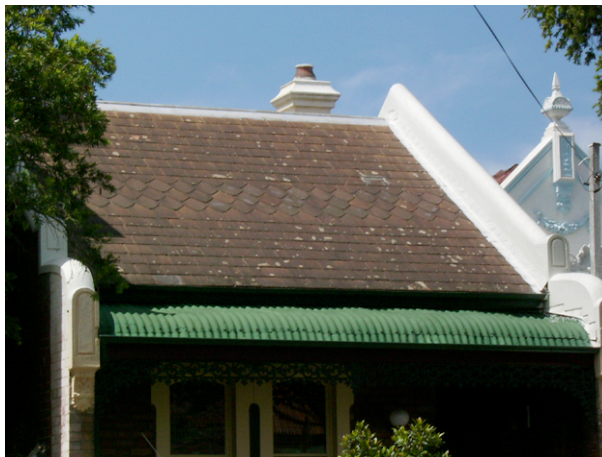
Figure 7.15. This original slate roof is finely textured and adds to the aesthetic value of the Area

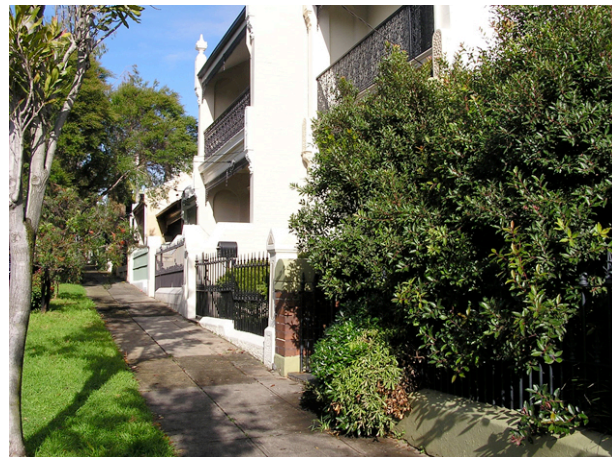
Figure 7.16 the footpath is separated from the road by a grass verge planted with mainly native street trees.

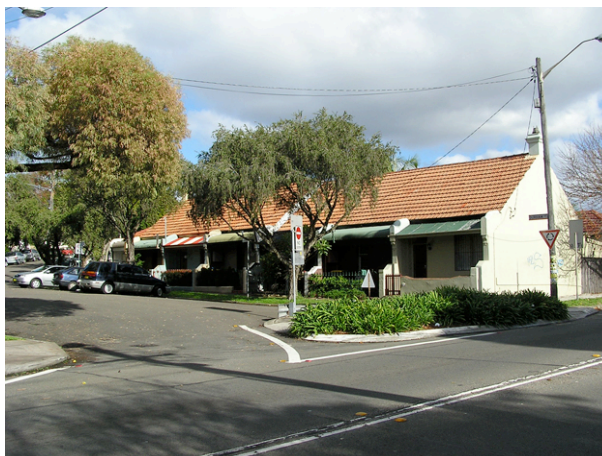
Figure 7.17. The entry to the area from Salisbury Road is marked by this good group of simple terraces under a common roof.

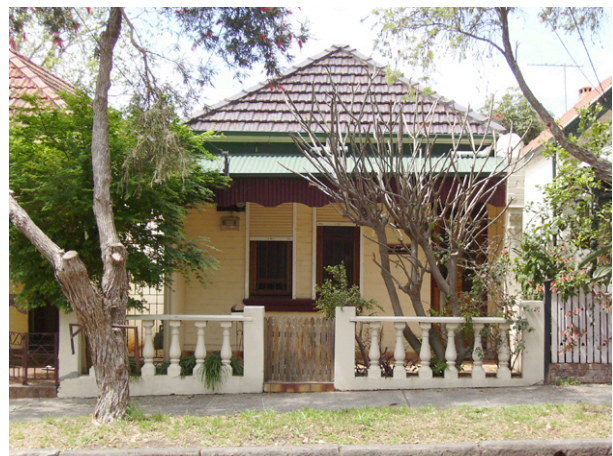
Figure 7.18. Changes such as rendering face brickwork, replacing the iron palisade fence with cement balustrading and the installation of roller shutters changes the aesthetic quality of the original cottages.

Layering to surviving existing buildings varies from minor to intrusive and the current gentrification trends are having a significant impact on the face brickwork throughout the area, with examples of recent rendering and painting found as well as examples of more major additions, some of which are highly innovative in their design.
