HCA 9 Hopetoun-Roberts-Federation Streets Heritage Conservation Area (Camperdown)

Figure 9.1 HCA 9 Hopetoun-Roberts-Federation Streets Heritage Conservation Area

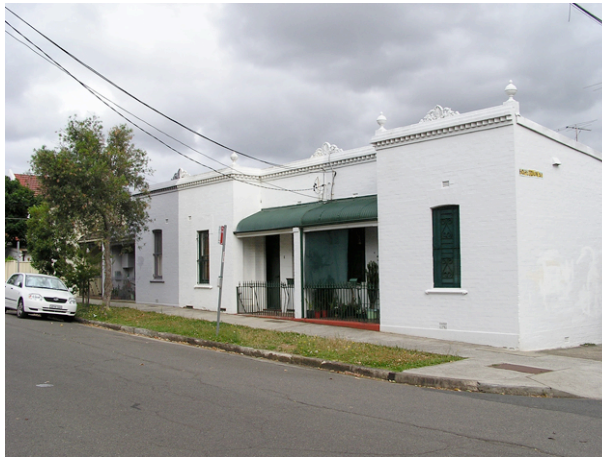
Figure 9.3. This very modest group of terraces marks the Federation Road edge of the area

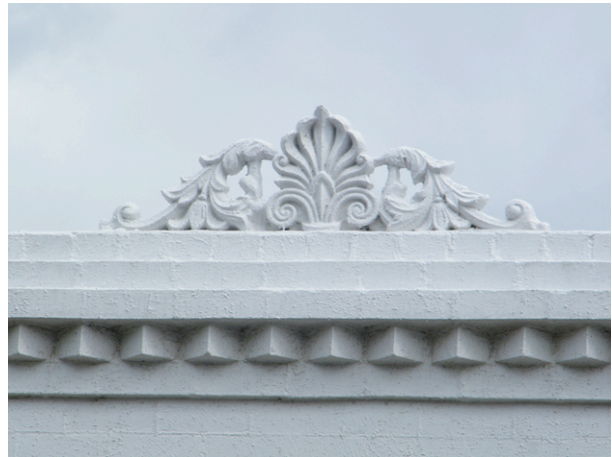
Figure 9.4. The skyline of the simple parapet is relieved by a small decorative element.

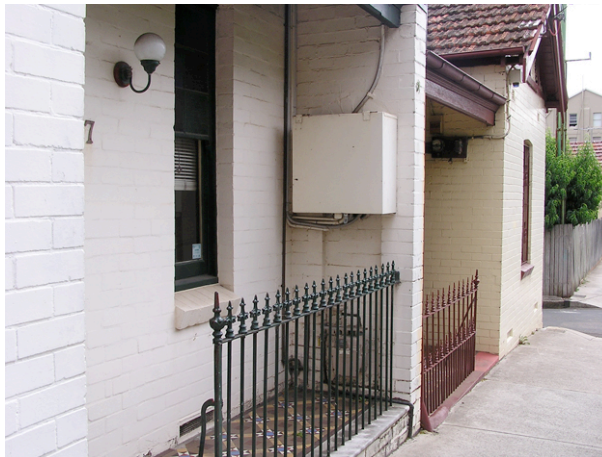
Figure 9.5. A similar group of terraces also facing Federation Road immediately to the north is similarly modest in its design and detailing although it demonstrates a Federation influence in its gabled roof form.

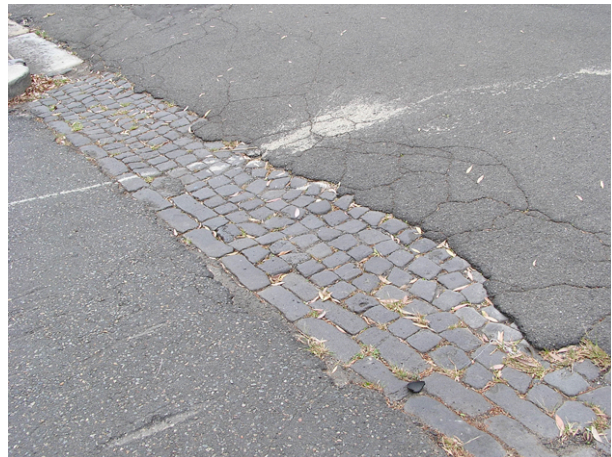
Figure 9.6. The original cobbled street surface drain has survived under the asphalt.

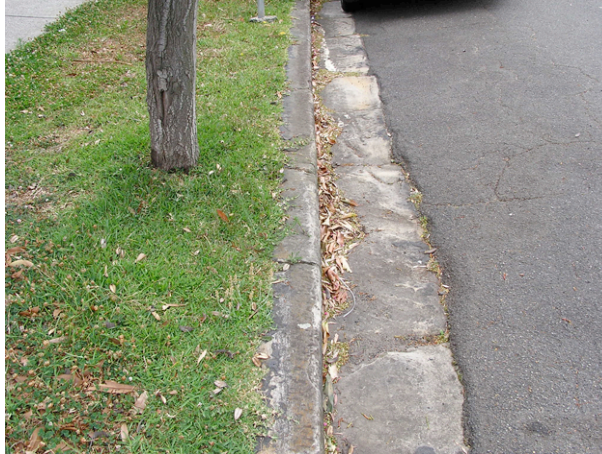
Figure 9.7. Kerbing and guttering is representative of that used throughout Marrickville in the 19th and early 20th centuries, being sandstone block.

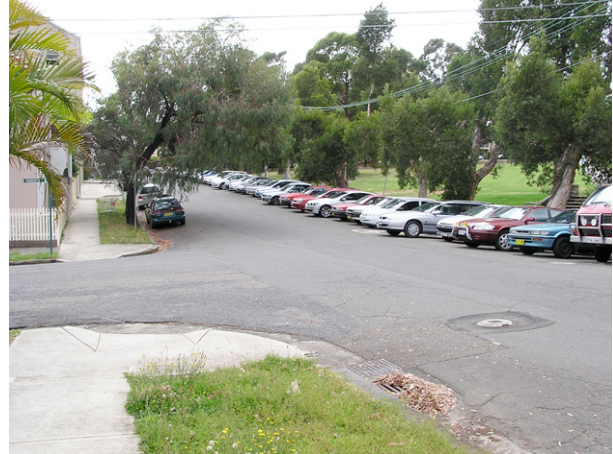
Figure 9.8. The area overlooks the Camperdown Memorial Rest Park, but the continuity of the view is interrupted by the line of parked cars.

Good views are available from the southern end of both streets over the park towards the steeple of St Stephen's Church. This helps to connect the area to the adjacent park and contributes to its historical and aesthetic qualities.

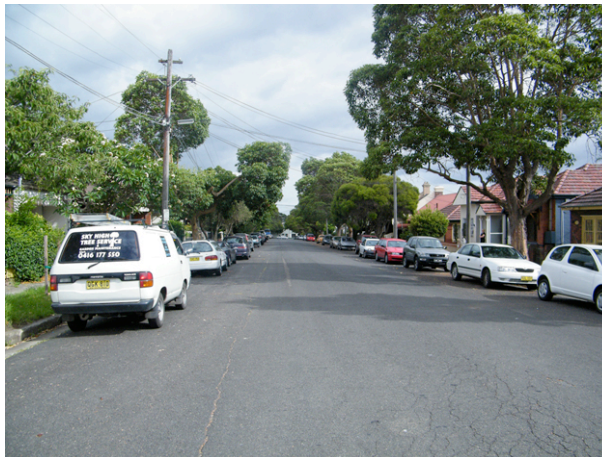
Figure 9.9. The streetscape views are opened in character due to the single storey nature of development and intermittent street tree planting.

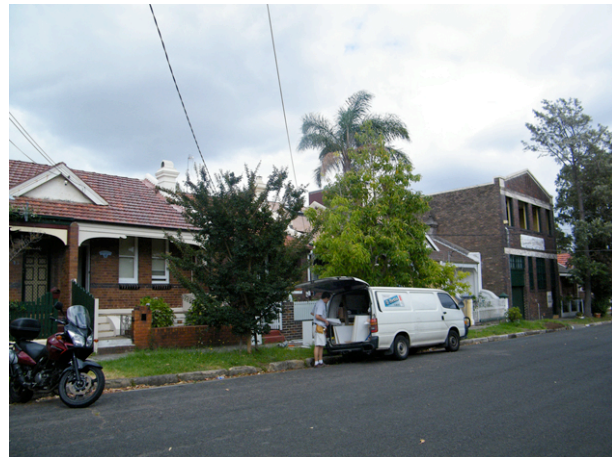
Figure 9.10. The area also includes some small-scale former industrial/commercial built forms. Note the original face brick facades.

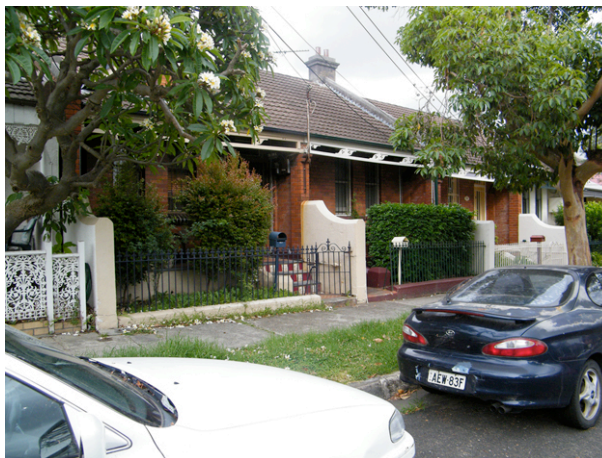
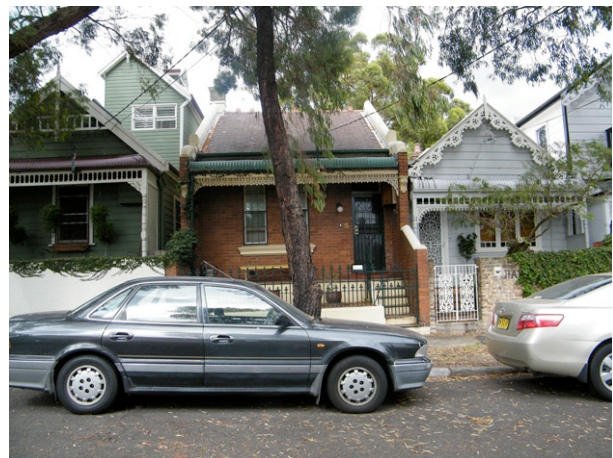
Figure 9.11 and 9.12 the area is characterised by its modest built forms from the late Victorian and early Federation periods. Figure 9.12 shows both a rare timber weatherboard cottage with a carved valance to the gable and an idiosyncratically proportioned roof extension that, although set well back, is intrusive in the local roofscape view.

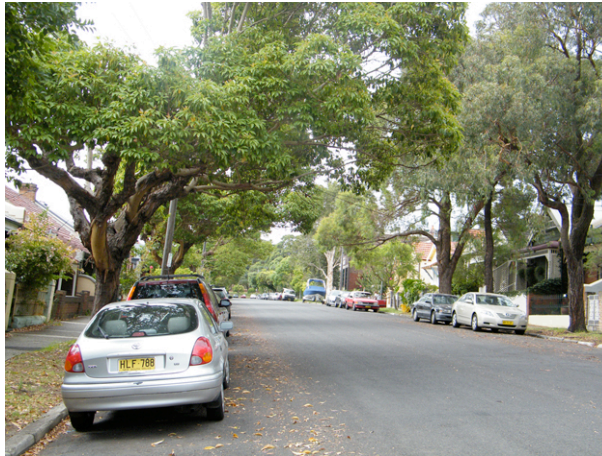
Figure 9.13. The street planting at the northern end of the precinct contributes to the aesthetic values of the Area.

The quality of street tree planting varies and includes Brush Box and various native species. Some have reached impressive scale and provide a focal point to the local streetscape.

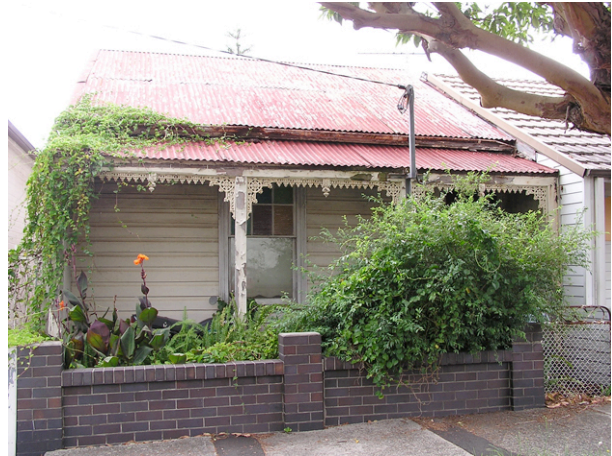
Figure 9.14. A substantially intact Victorian timber cottage. The survival of timber Victorian cottages is rare in Marrickville.

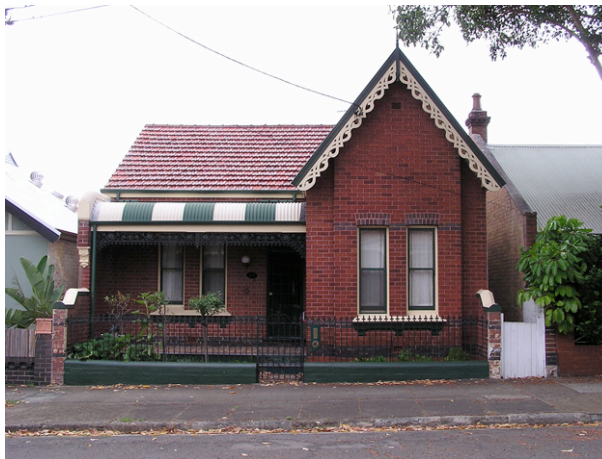
Figure 9.15. This house demonstrates characteristics of both the late Victorian Gothic and Federation periods, with Federation face brick and window proportions and Gothic roof form. The Marrickville iron palisade fence contributes to the streetscape value although is difficult to see because it is currently painted a dark colour.

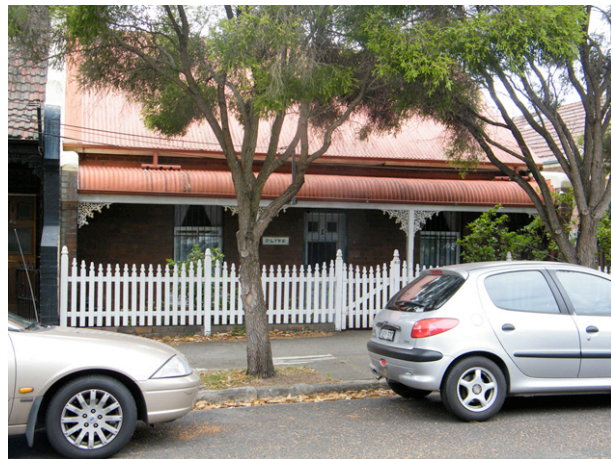
Figure 9.16. This workers cottage is sheltered under its Victorian-style bull nosed veranda. The white painted picket fence is a prominent element in the immediate streetscape.

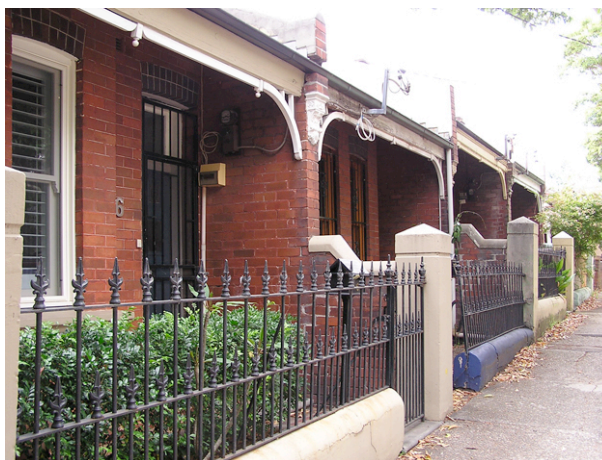
Figure 9.17. Row of simple Federation terraces with original fences and angular ogee based dividing walls to the gardens. Their unpainted face brick facades adds significantly to the integrity and the value of the group.

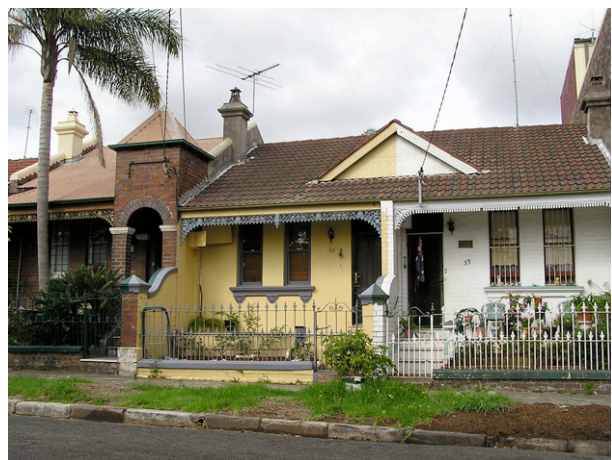
Figure 9.18. Rendering and painting facades results in a disjointed aesthetic quality to the streetscape with each house in the group competing for attention.

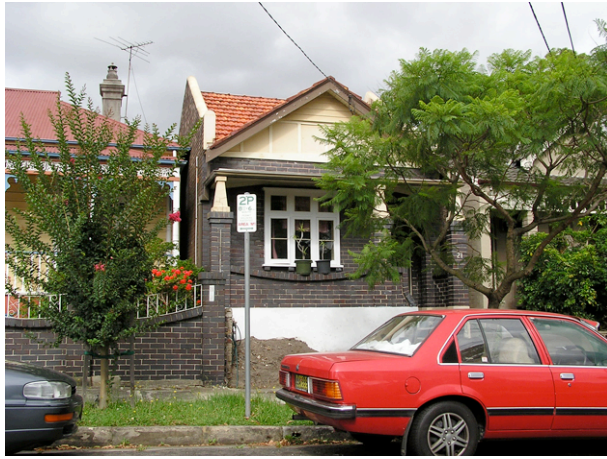
Figure 9.19. The area also includes some simple Inter-War cottages.

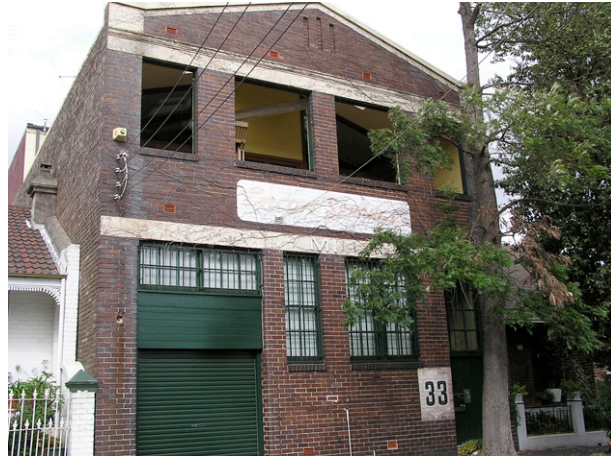
Figure 9.20. The area demonstrates the integration of industrial/commercial land uses found prior to the introduction of planning laws. This example has retained much of the integrity of its original industrial façade.

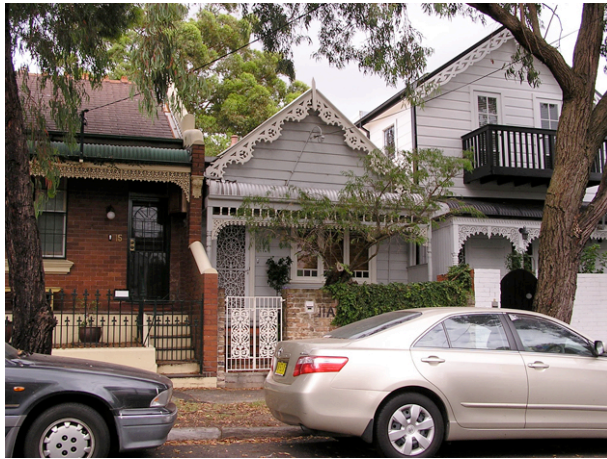
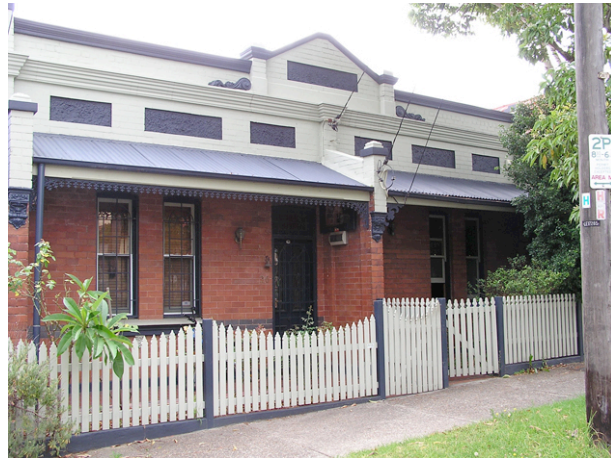
Figure 9.21 and 9.22 demonstrate the range of development in the area which includes both individual and eclectic cottages and disciplined rows of terraces.

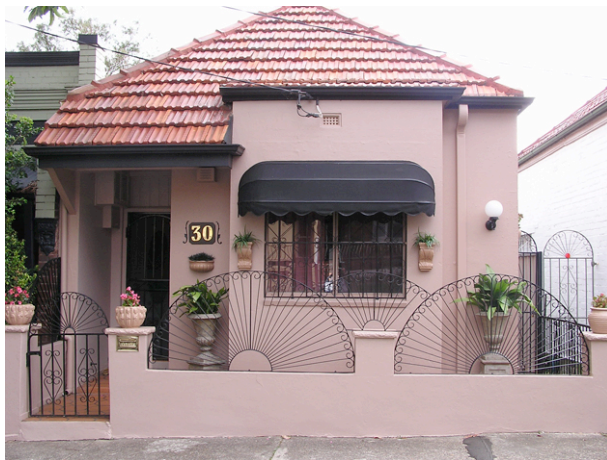
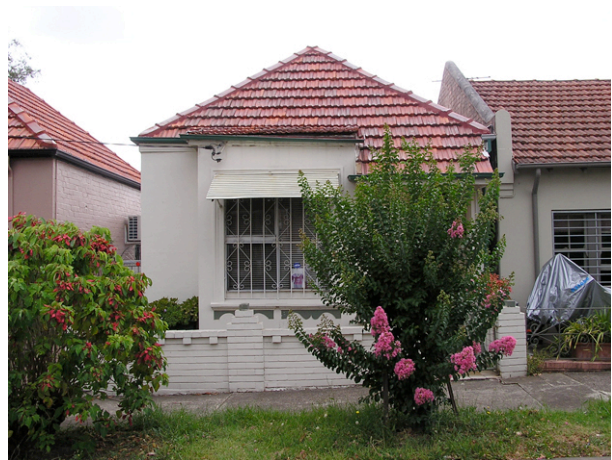
Figures 9.23 and 9.24 demonstrate some of the more recent layering that has occurred to some houses.

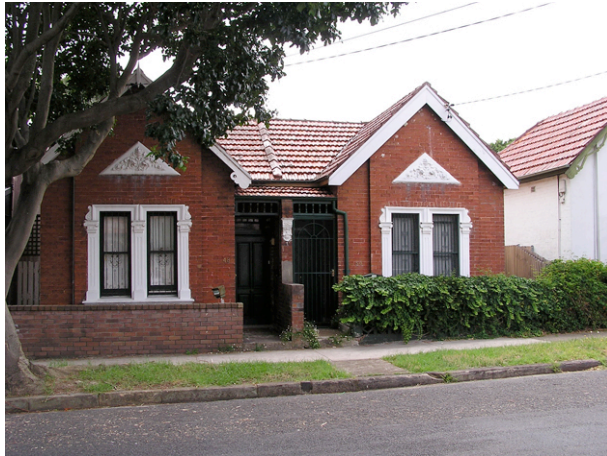
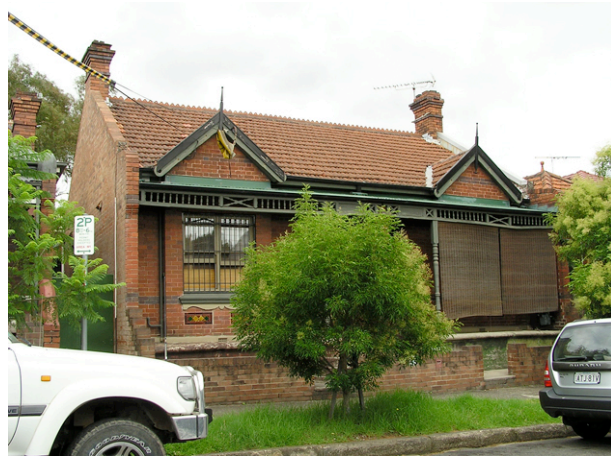
Figures 9.25 and 9.26 demonstrate some of the symmetrical built forms within the area.

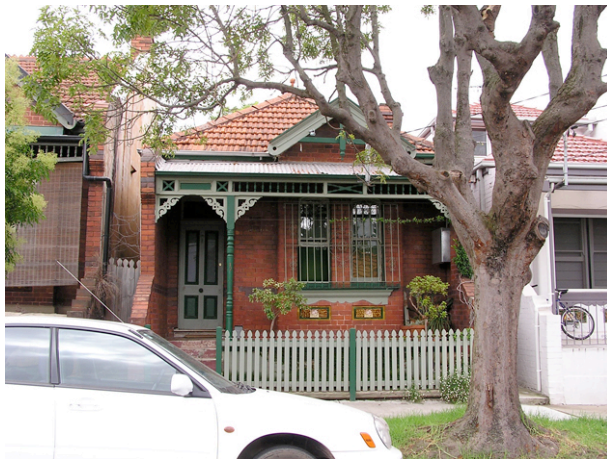
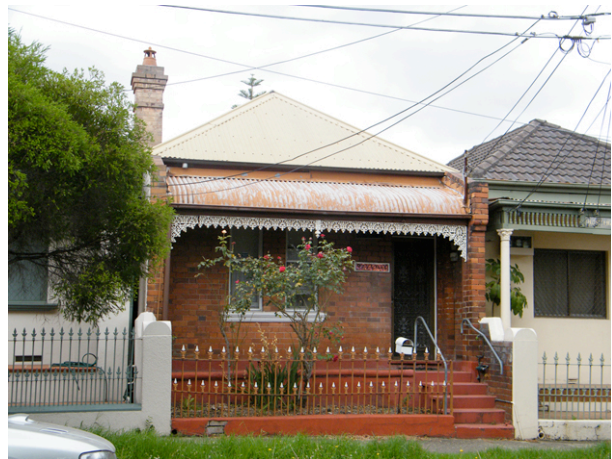
Figures 9.27 and 9.28 are good examples of simple Federation single fronted cottages.

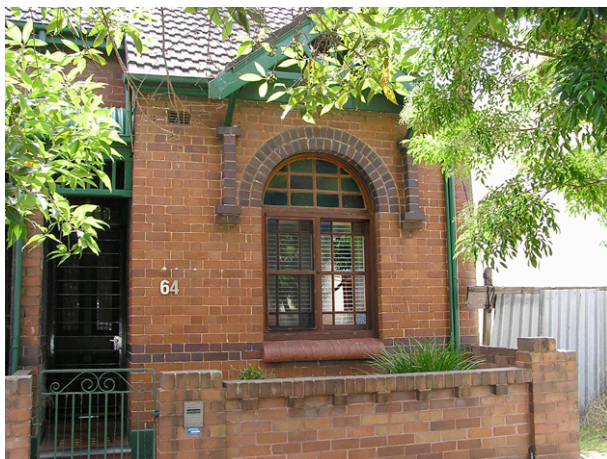
Figure 9.29. A finely detailed Federation facade with arched header and duo chrome banded brickwork.

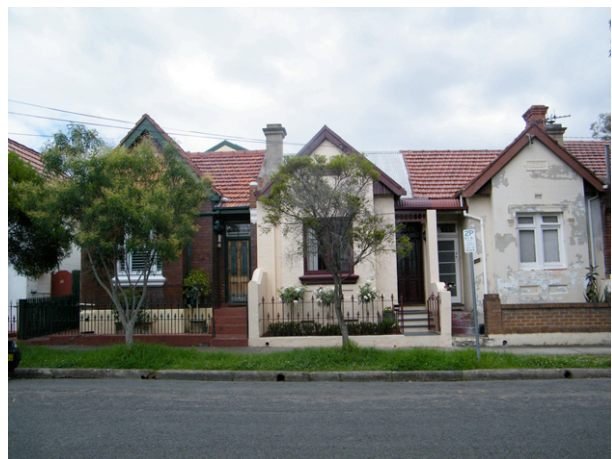
Figure 9.30. The aesthetic quality of this group has been compromised by the rendering and painting of brickwork and the replacement of windows but its overall form of prominent gables protruding from a main ridgeline parallel to the street alignment is still contributory to the streetscape.

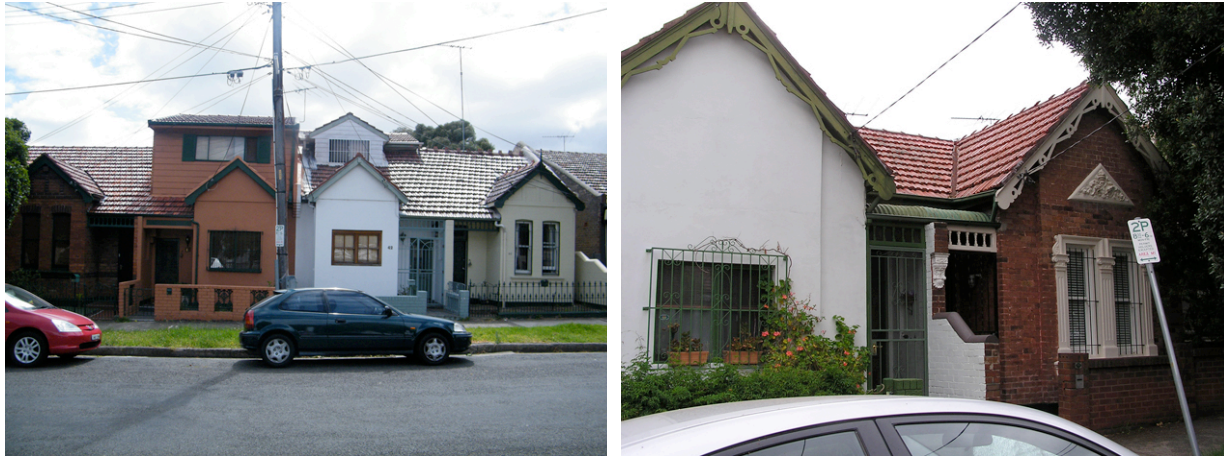
Figures 9.31 and 9.32 demonstrate some of the less sympathetic layering that has occurred in the area.

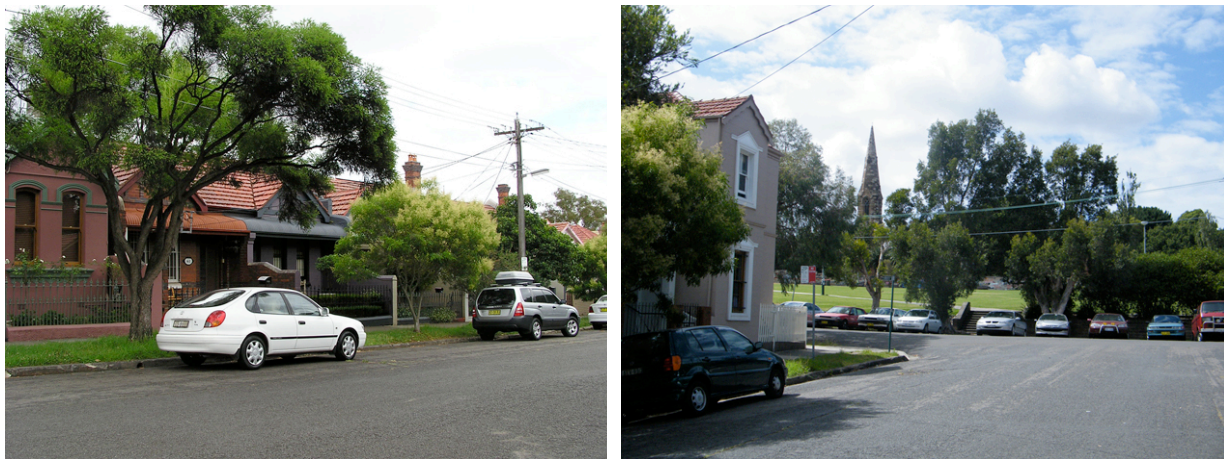
Figure 9.33. A contributory streetscape group. Note consistent rooflines and chimneys
