HCA 10 Camperdown Park Heritage Conservation Area

Figure 10.1 HCA 10 Camperdown Park Heritage Conservation Area

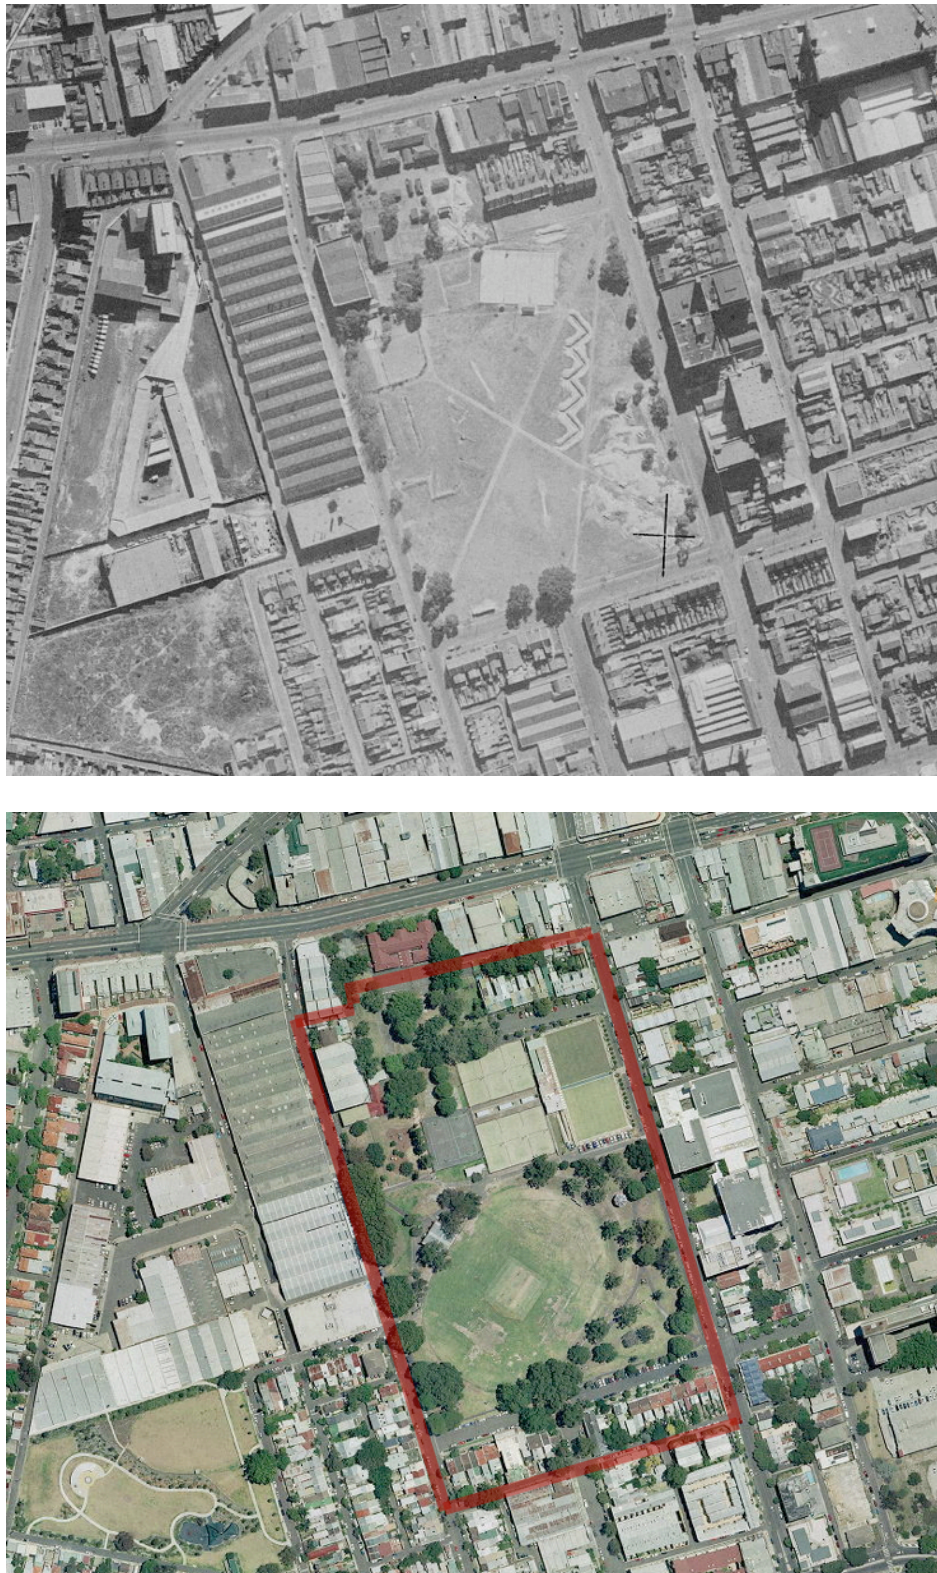
Figure 10.2 The Area in 1943 and 2009. The zigzag lines in the park in the 1943 photograph are an air raid shelter. (source: NSW Lands Department SIX Viewer)

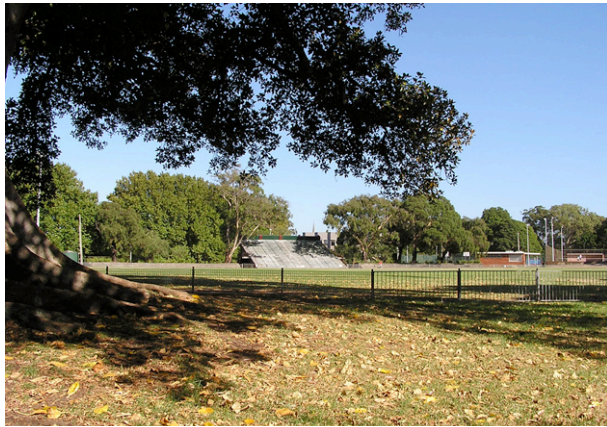
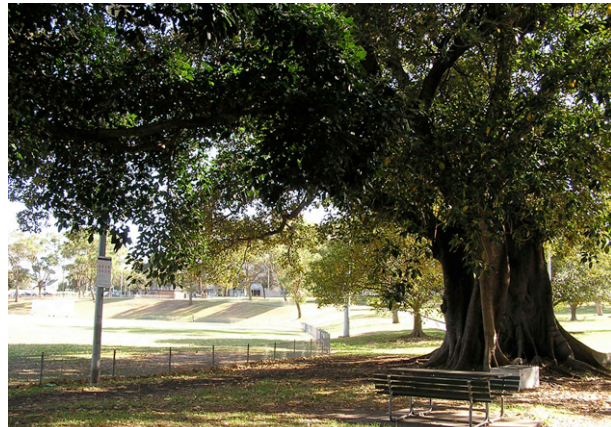
Figure 10.3 and 10.4. Camperdown Oval was created after the closure of the Fowlers Pottery Works pit and is a simple open space surrounded by mature ficus plantings. Its northern end is devoted to recreational facilities such as tennis courts and bowling greens with two simple banked grandstand seating areas overlooking the oval. The southern end integrates with the streetscape at the intersection of Fowler and Gibbons Streets.

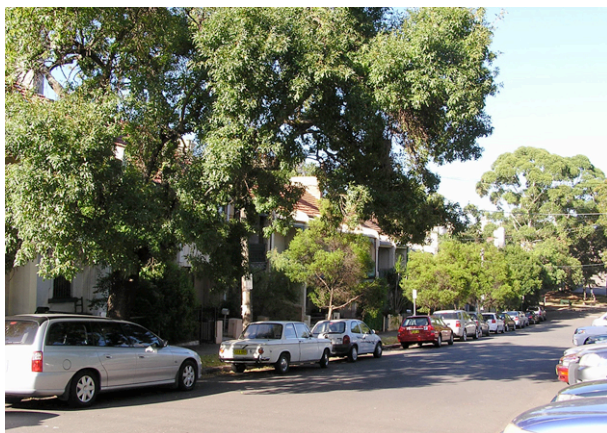
Figure 10.5. The streetscape of Fowler Street includes some mature trees that help to extend the open space qualities into the surrounding area.

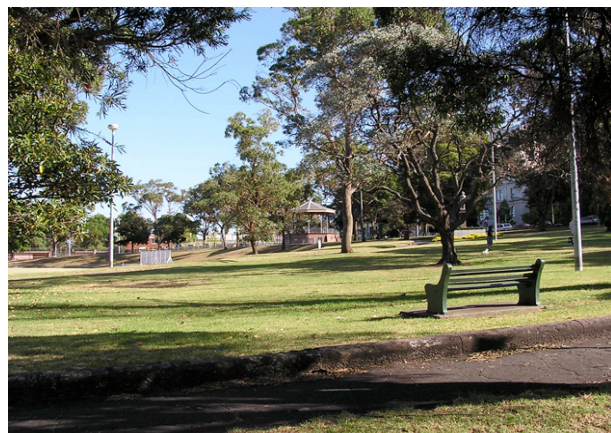
Figure 10.6. Park furniture includes a bandstand and simple bench seating.

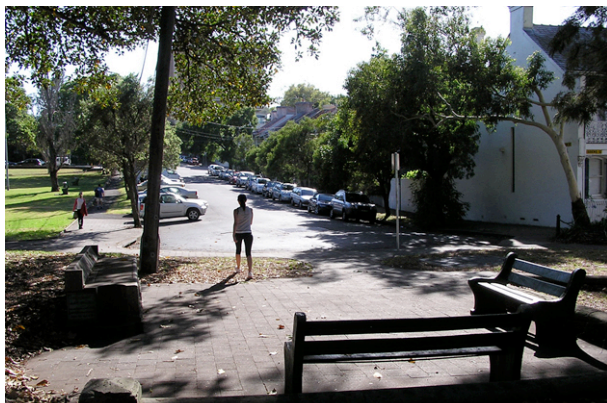
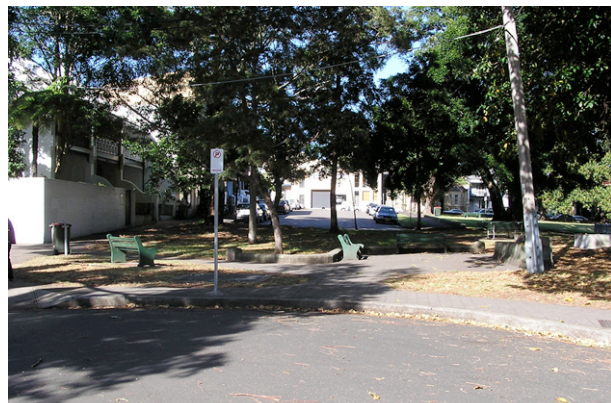
Figure 10.7 and 10.8. Fowler Street is truncated by a street closure near Gibbons Street. This space has an oasis quality due to the deep shade created by the ficus trees.

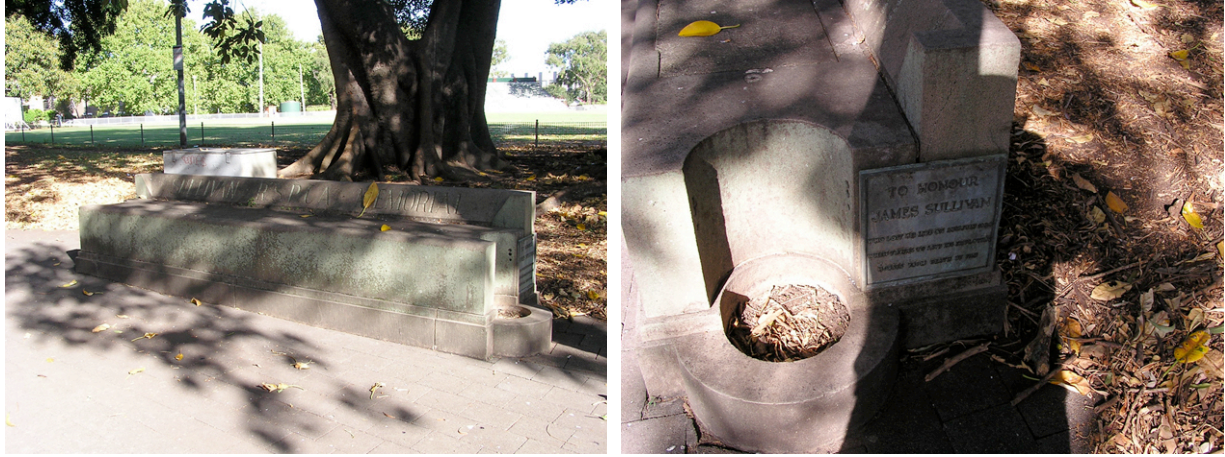
Figure 10.9 and 10.10. The closure is also marked by the Sullivan RSPCA horse water trough with a separate bowl for dogs at the end (now disused).

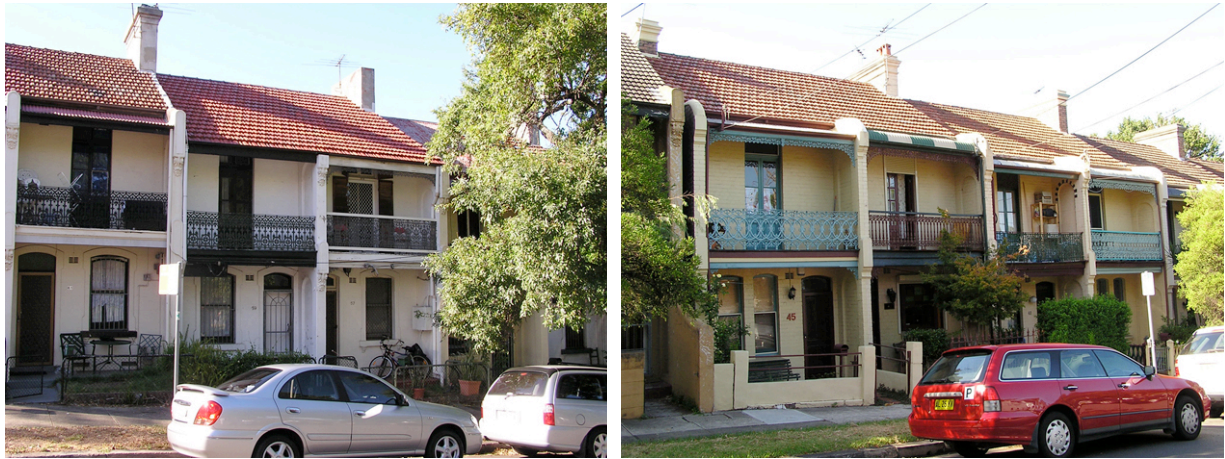
Figure 10.11 and 10.12. Terraces to Fowler Street are simple and step down the hill under paired roofs. Those at the eastern end are narrow examples of their type. The streetscape quality of the group is high..

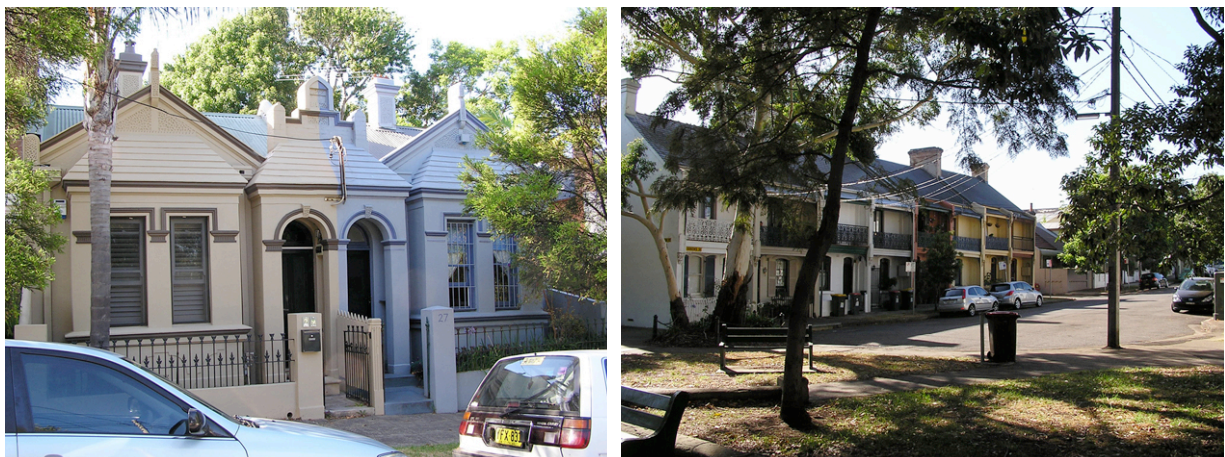
Figure 10.13. Fowler Street includes this unusual variation on a semi-detached terrace.

Figure 10.14. The Gibbons Street terrace forms a strong streetscape element through its unity of built form and detailing, terminating in the road closure at the southern end of Camperdown Park.

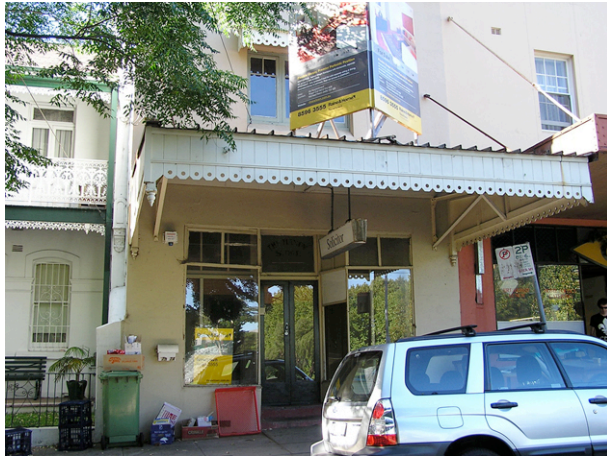
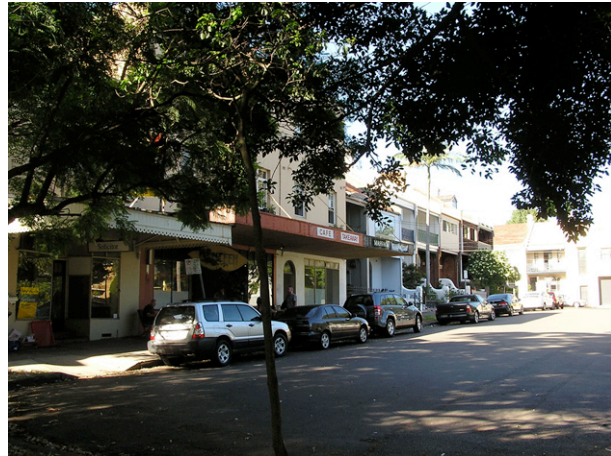
Figure 10.15 and 10.16. A small group of shops at the southern end of Camperdown Park provides a focal point for the area. The shops have retained their original facades with ingo entrances. The awning to the small shop in figure 10.15 is fringed by a decorative valance.

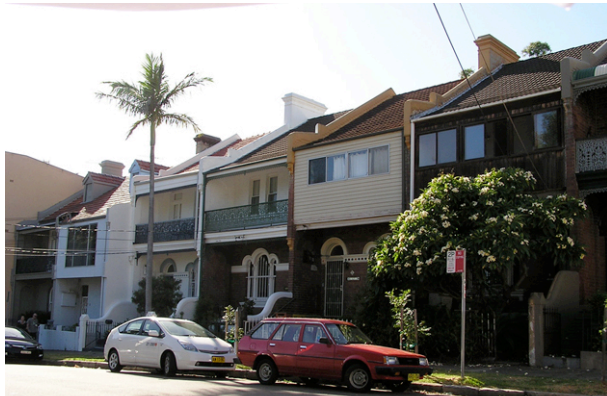
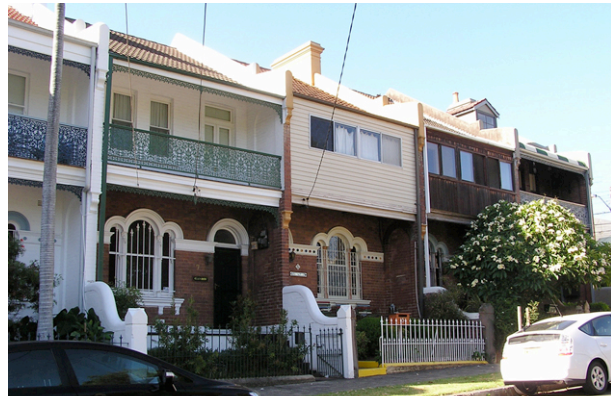
Figure 10.17 and 10.18. The terrace facing the south western corner of Camperdown Park is more substantial and demonstrates a combination of Victorian and Federation influences. Some balconies have been infilled but these changes are largely reversible. The prevailing iron palisade fence can also be seen.

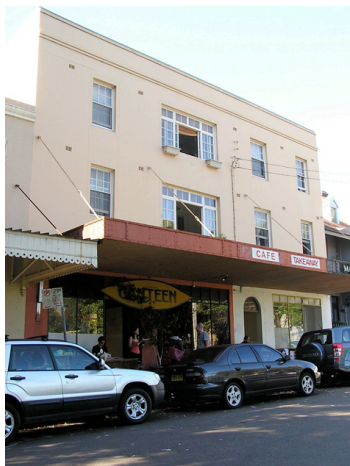
Figure 10.19. The shop is part of a relatively substantial commercial group that is a prominent element in the internal views from Camperdown Park.

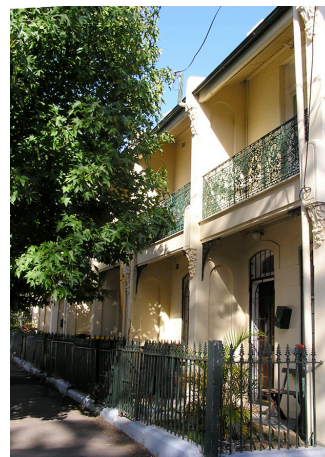
Figure 10.20. The northern end of Camperdown Park is also lined by groups of terraces. The lack of dividing walls and use of iron palisade fences between properties establishes a spacious streetscape character.

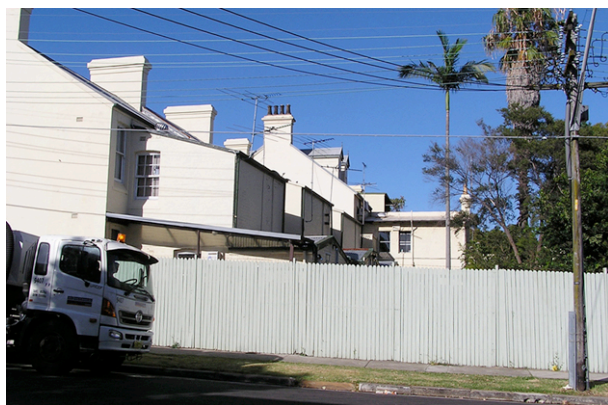
Figure 10.21. The rear of the Pidcock Street terraces are highly visible from Mallett Street. The survival of the original form of a group such as a terrace of this scale without any major extensions is rare.

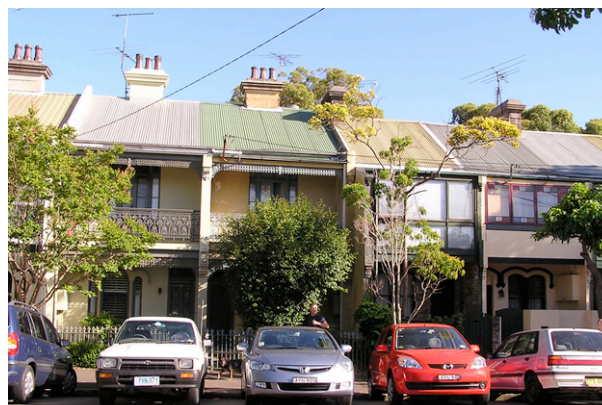
Figure 10.22. The Pidcock Street terraces were built in several distinct groups. The group at the left of this photograph have prominent chimneys located in the centre of each bay on the ridgeline.
