HCA 15 Holmwood Estate Heritage Conservation Area (Newtown)

15.1 LOCATION

15.2 DESCRIPTION

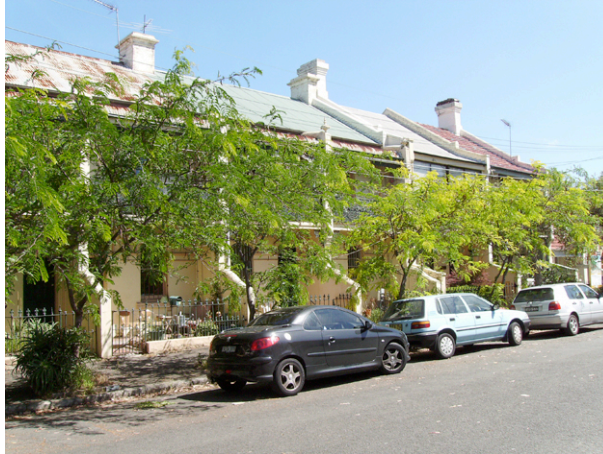
Figure 15.5. Terrace in Dickson Street

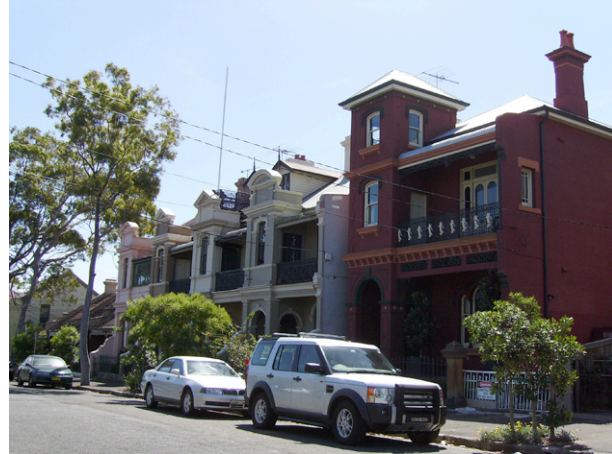
Figure 15.6. Substantial terrace and house in Dickson Street built by Josiah Gentle, the developer of the area who continued to live in the house.

No currently listed individual heritage items are within the area although the Heritage Items Review has found that the house at number 15 and adjoining terrace 17-23 are of local heritage significance as individual items and should be listed. All were built by Josiah Gentle, the owner and subdivider of the estate, and 15 Holmwood was built as his residence. They therefore have a close association with the Heritage Conservation Area and contribute to the variety and quality of their immediate streetscape and the heritage significance of the area.

The Holmwood Estate Area also has historical association with Josiah Gentle, owner of the Bedford Brickworks (now Sydney Park) who purchased the site of "Holmwood" plus some other blocks within the subdivision, and developed 15 Dickson Street in 1896 as his own house, and terraces at 17-23 Dickson Street circa 1900.

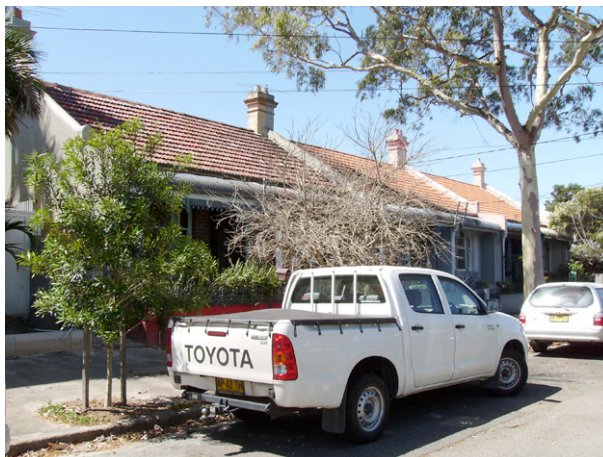
Figure 15.7. A modest single storey terrace with prominent ridge line and chimneys marking the paired roof form.

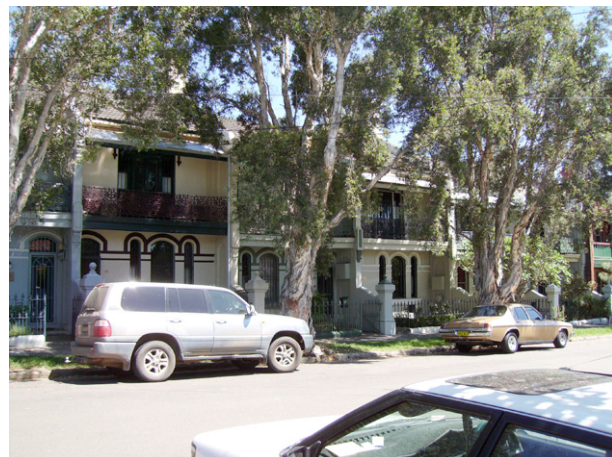
Figure 15.8. These terraces in Holmwood Street partially obscured by the Melaleuca street tree planting but have retained their cohesive and rhythmic built form and streetscape value.

The aesthetic attributes of the public domain are established primarily through the quality of the adjoining development. Street tree planting consists of Australian natives (mainly *Melaleuca*) which have reached maturity and now provide a reasonable degree of softening to the streetscape although they make it difficult to appreciate the quality and consistency of facades in places.

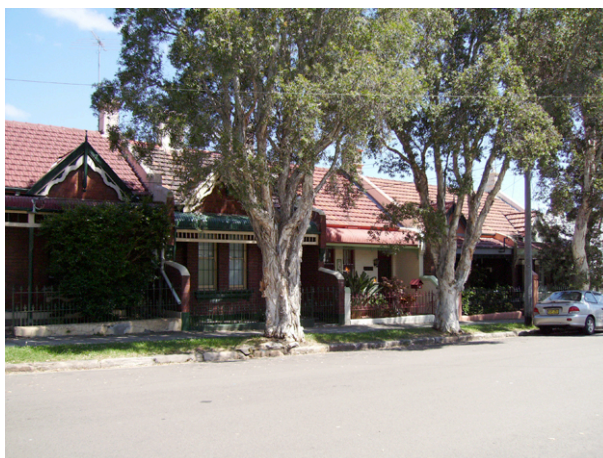
Figure 15.9. Federation terrace in Holmwood Street.

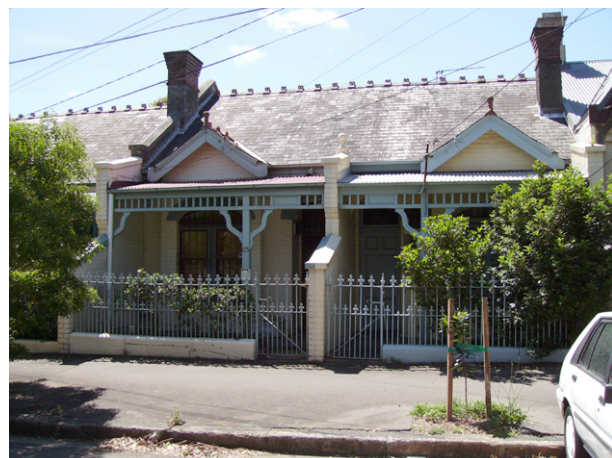
Figure 15.10. Good-quality but modest terrace with slate roof and decorative ridge capping.

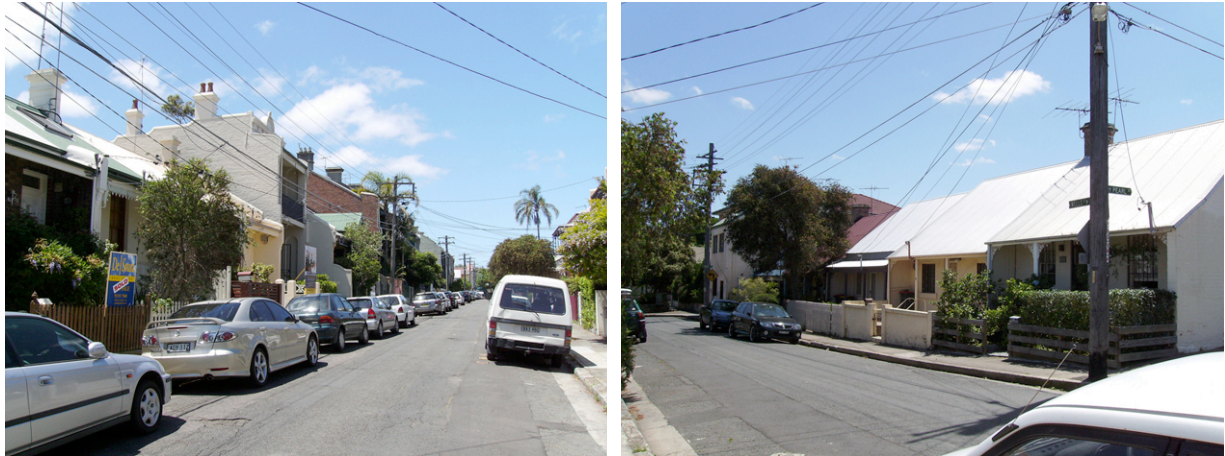
Figure 15.11 and 15.12. Wells Street contains more modest terraces and a more varied streetscape than those of Holmwood or Dickson Streets.

Wells Street is more modest in its character and built forms, being predominantly small cottages and modestly detailed one and two storey terraces that provide good examples of modest housing for workers in the nearby factories and brickworks.

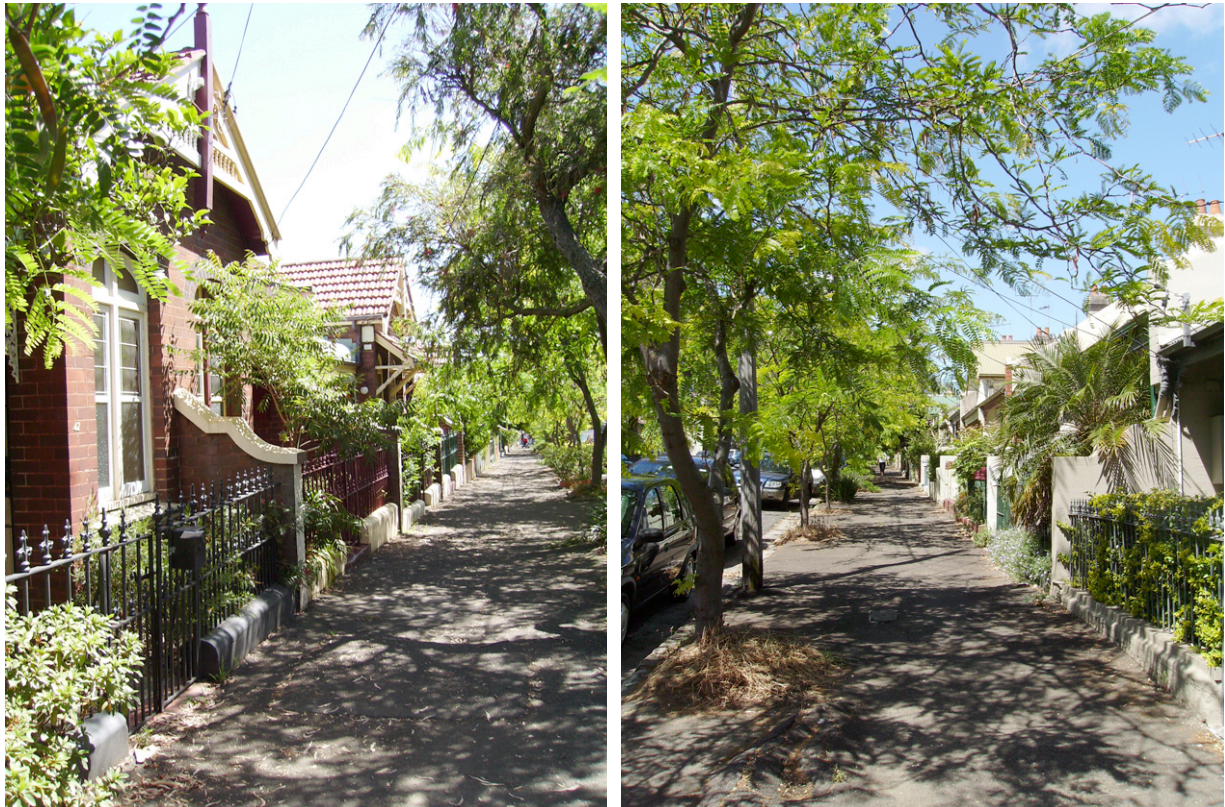
Figure 15.13 and 15.14. The minimal but consistent setbacks from the street alignment and consistent pattern of built forms have led to a high-quality streetscape in Dickson Street.

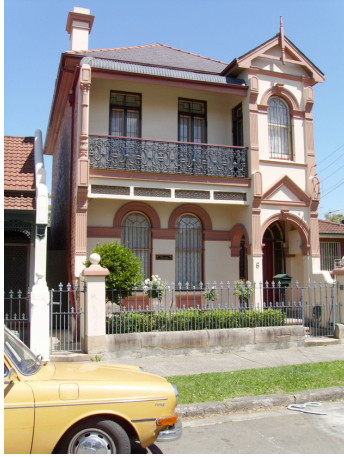
Figure 15.15. Victorian Terrace in Holmwood Street

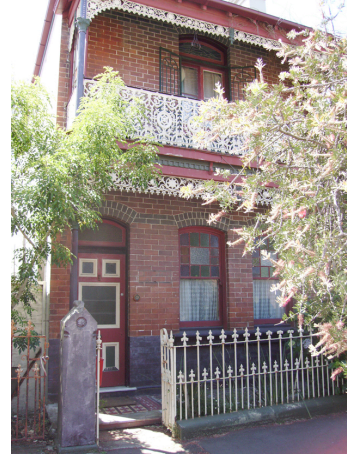
Figure 15.16. Federation terrace in Holmwood Street with original glazing pattern and the duochrome brickwork. Victorian elements include the iron filigree balustrade and finge and the iron palisade fence, each of which is typical of the Federation period in this part of Marrickville.

The evidence of the surviving fabric suggests that many early fences were of iron palisade construction. Many have survived and continue to contribute highly to the integrity and quality of the streetscapes and the area. They are particularly prominent elements when viewed on an angle from the footpath; when their strong rhythms yet transparent quality is highlighted. Other early fences, particularly in the more modest streetscape of Wells Street, may have included low (less than 600mm) timber paling pickets (with flat tops). Many original fences have been replaced by a variety of styles, materials and heights, introducing a highly discordant element into the streetscape views. These fences are however all potentially removable and although impossible to replace the original fabric, the opportunity exists to construct a new fence that fits more gently within the streetscape.

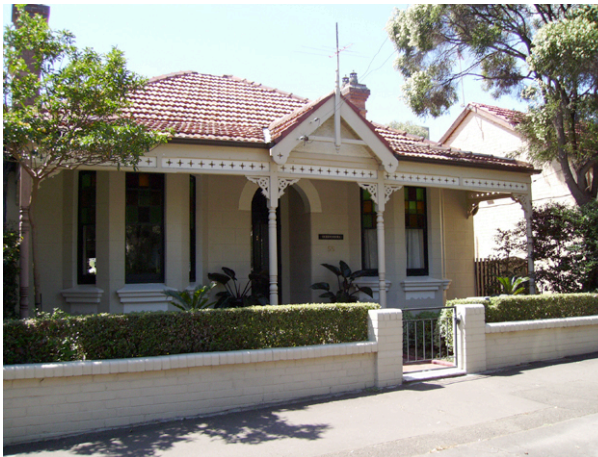
Figure 15.17. Symmetrical late Victorian/early Federation house in Holmwood Street

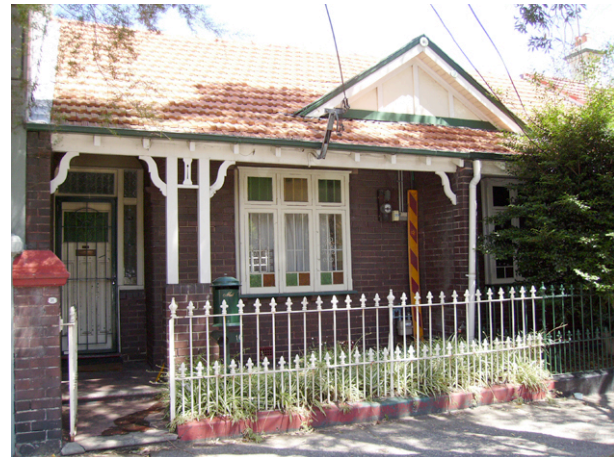
Figure 15.18. Pair of Federation semis in Holmwood Street.

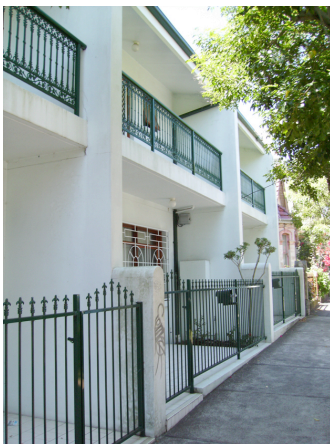
Figure 15.19. Infill terrace development in Holmwood Street with poor proportions, scale or detailing forms an intrusive element in the streetscape.

The former church at 35 - 39 Dickson Street has been adapted for use as a community centre. A large infill development has been built at 15 to 21 Holmwood Street that has attempted to replicate the terrace form but a lack of attention to details such as design, proportion and appropriate colour schemes has meant that this has not been a successful infill development in the context of this area.

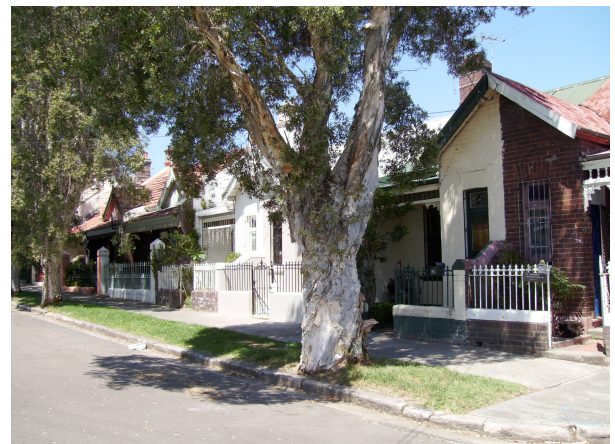
Figure 15.20. Rendering and painting face brick has a significant adverse impact on the aesthetic quality of the group.

Many of the groups demonstrate high quality design and attention to detail in their construction and ongoing maintenance. Most have remained substantially intact although some rendering and painting of face brickwork has occurred which has introduced an unsympathetic element into the streetscape.

- Painting and rendering etc (including to original face brick)
- Removal of original detailing
- Alteration to fenestration patterns (including reconfiguration/re-orientation of vertical openings to horizontal)
