HCA 16 Goodsell Estate Heritage Conservation Area (St Peters)

16.1 LOCATION

16.2 DESCRIPTION

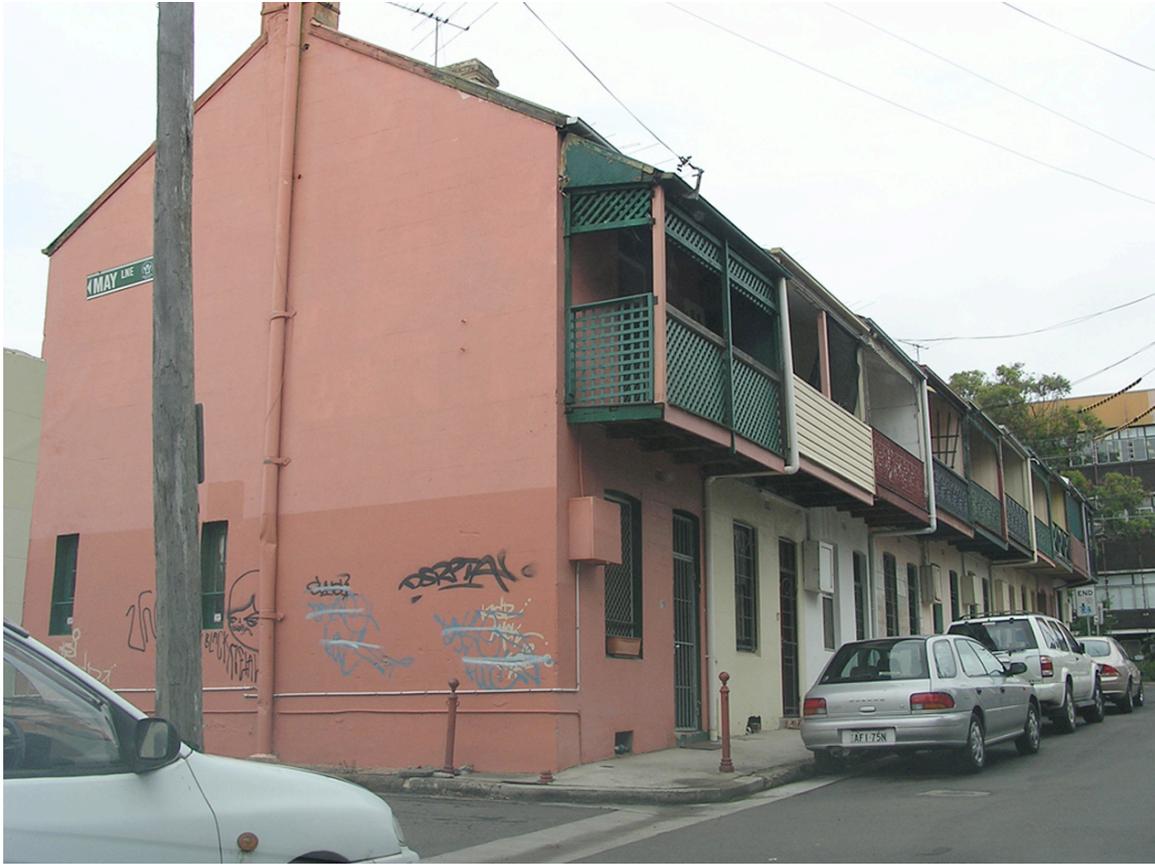
Figure 16.1 HCA 16 Goodsell Estate Heritage Conservation Area

The Goodsell Estate Heritage Conservation Area is located to the south of St Peters Station between the Illawarra railway line and May Street; and Bedwin Road and the Princes Highway.

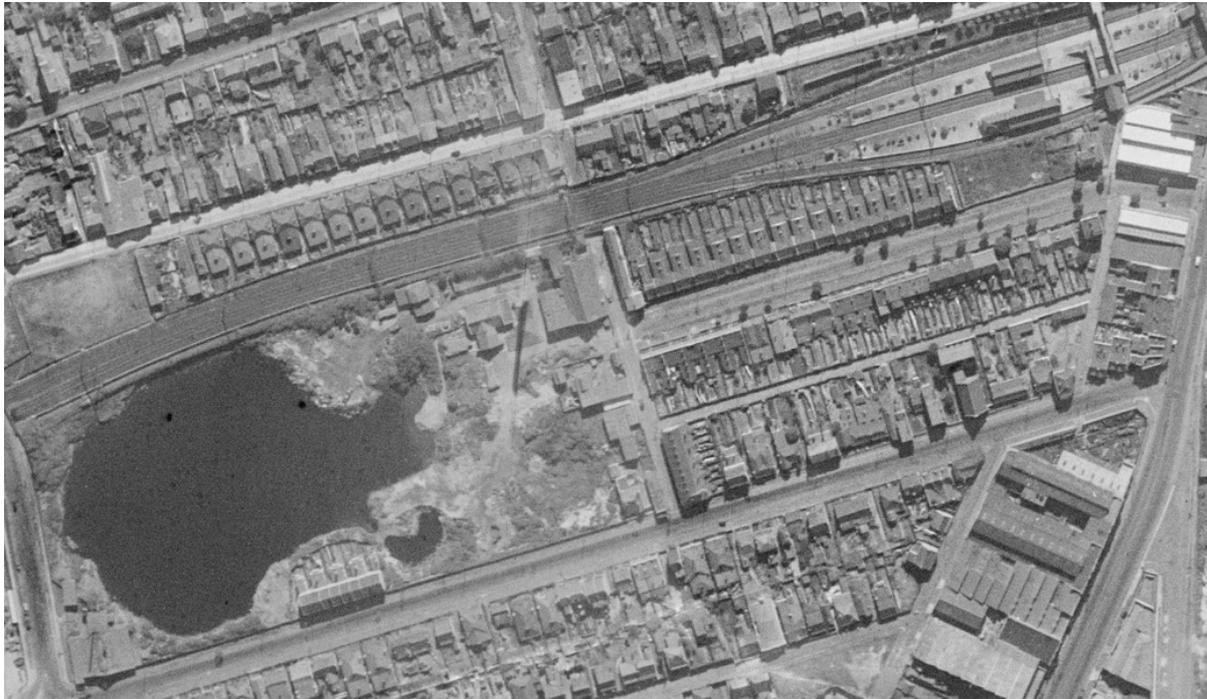
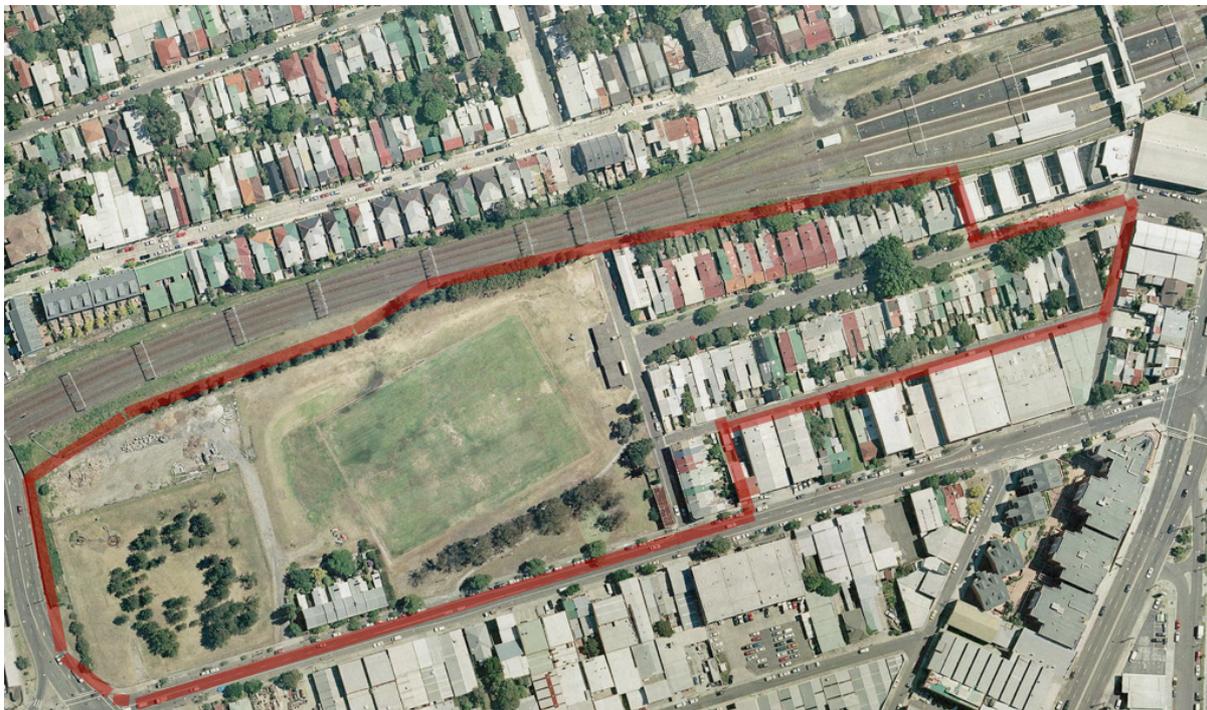
Figure 3.2 The Area in 1943 and 2009 (source: NSW Lands Department SIX Viewer)

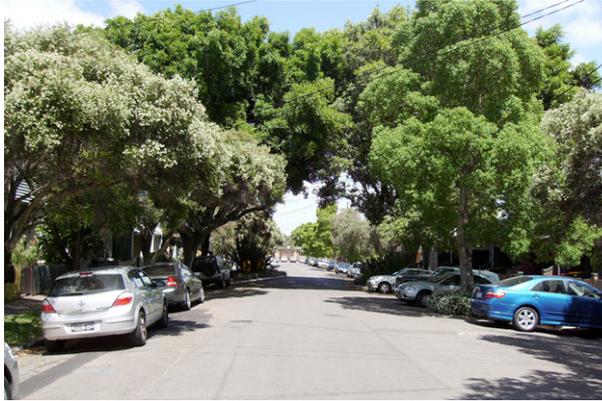
Figure 16.3 The mature Ficus at the northern end of Goodsell Street create a sense of arrival to the area and terminate internal views from Camdenville Park towards the east. They also help to minimise the impact of the recent residential flat development and establish a sense of separation from the busy Princes Highway at the end of the street.

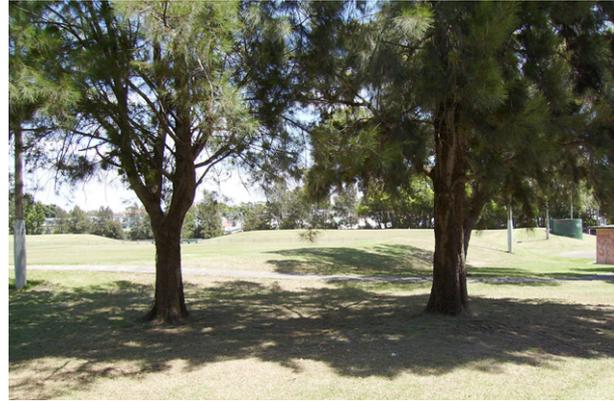
Figure 16.4 Camdenville Park was formed after the Goodsell brickworks clay pit was filled.

The Goodsell Heritage Conservation Area is named after the prominent Sydney brick maker Frederick Goodsell who owned and operated a major steam-operated brickworks on the site. This is thought to be Sydney's first steam operated brickworks and the source of the first shale 'plastic' bricks in the 1870s. The main brick pit was on the part of the site now occupied by Camdenville Park.

Much of the Area is now occupied by Camdenville Park and Oval which were constructed on part of the former brick pit and manufacturing site. The formal entrance to the park is located at the end of Goodsell Street and terminates the local view along the street. A small shop located at the south-eastern corner of the park was demolished during the course of site inspections. The terrace of eight dwellings stand alone on this edge of the park as they once did on the edge of the clay pit for the brickworks.

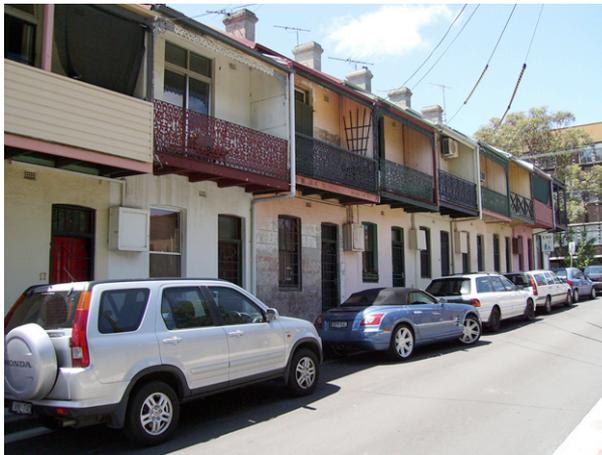
Figure 16.5. The Council Street terrace is substantially intact and exhibits a strong and rhythmic streetscape pattern. Facades are set flush to the property boundary and the balconies are cantilevered over the footpath.

The two-storey terrace overlooking the park at the southern end of Council Street is a good example of one of the most modest two-storey terrace forms that was usually intended for basic workers housing. Built to the street alignment with an veranda cantilevered over the footpath, the group forms a strongly expressed and rhythmic streetscape and roofscape, enlivened by the prominent chimneys rising above the main roof form and their slight stepping to accommodate the fall of the land. The view over the rear elevation of the terraces (from Goodsell Street) is also a good one and highly contributory to the aesthetic value of the area as a three-dimensional urban space.

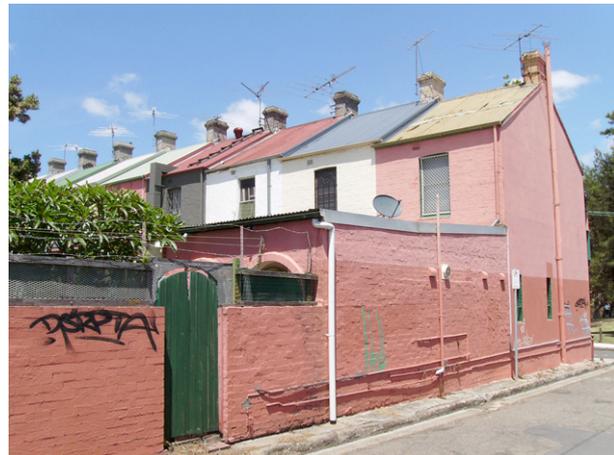
Figure 16.6. The Council Street terrace from the rear. Its unity of form and the important role of the chimneys and unbroken roofline, together with lack of major extensions to the upper level give this otherwise mundane view an important streetscape quality.

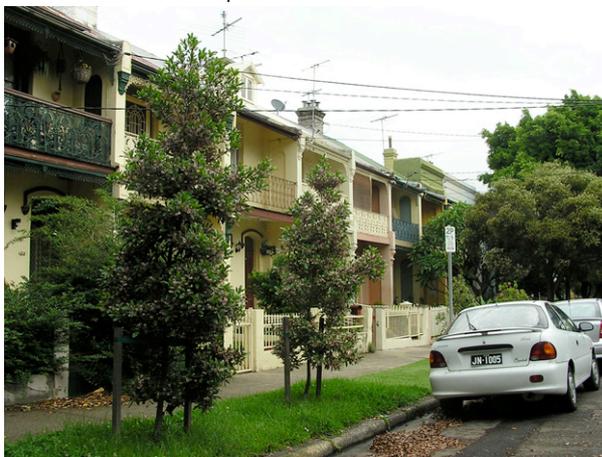
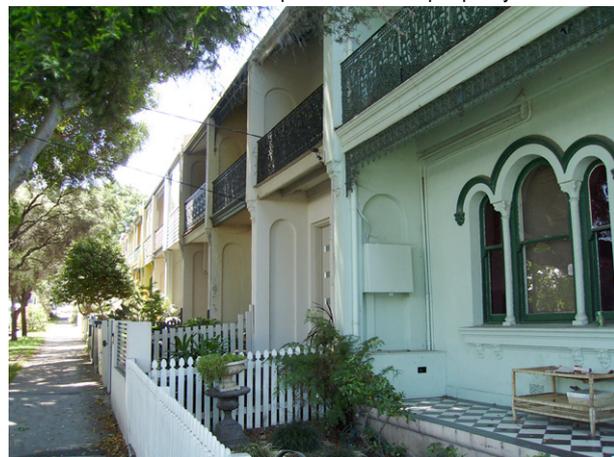
Figure 16.7 and 16.8. The terraces to Goodsell Street are a combination of single and two-storey typologies. They are set well back from the street with a wide verge, footpath and building setback creating a sense of spaciousness.

The streetscape of Goodsell Street is a tight and cohesive one comprised of single and two-storey terraces from the late Victorian/Federation period, including some modest single storey parapeted terraces and freestanding cottages. The streetscape demonstrates some subtle differences from other areas of terrace development in this part of the Marrickville area: the facades are set well back from the street alignment, providing for an unusually generous amount of soft landscaping; yet the individual terrace houses are very narrow. The reason for this configuration is not known.

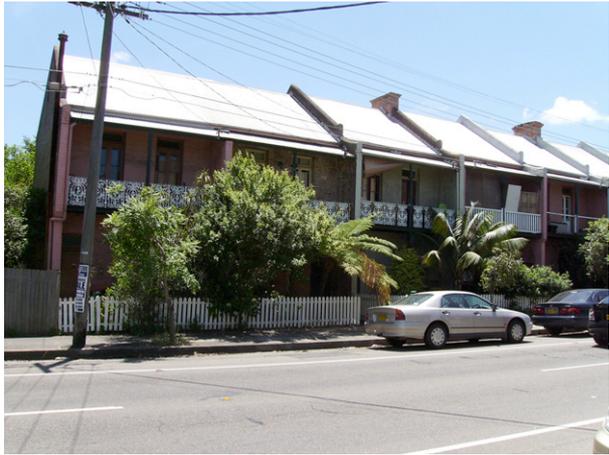
Figure 16.9. This terrace in Main Street was constructed on the edge of the brick pit to house Goodsell’s employees.

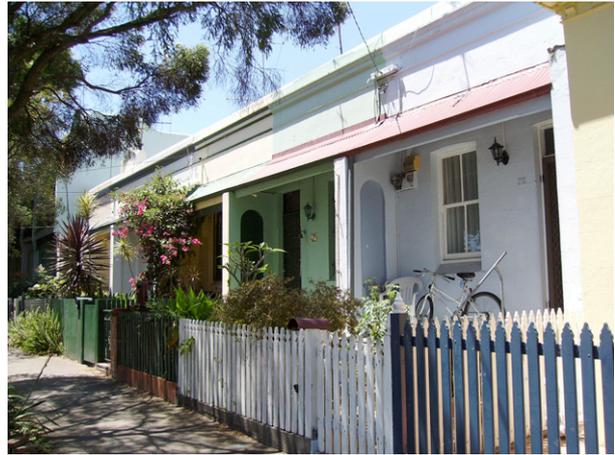
Figure 16.10. A modest single storey terrace behind a continuous parapet and veranda line.

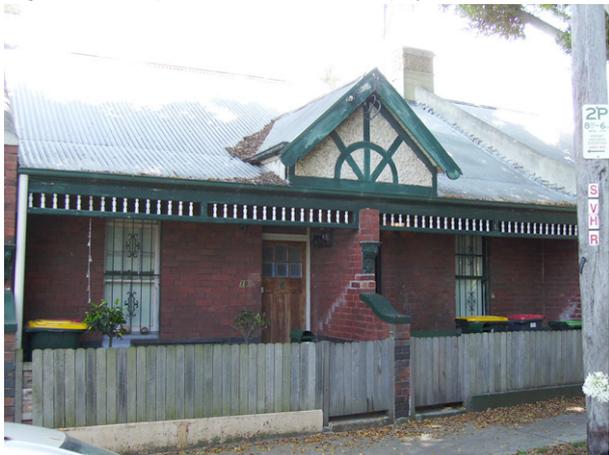
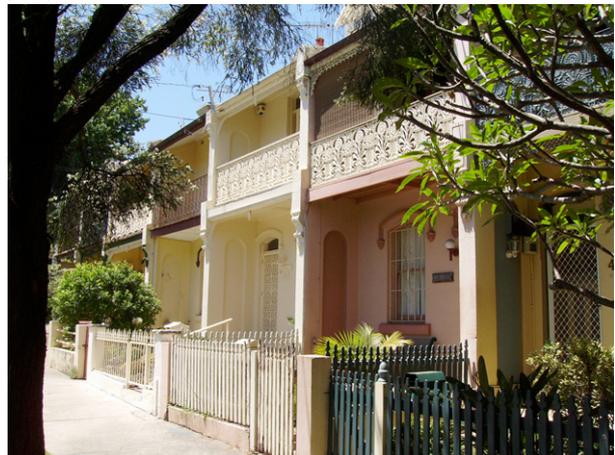
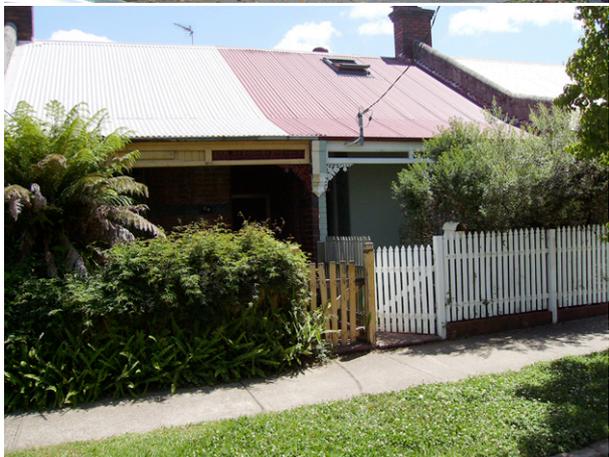
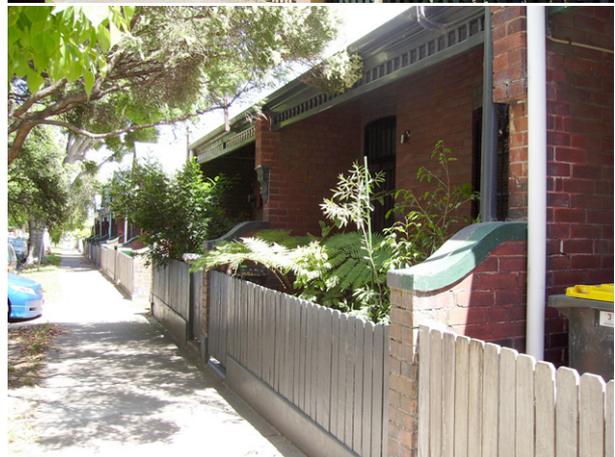
Figure 16.10 to 16.14. Goodsell Street. The long run of terraces creates a visually cohesive streetscape. Unlike most other areas from this period in Marrickville, the fences in Goodsell Street are a simple low timber picket and not iron palisade.

Some front fences are the original iron palisade but many have been replaced by newer metal panels, aluminium or timber picket or low brick walls. A substantial pair of Victorian terrace shops with cantilevered balconies is situated at the eastern end of Goodsell Street.

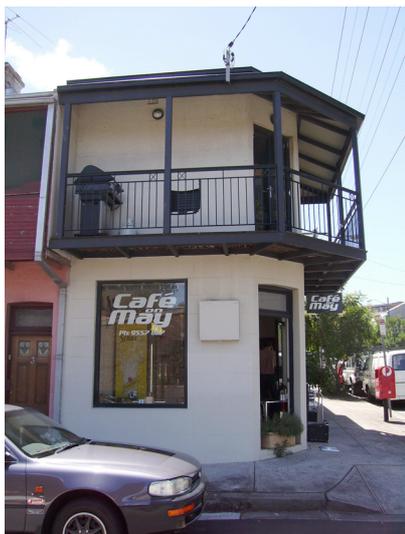
Figure 16.15. The small corner shop at the southern end of the Council Street group has retained its cantilevered balcony which returns into May Street.

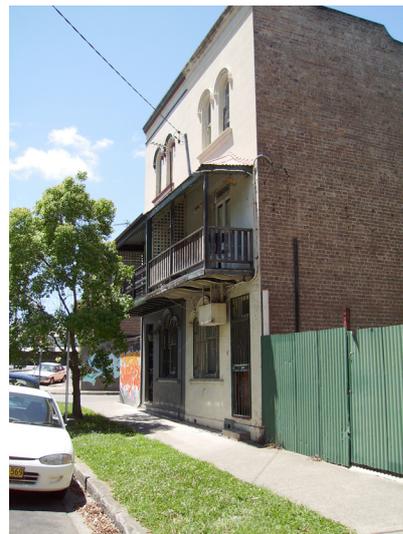
Figure 16.16. A more substantial group of three, three storeyed shops with residence above is located at the eastern end of the Area near the intersection with Princes Highway and close to the St Peters Railway Station.

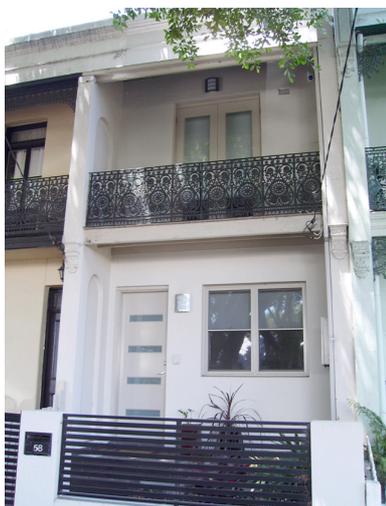
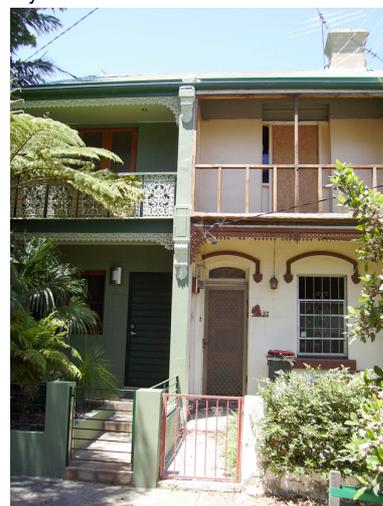
Figure 16.17 and 16.18. Many of the terraces have been layered over the years, mainly through the replacement of windows and infill of balconies. The most recent group of residents are introducing gentrification-style layers including changing the emphasis from a vertical bay to horizontal through the use of decorative elements and fence design.
