## HCA 17 Kingston South Heritage Conservation Area

## 17.1 LOCATION

## 17.2 DESCRIPTION

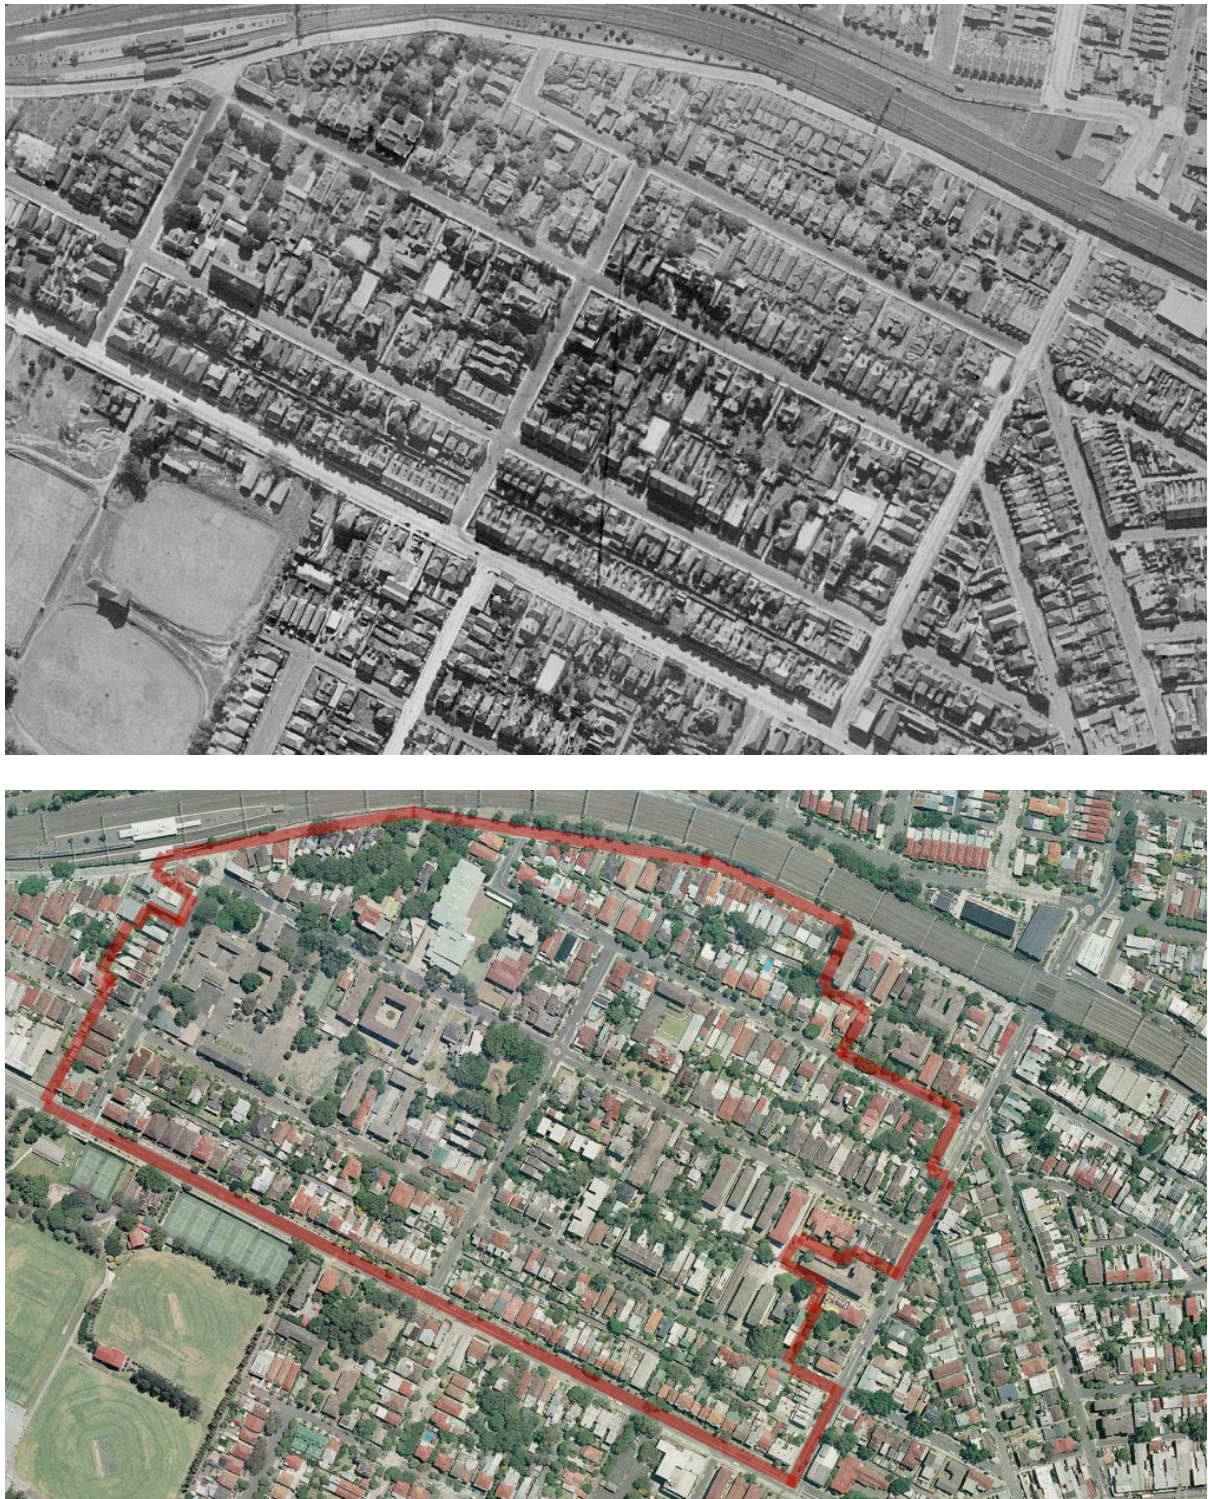
Figure 17.2 The Area in 1943 and 2009 (source: NSW Lands Department SIX Viewer)

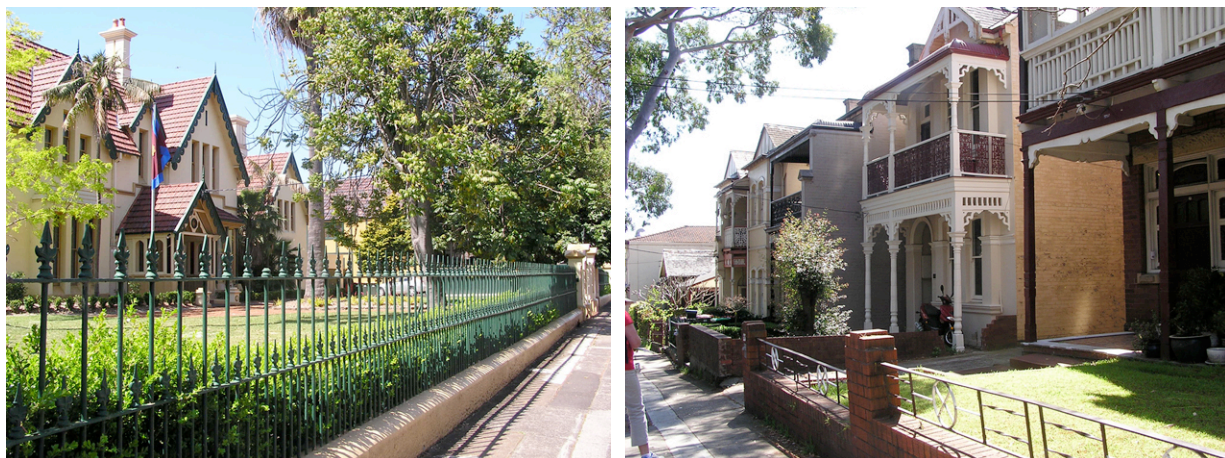
Figure 17.3 and 17.4. The Kingston South Heritage Conservation Area includes a rich variety of high-quality residential and institutional development from the mid-19<sup>th</sup> century.

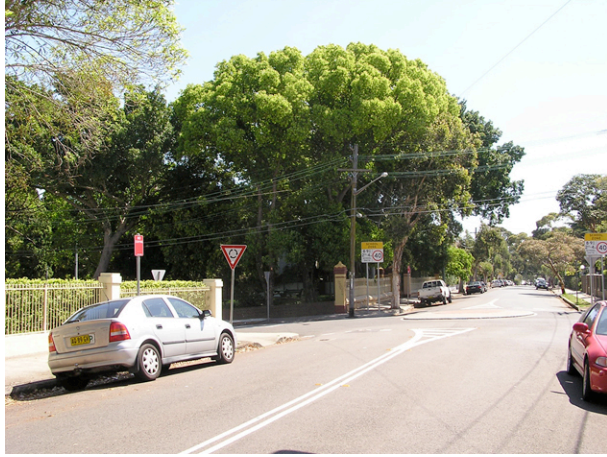
Figure 17.5. The park at the corner of Cambridge and Merchant Streets includes mature trees that act as a focal point in the streetscapes of Cambridge and Merchant Streets.

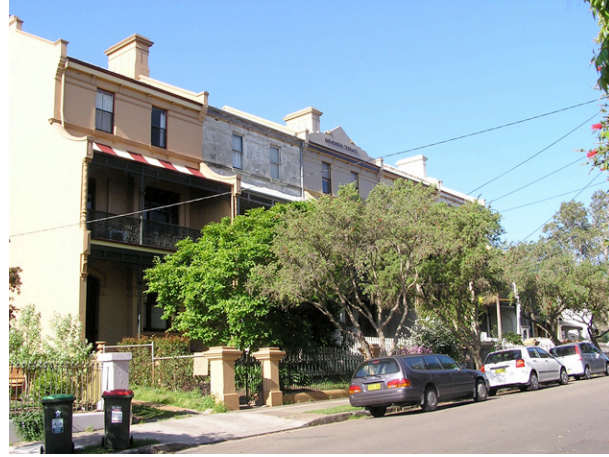
Figure 17.6. This three-storey terrace is sited in a prominent position and forms an imposing element in the local streetscape. Terraces of this scale are rare in the Marrickville area (Cavendish Street)

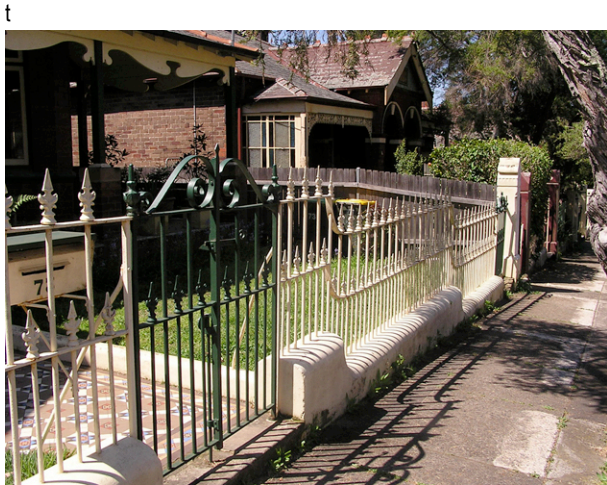
Figure 17.7. The Area also includes good groups of more modest Victorian and Federation detached and semi-detached houses. The iron palisade fenceline in the street steps as it follows the local topography.

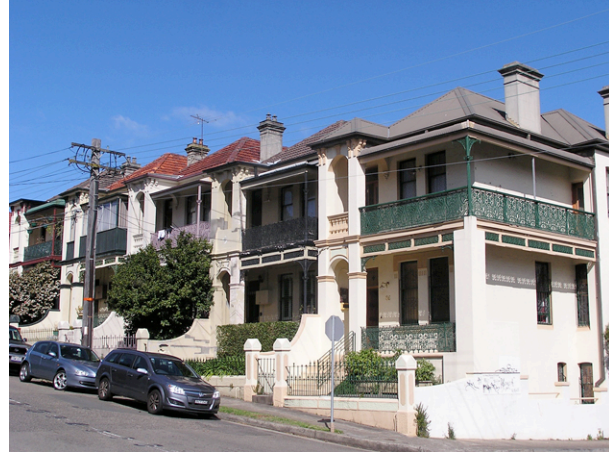
Figure 17.8. This imposing row of town houses rises up Cavendish Street from the low point where it meets Merchant Street. Their consistent form and setback contributes to the strongly patterned streetscapes near this intersection.

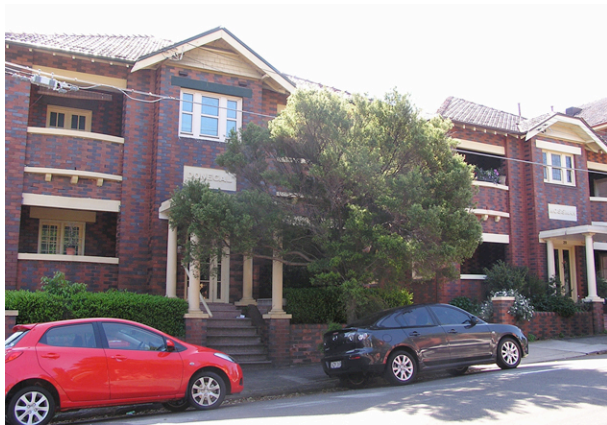
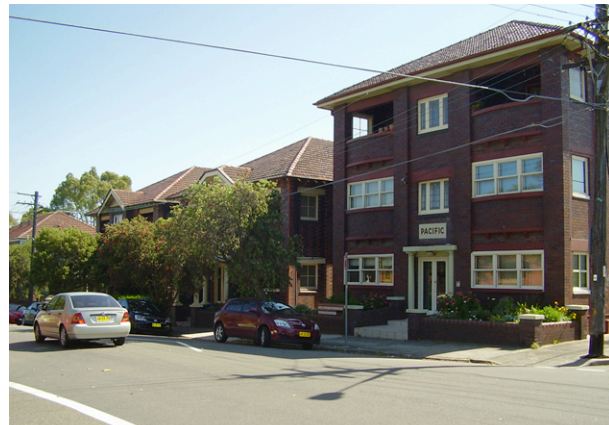
Figure 17.9 and 17.10. This imposing group of highly detailed and well maintained Inter-War residential flat buildings provide a strong Western edge to the area and contribute significantly to its heritage value.

A notable group of Inter-War flat buildings marks the western edge of the area (Holt Street). Some of the large original houses have been used as boarding houses although many of these are now returning to their original use as a single-family dwelling. The area also includes good groups of terraced dwellings, including both superior and modest variations; a rare (for the Marrickville area) example of a three-story terrace (Hughendon Terrace) and a notable row of formal 2-storey Edwardian detached and paired houses overlooking Stanmore Road in the south-eastern corner of the area.

The western edge is defined clearly by its high quality and imposing groups of Inter-War residential flat buildings and 19<sup>th</sup>/early 20<sup>th</sup> Century dwellings that address Holt Street and provide a strong edge of very high aesthetic value (although they are within Sector 3 of DP1).

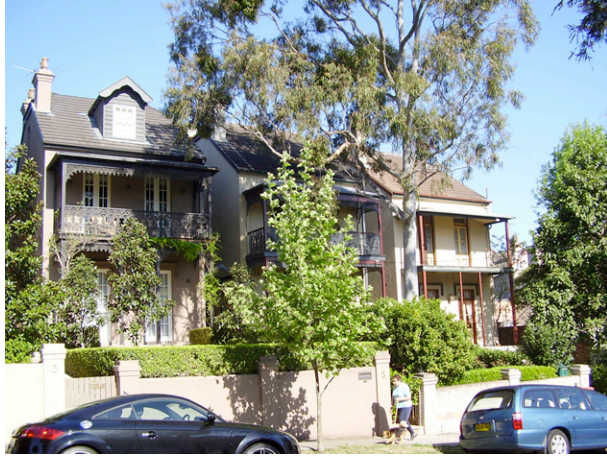
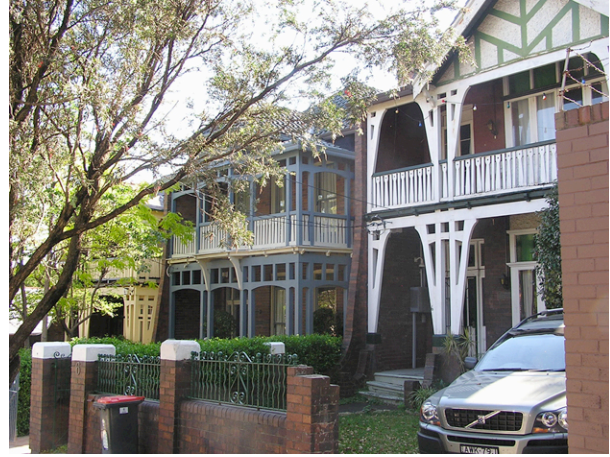
Figure 17.11 and 17.12. The groups of freestanding terrace-style houses step up as they follow the steep hill of Merchant Street. Some are showing signs of having been recently gentrified. Those on the west are very good and substantially intact examples of the freestanding Federation terrace. Note also the generous setbacks on both sides of the street.

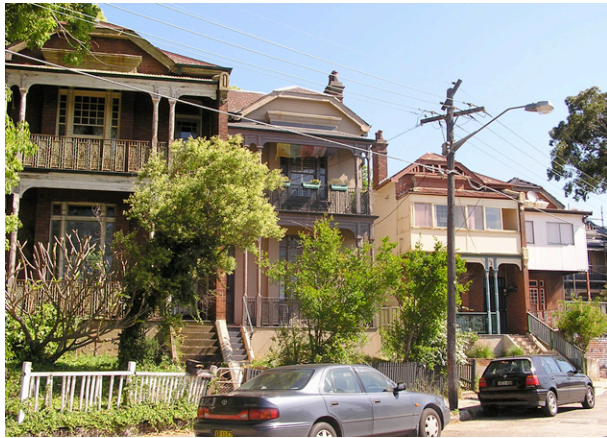
Figure 17.13. Trafalgar Street forms the northern edge to the precinct as it abuts the railway line. It is lined by a serrated row of two-storey terraces with half gabled roofs set on substantial bases. Many have been heavily layered but the overall scale, form and street rhythm of the group remains substantially intact.

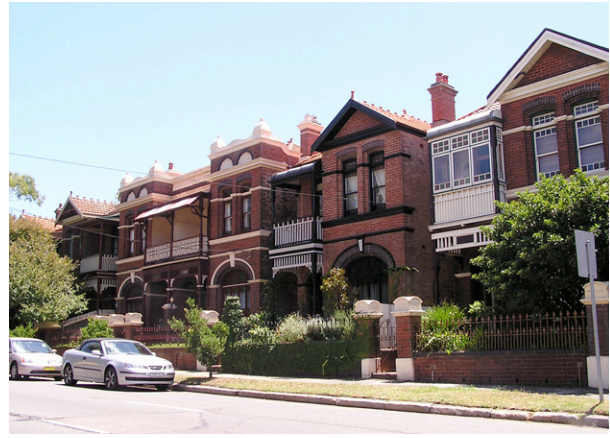
Figure 17.14. The south eastern corner of the precinct includes this notable group of Federation semi-detached houses set very close to side boundaries and which read as a continuous street wall.

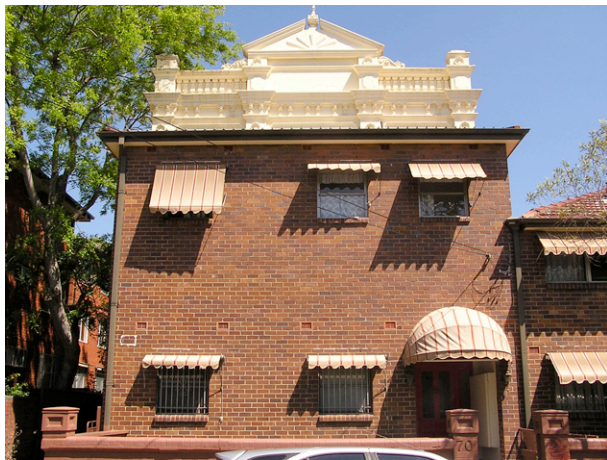
Figure 17.15. The elaborate Victorian terrace on this property in Cambridge Street has been obscured by this highly unsympathetic and aesthetically ungainly proportioned extension towards the

street. It is not known whether the original facade was removed or whether it still exists within the building.

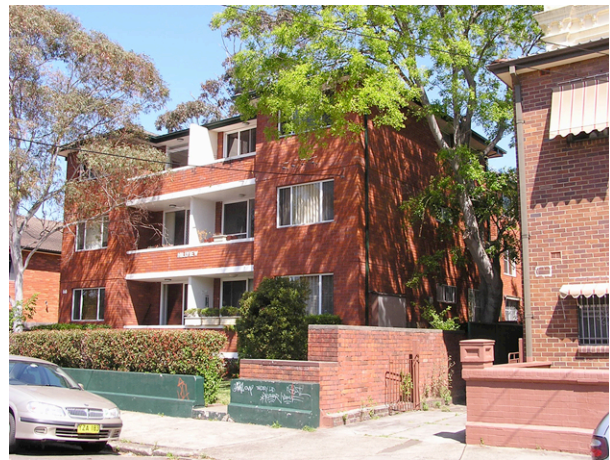
Figure 17.16. The area includes many three-storey walk up blocks of flats from the second half of the 20th century. Although they do not contribute towards the significance of the area other than to

demonstrate the impact of post-war planning regulations, their presence must be recognised as part of the area. Many are good examples of their type.(Cambridge Street)

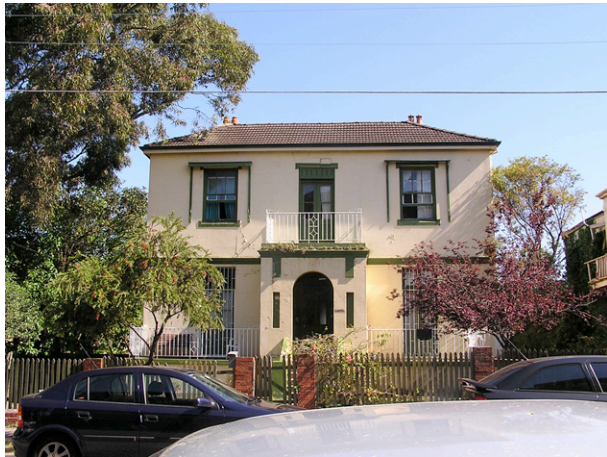
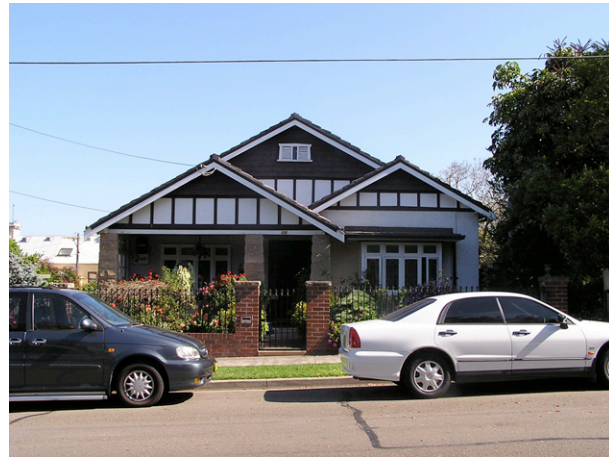
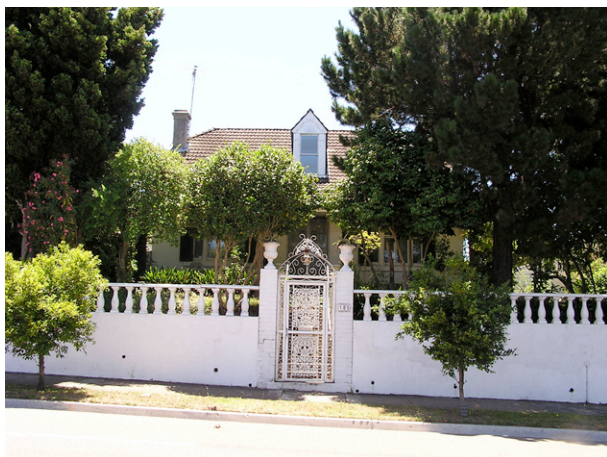
Figure 17.17, 17.18 and 17.19 One of the most important heritage values of this area is that it was the location of the first subdivision under the Torrens title system. Only six lots have not been re-subdivided since then and have retained their 'DP1' title, including this simple Victorian Georgian house and the Inter-War Bungalow in Cavendish Street and the Victorian house on Stanmore Road (below).

The Kingston South Heritage Conservation Area is also significant because it forms part of the first subdivision made under the Torrens Title system in New South Wales. Only six lots within the area have not been re-subdivided and have retained their 'DP1' land title. Most of these also contain highly contributory original houses.

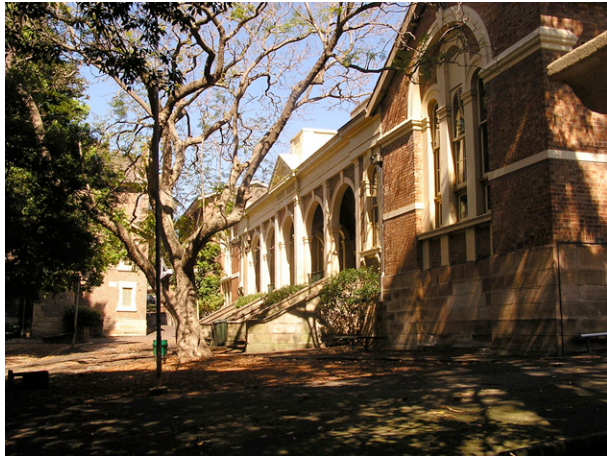
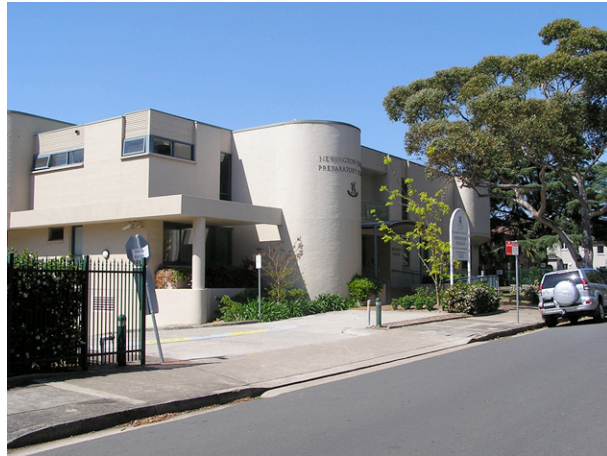
Figure 17.20 to 17.23. The Area is also significant as a focus for institutional and educational uses. Figure 17.20 shows Stanmore Public School and 17.21 is the recently completed Newington Preparatory School, both in Cambridge Street.

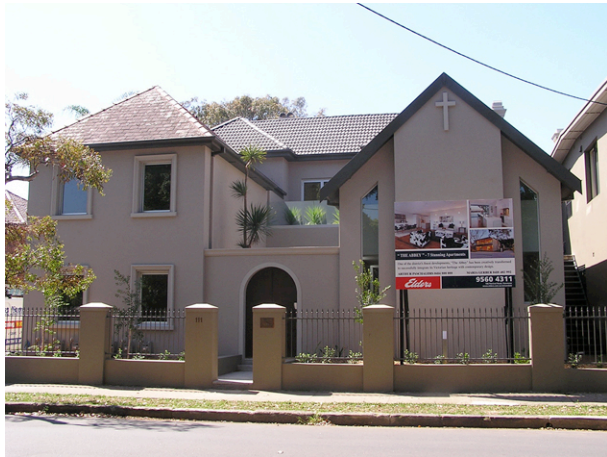
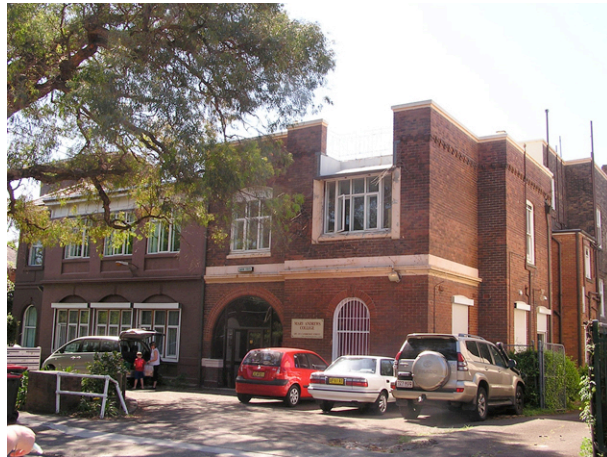
Figure 17.22 and 17.23. The former Catholic Church property shown in Figure 17.22 has recently been adapted for residential apartments. The area also includes several accommodation facilities associated with other institutions such as the Anglican centre shown in Figure 17.23.

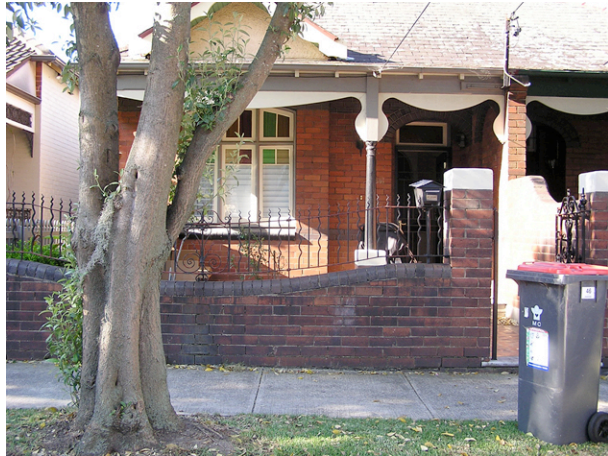
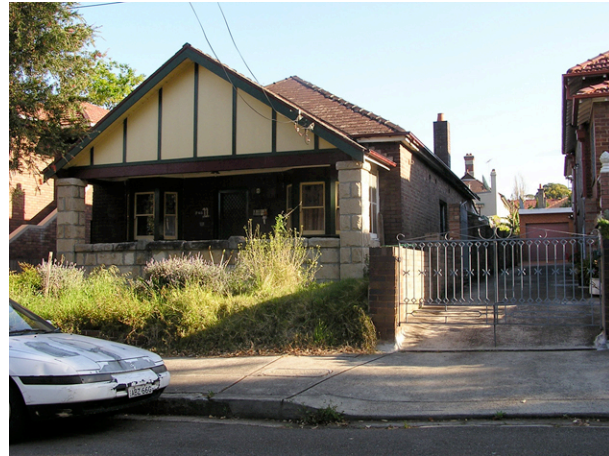
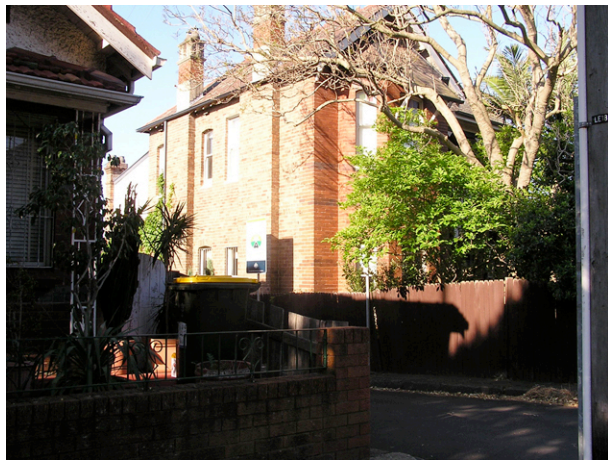
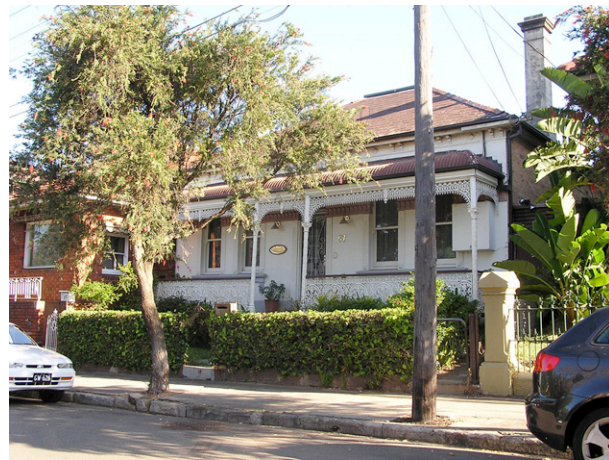
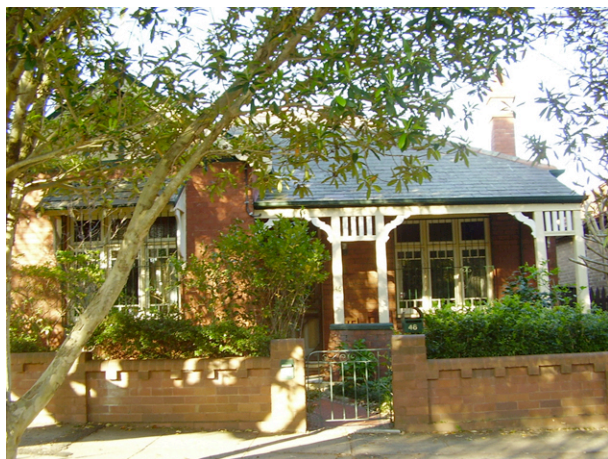
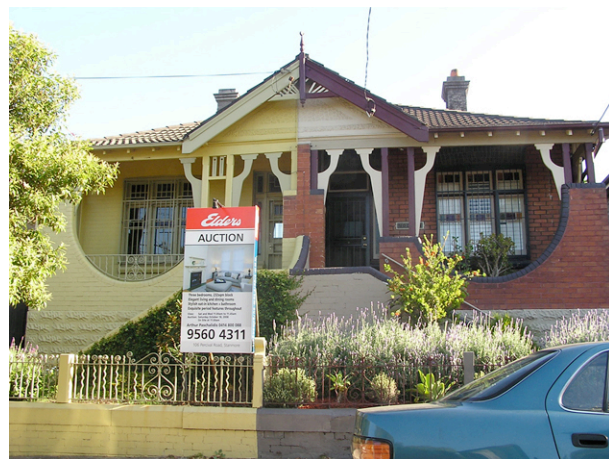
Figure 17.24 to 17.29. The eastern end of Harrow Road is consistently residential in its character and includes some good examples of Victorian, Federation and Inter-War residential architecture. Half of the fine face brick semi-detached Federation cottage in the bottom right photograph has been rendered and painted, possibly in an attempt to make it appear 'fashionable' for sale, but causing permanent damage to the original bricks.

Layering to surviving existing buildings varies from minor to intrusive and the current gentrification trends are having a significant impact on the face brickwork throughout the area, with examples of recent rendering and painting found as well as examples of more major work.

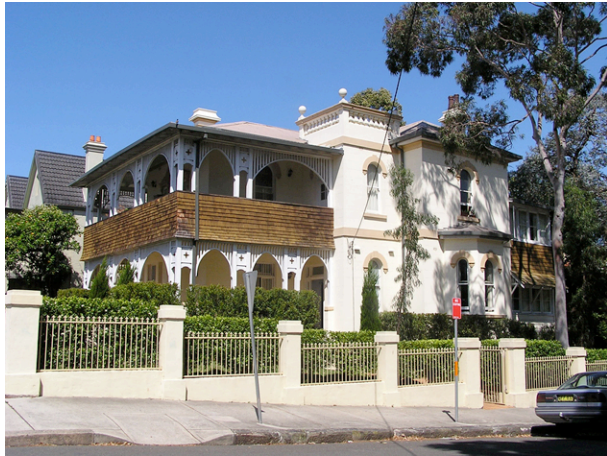
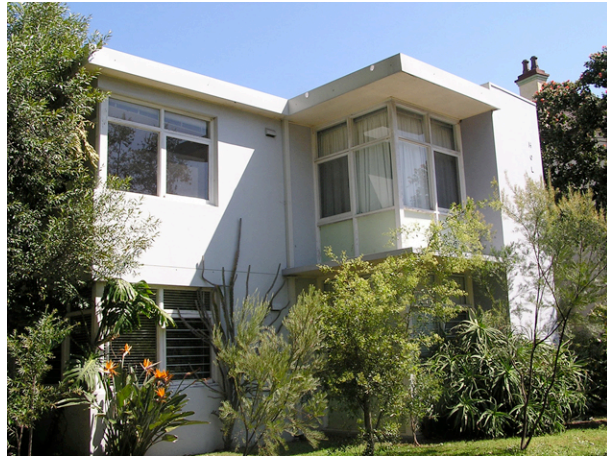
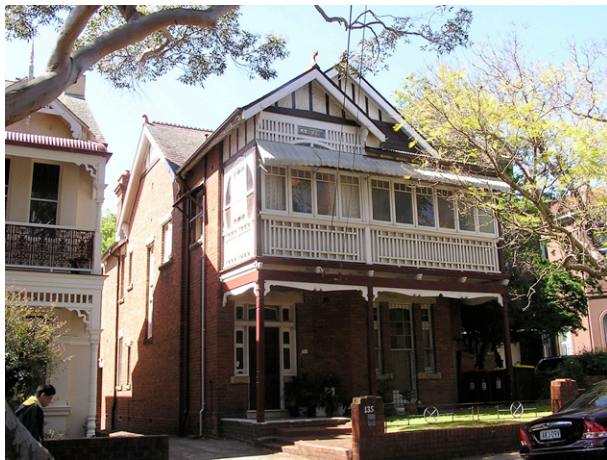
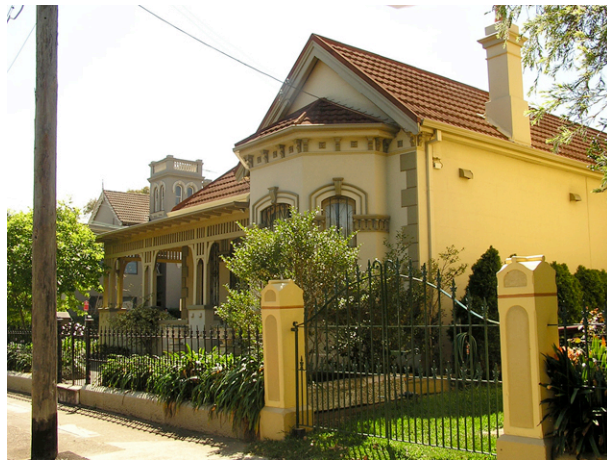
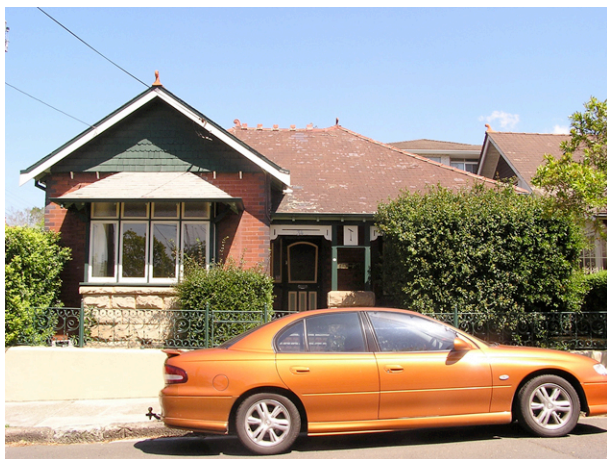
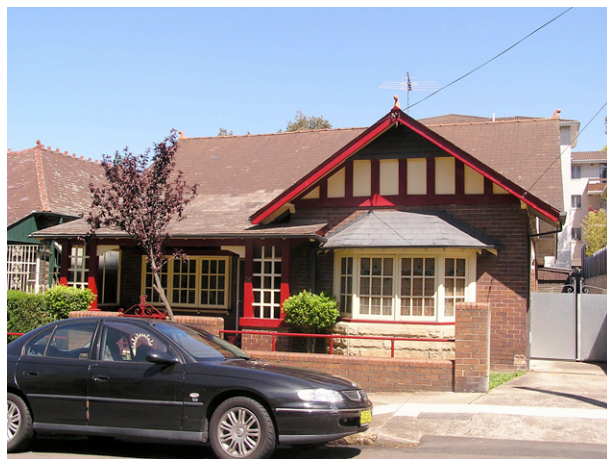
Figures 17.30 to 17.36 show a selection of properties from Cambridge Street. Its high situation with good outlook and views made it popular with the wealthy merchant classes and many substantial homes from this period have survived.

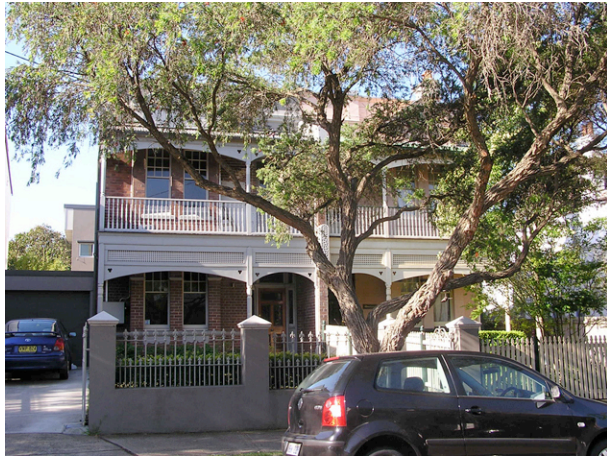
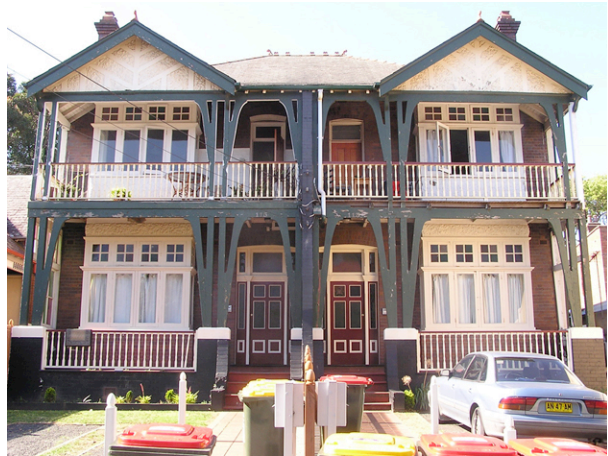
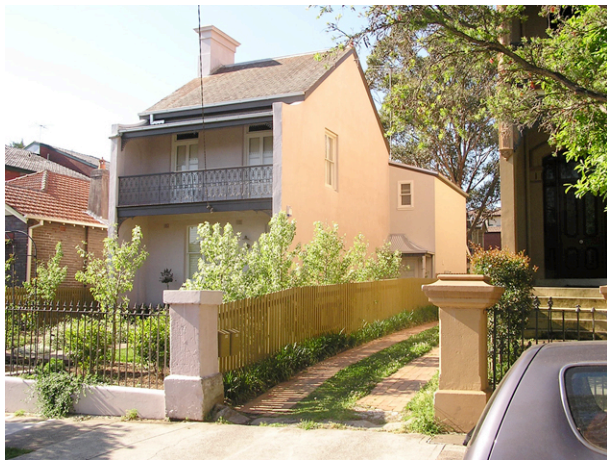
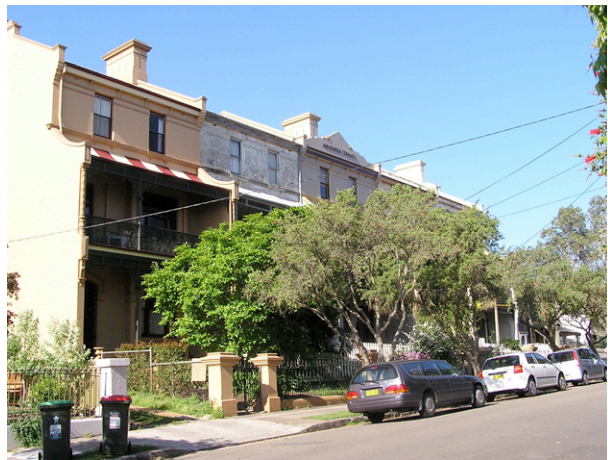
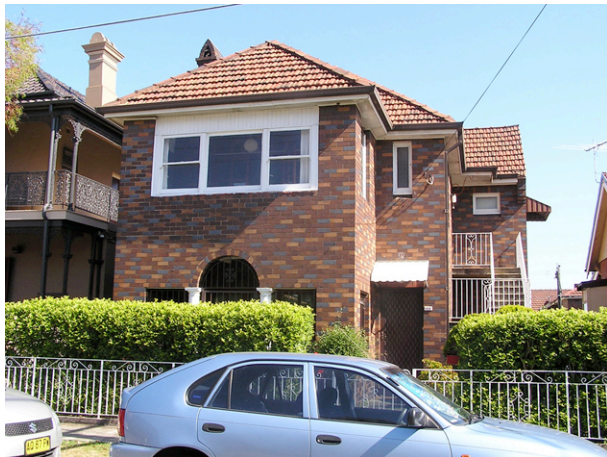
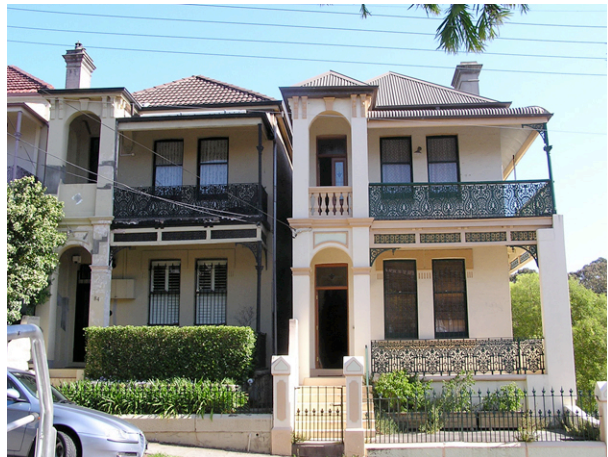
Figures 17.37 to 17.42 show houses in Cavendish Street. The two-storey Federation terrace in 17.38 is one of a group of similar terraces in Cavendish Street which are good examples of their type.

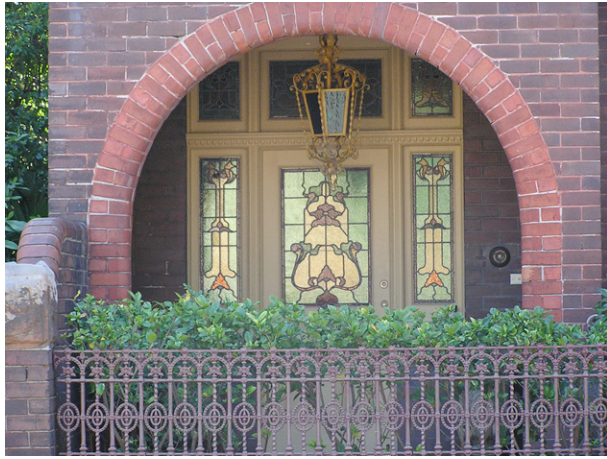
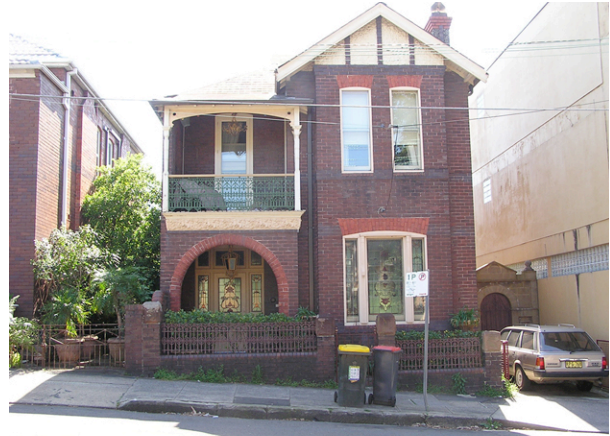
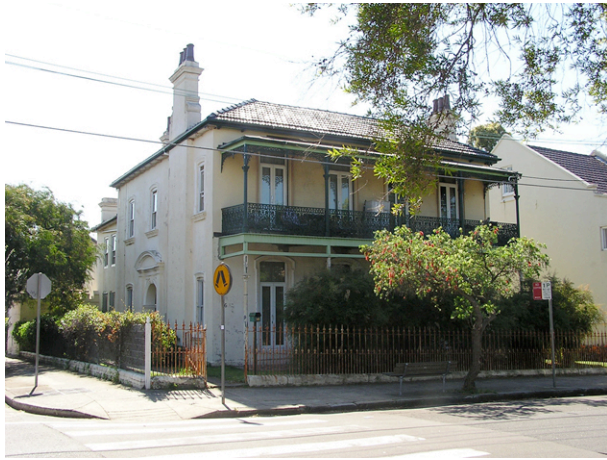
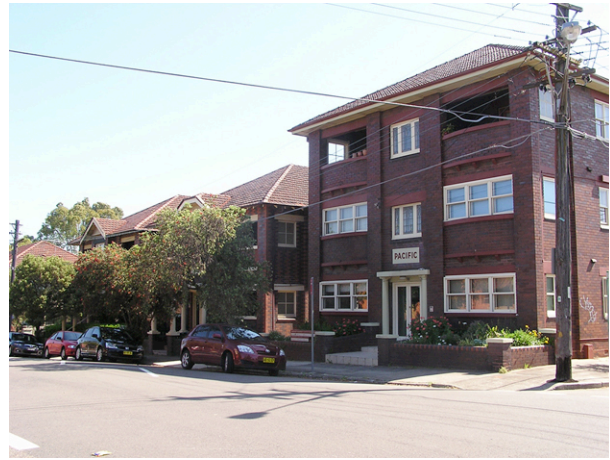
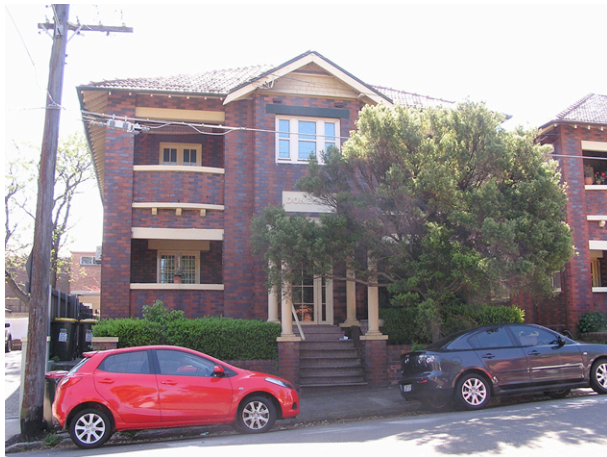
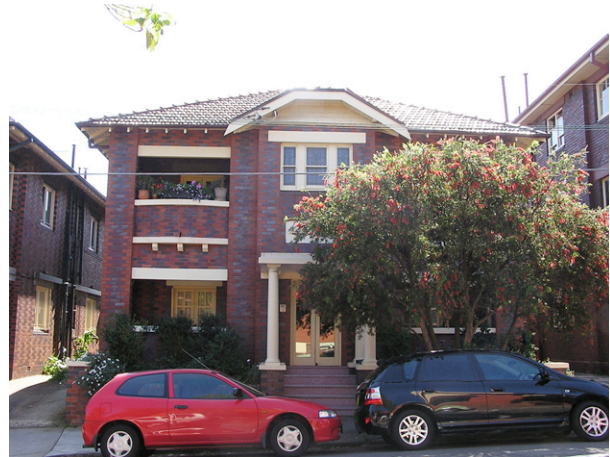
Figures 17.43 to 17.48 show properties on the western side of Holt Street. The recent infill development near the station can be seen at the edge of Figure 17.44 and is not included within the conservation area.

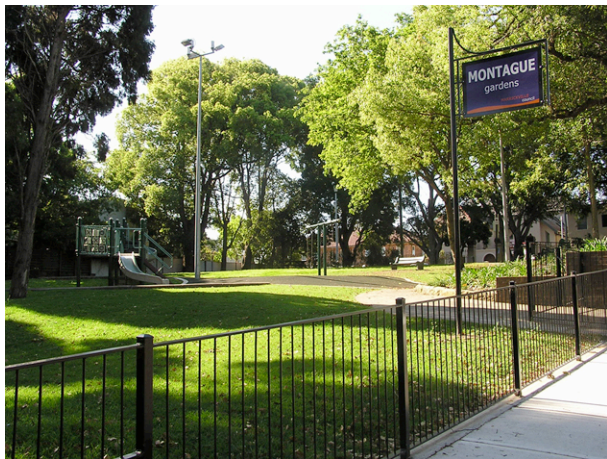
Figure 17.51. Montague Park was created following the demolition of the mansion owned by the Paling family.
