HCA 22 Morgan Street Heritage Conservation Area (Petersham)

22.1 LOCATION

22.2 DESCRIPTION

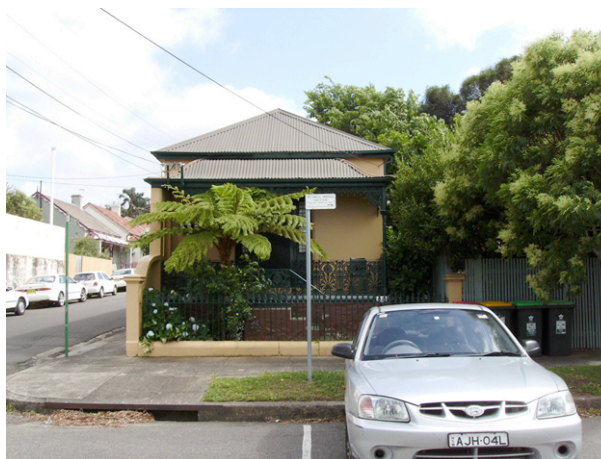
Figure 22.3 The western end of the Area includes a Victorian Vernacular cottage set in an 'L' shaped configuration with the long wing extending towards Morgan Street.

The adjacent cottage is L-shaped in footprint, though from the street it reads as a single-fronted cottage. The return is obscured from casual view by the mature garden plantings.

- Separate cottage demonstrates unusual built form for the Marrickville area being an 'L' shape footprint with wing projecting towards street
- Building typologies reinforce the urban grain.

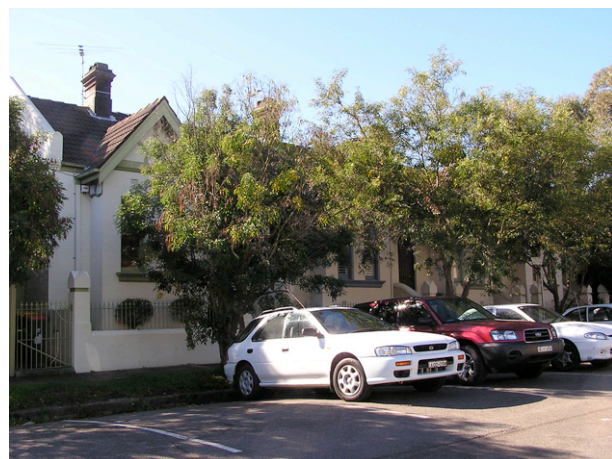
Figure 22.4 The remainder of the area is comprised of a single terrace of eight dwellings. The group has retained a high degree of cohesiveness: although the original face brick has been painted, none have undergone significant external extensions. Those at the western end of the group are screened by the street planting.

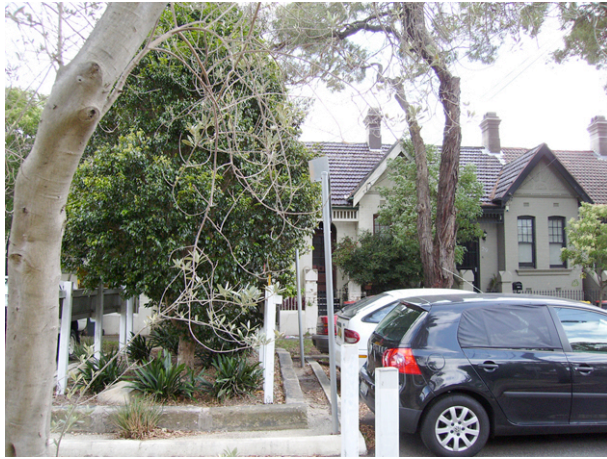
Figure 22.5 The middle of the group is obscured by the planted street closure.

The plantings associated with the road closure in front of the group has obstructed views towards the group from the street and does little to contribute to its streetscape qualities.

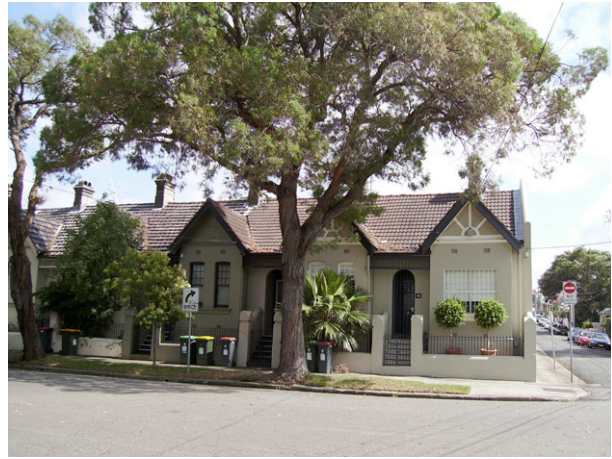
Figure 22.6. The eastern end of the group is not hidden by landscaping and its cohesive built form forms a prominent element in the local streetscape.

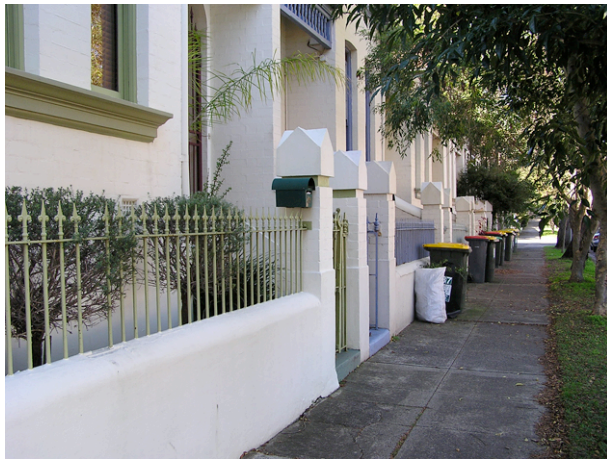
Figure 22.7 The group demonstrates a highly cohesive built form

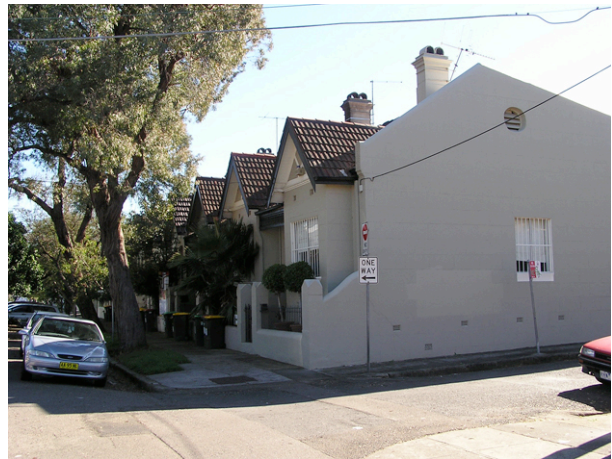
Figure 22.8 The gabled roof and prominent chimneys of the terrace have retained their original forms although the roof cladding has been replaced.

The terrace presents a unified group to the street with a good rhythm of gables protruding from a continuous gable-ended main roof devoid of external firewalls. The roof tiles have been replaced by unglazed cement tiles but the chimneys are intact and contribute strongly to the rhythm of the roofscape. The gables are typical of the Federation period with their rising sun motif against a roughcast panel. Their original purpose as a rental property is expressed through the simple detailing and minimal setbacks from the street. Windows are paired in the Federation style and front doors recessed under a small porch. Fences are a half-palisade on a heavy rendered base with prominent pillars framing the centre-opening gates. The dividing walls to the setback area are finished in an ogee profile.

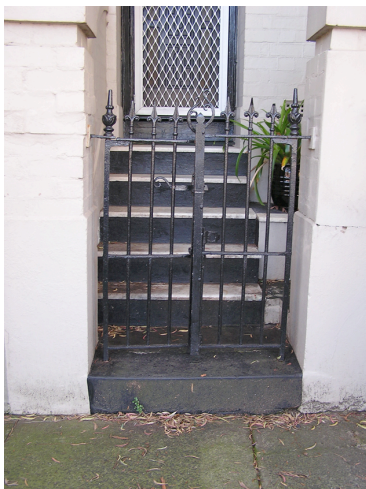
Figure 22.9 The original iron gates are an uncommon split design.

- Original Iron Palisade fences – variant on standard design with centre-opening gate
- Lack of car parking infrastructure

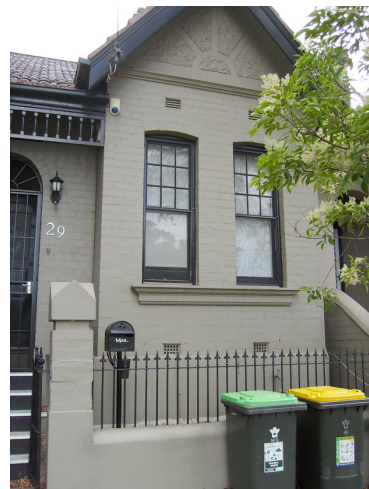
Figure 22.10 The group has been subjected to layering in the gentrification style. The main impact of this on the fabric has been caused by the painting of the original face brickwork.

The terrace has been gentrified through the painting of brickwork and the addition of reversible details. The palette is limited to neutral colours - mostly greys with dark charcoal/black detailing and the terrace still reads as a unit.

The Morgan Street Heritage Conservation Area was developed during the early Federation period and although the structural integrity is substantially intact, the terrace has been painted/rendered and gentrified details applied. This change is effectively permanent, and detracts from the ability of the group to demonstrate the original appearance of the face-brick Federation terrace, but does not alter
