HCA 27 Hordern Avenue Heritage Conservation Area (Petersham North)

Figure 27.1 HCA 27 – Hordern Avenue Heritage Conservation Area

27.1 LOCATION

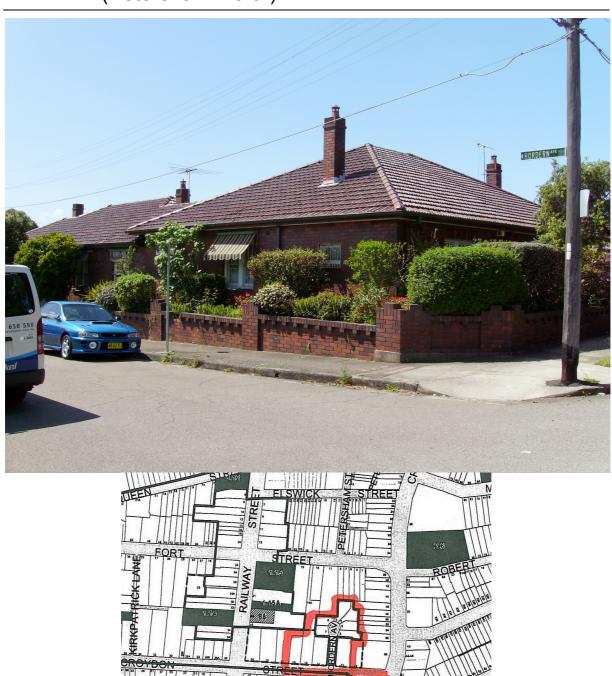
The Hordern Avenue Heritage Conservation Area is located in North Petersham near the intersection of Crystal Street and Croydon Avenue.
