HCA 28 Dulwich Hill Commercial Precinct Heritage Conservation Area (New Canterbury Road, Dulwich Hill)

Figure 28.1 HCA 28 Dulwich Hill Commercial Precinct Heritage Conservation Area

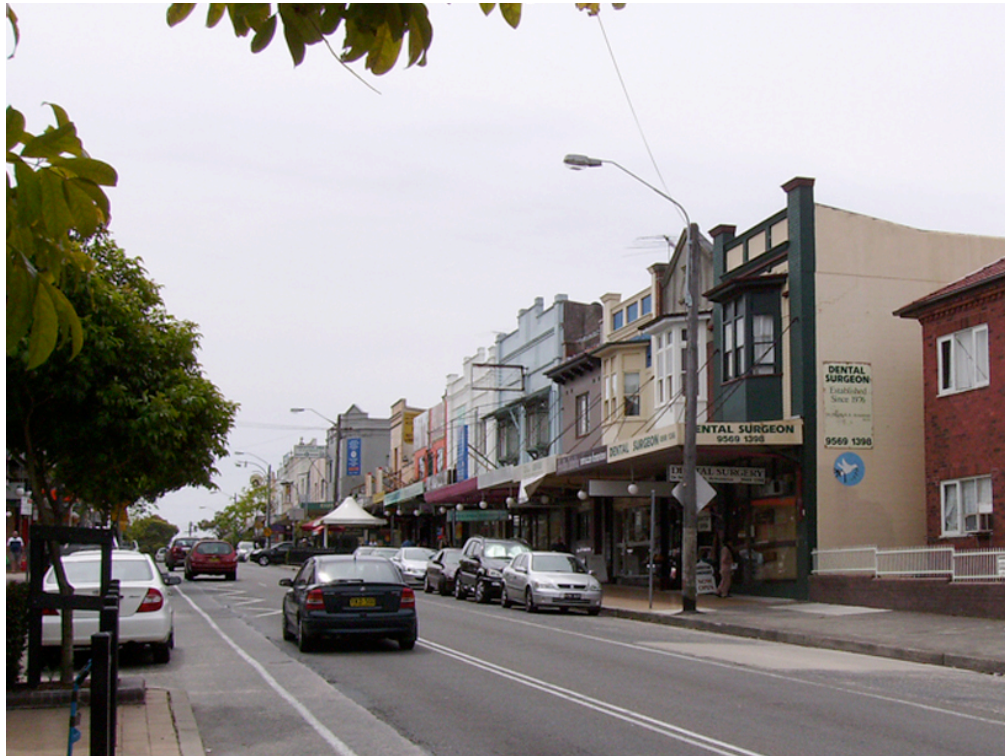
The Dulwich Hill Commercial Precinct Heritage Conservation Area follows the alignment of New Canterbury Road between Constitution Road/Beach Street and Herbert Street and Marrickville Road from its intersection with New Canterbury Road to Macarthur Parade.

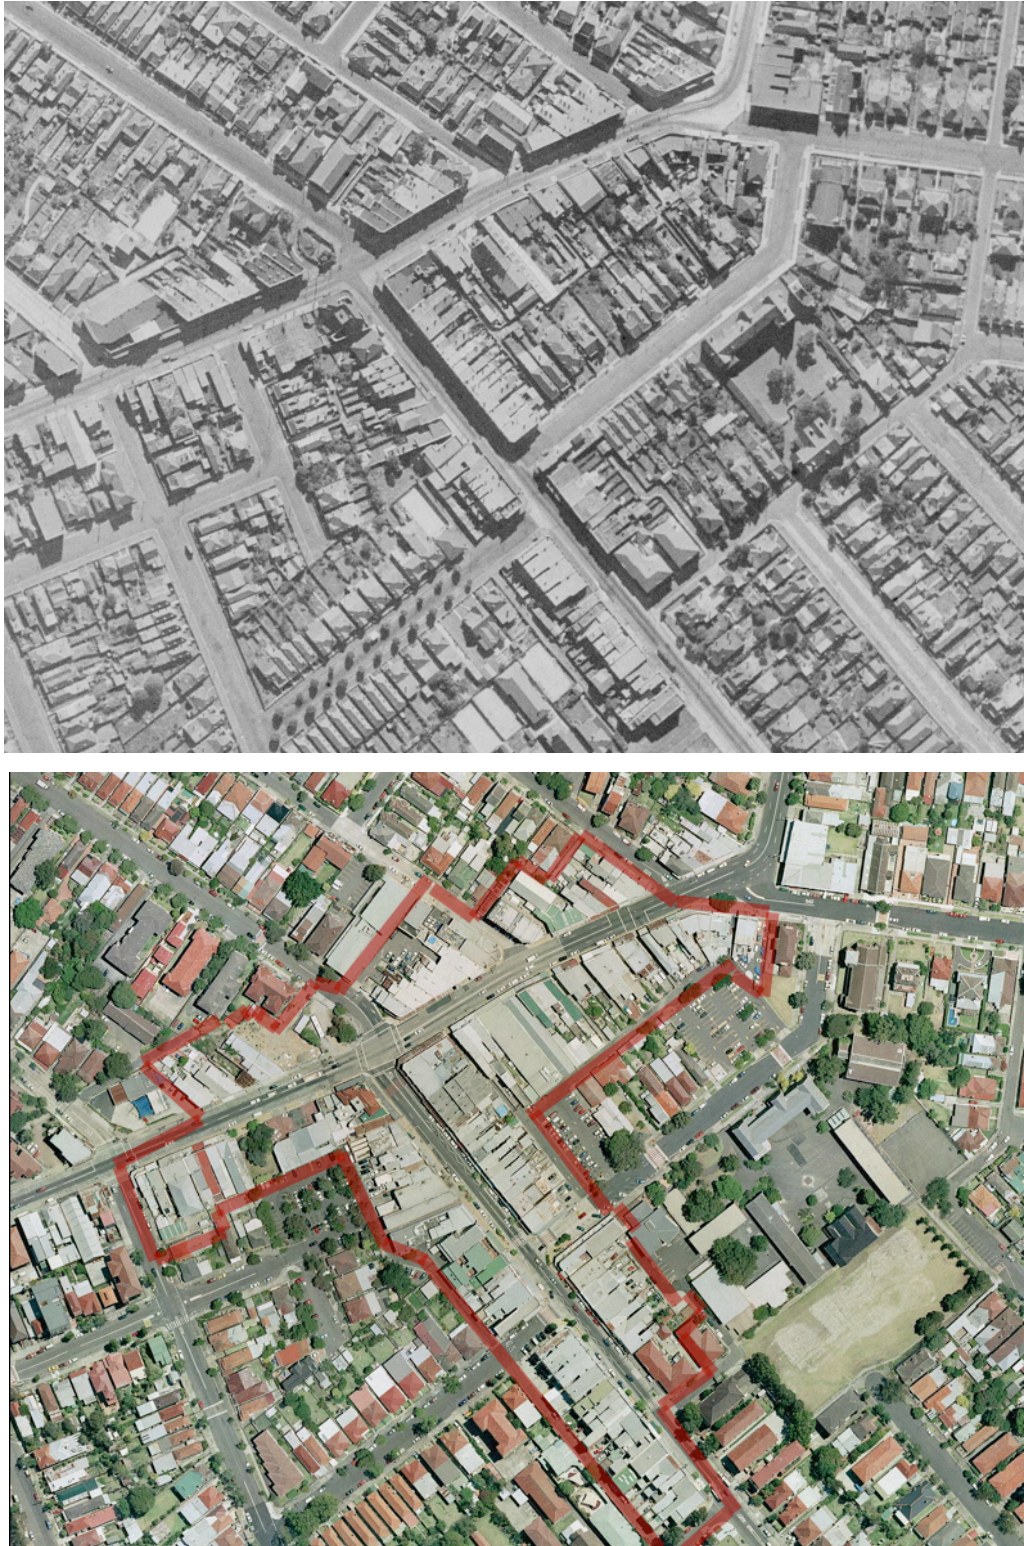
Figure 28.2 The Area in 1943 and 2009 (source: NSW Lands Department SIX Viewer)

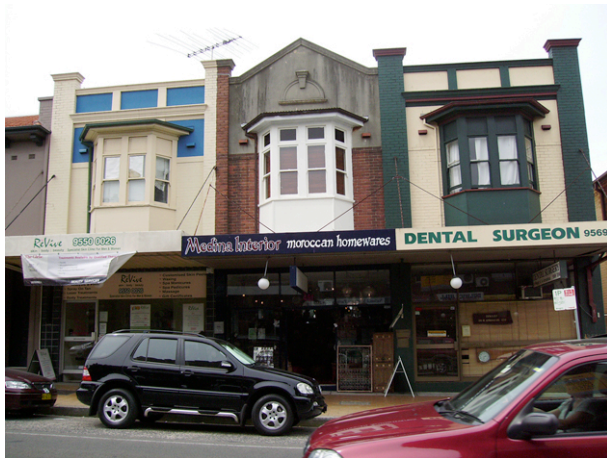
Figure 28.3. Group of substantially intact (above awning) shops on Marrickville Road

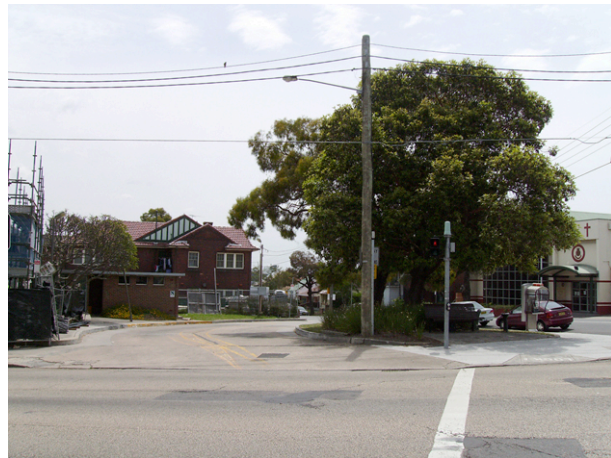
Figure 28.4. The Dulwich Hill shops developed after the arrival of the tram service along Marrickville Road which terminated within the area now used as a bus turning circle. This space is important to understanding the significance of the area.

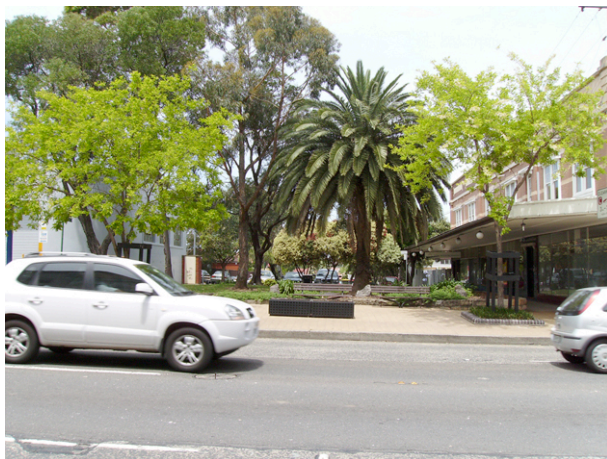
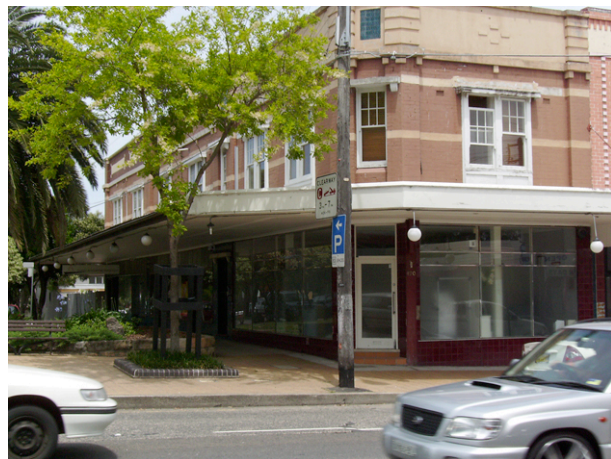
Figure 28.5 and 28.6. This small group of shops overlooks a park created by a street closure of Loftus Street and contributes to the aesthetic values of the Area.

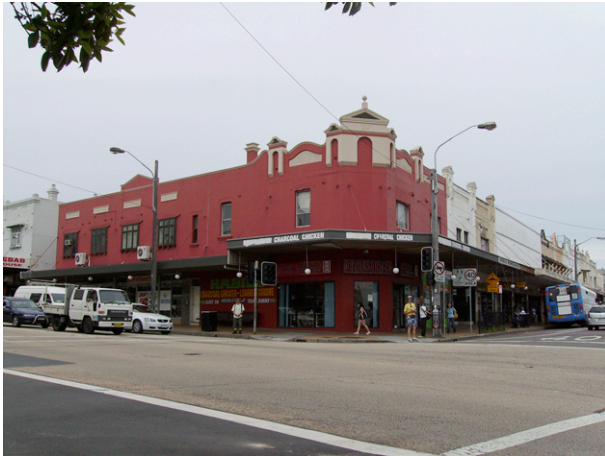
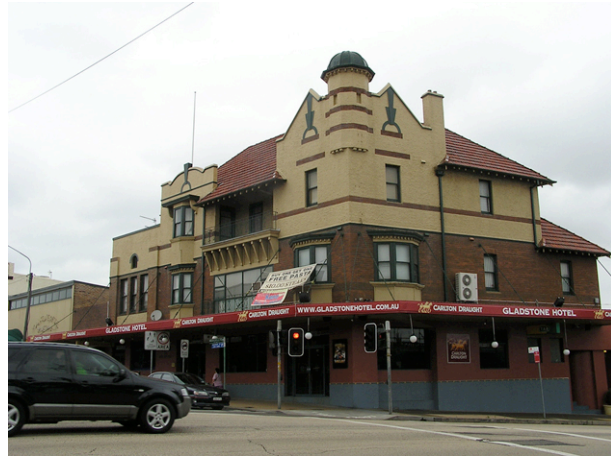
Figure 28.7 and 28.8. The intersection of New Canterbury and Marrickville Roads is punctuated by the Gladstone Hotel (R) and a commercial building with a similarly formed parapet line (R) which enhance the streetscape qualities of this busy intersection.

The focal point of the area is the Gladstone Hotel. Situated in a prominent position at the intersection of New Canterbury and Marrickville Roads, this building exhibits strong Federation Arts and Crafts influences and has significant impact on the local streetscape, particularly when viewed from the east. This building has been investigated as part of the Heritage Items Review 2009 and is recommended for listing as an individually significant item.

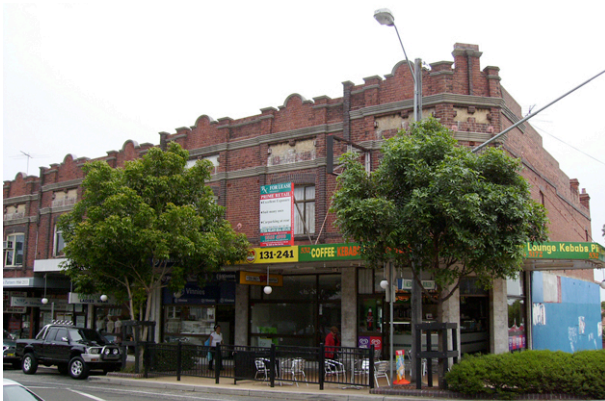
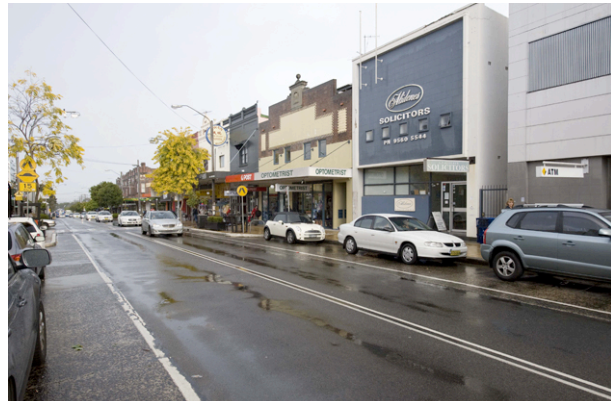
Figure 28.9 to 28.17 show some of the contributory parapet lines found in the Area.

formed parapets create an aesthetically complex and pleasing skyline when viewed from the opposite footpath. The visually prominent early ball light fittings found in the Marrickville local government area's shopping areas add a further unifying element to the streetscape.

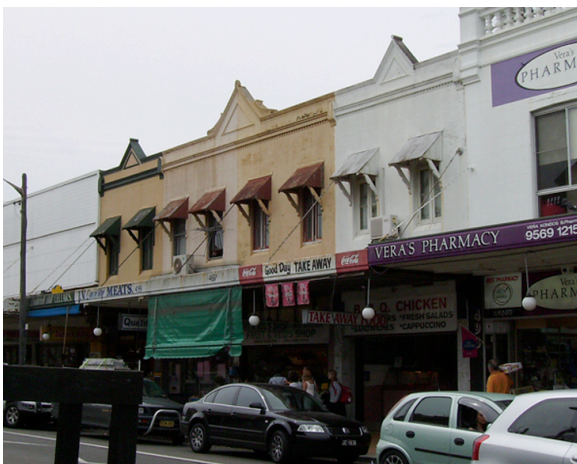
Figure 28.11 demonstrates the important contribution that repetition and rhythm can make to the creation of aesthetically interesting retail streetscapes, even if only through the very simple device of a basic hood and consistent window placement.

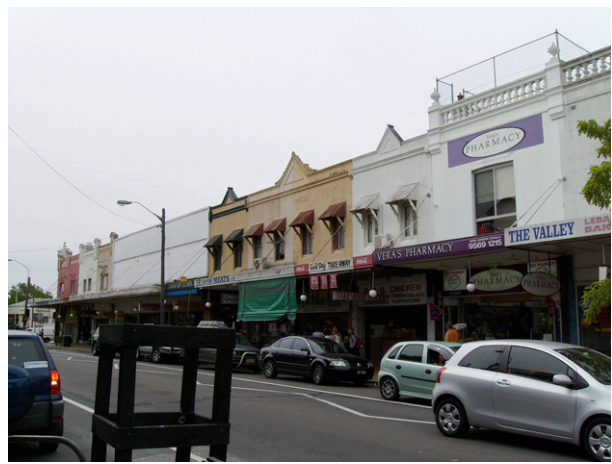
Figure 28.12 (background) highlights the impact of removing or obscuring these fine elements, resulting in a blank and uninspiring façade.

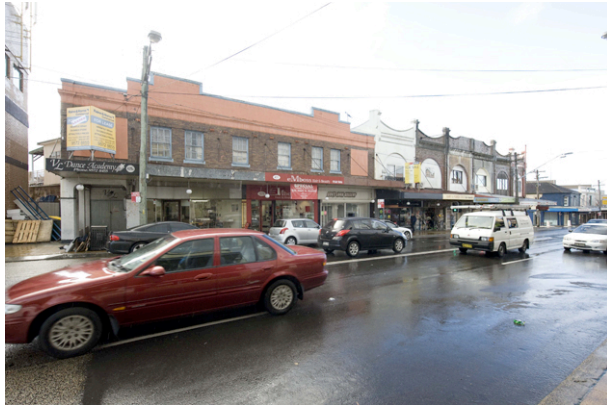
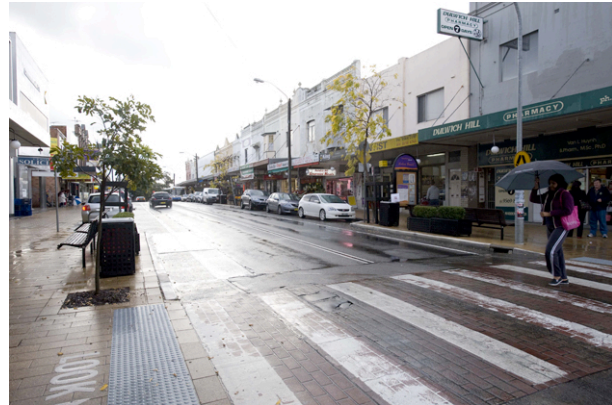
Figure 28.13 and 28.14. The parapet line throughout the shopping centre is consistently two stories in height with decorative detailing varying according to the underlying built form and period of construction of the relevant group of buildings.

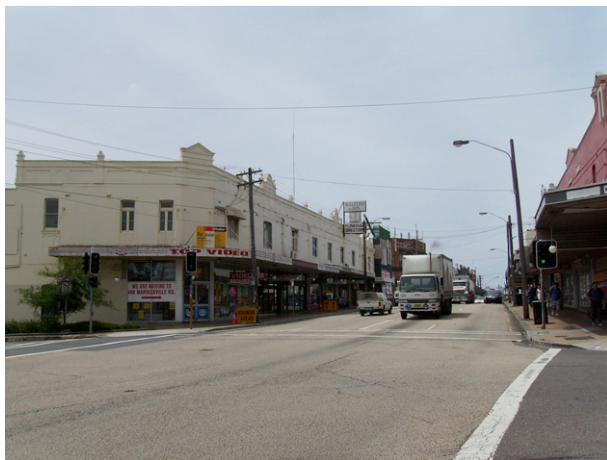
Figure 28.15 New Canterbury Road demonstrates a consistent parapet and skyline.

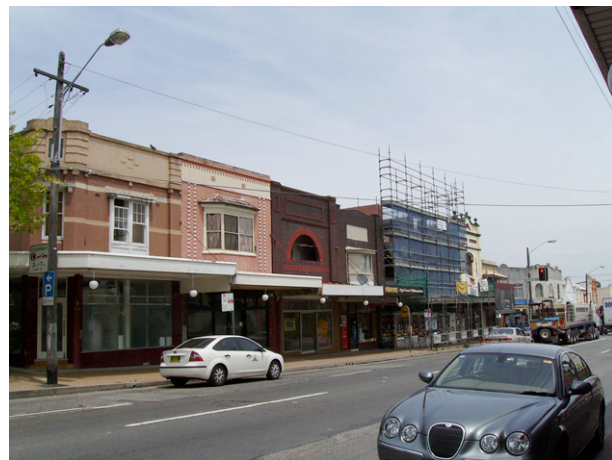
Figure 28.16. Marrickville Road. This group demonstrates considerable variation within the detailing of the façade but a consistent parapet height.

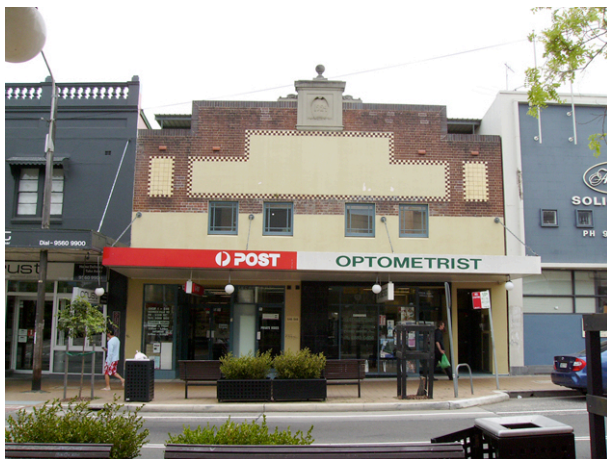
Figure 28.16 Parapet detail on Marrickville Road

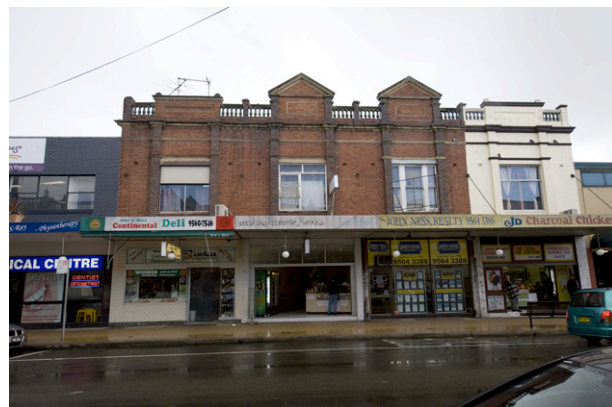
Figure 28.17. Parapet detail on Marrickville Road

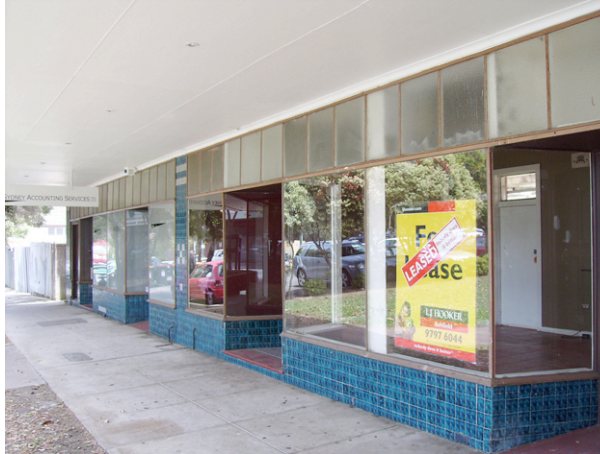
Figure 28.18. Detailed shopfront to Loftus Street showing original tiled façade and glazed shopfronts.

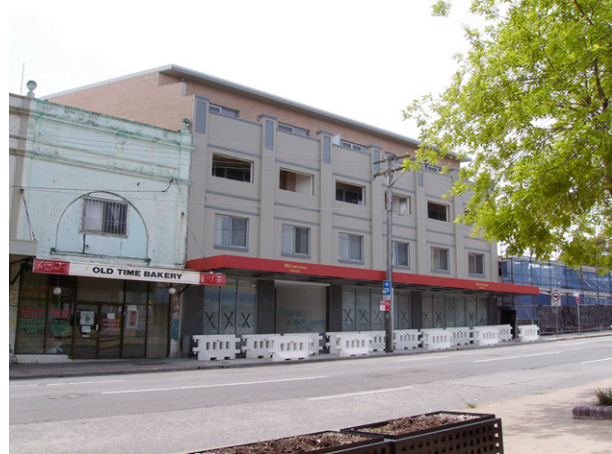
Figure 28.19. This recent infill development has attempted to replicate the rhythm of the original shop bays whilst also achieving additional levels. Its success from the streetscape perspective is limited because the additional level setback from the main parapet obstructs the variations created along the new parapet line.
