HCA 31 David Street Heritage Conservation Area (Marrickville)

31.1 LOCATION

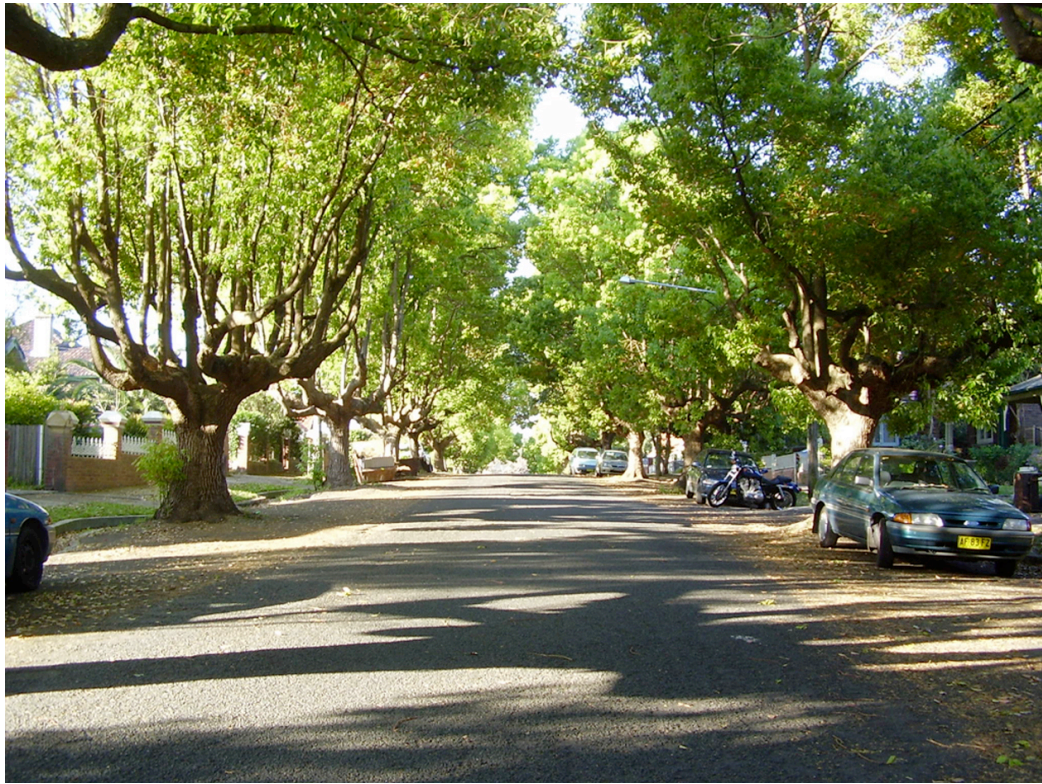
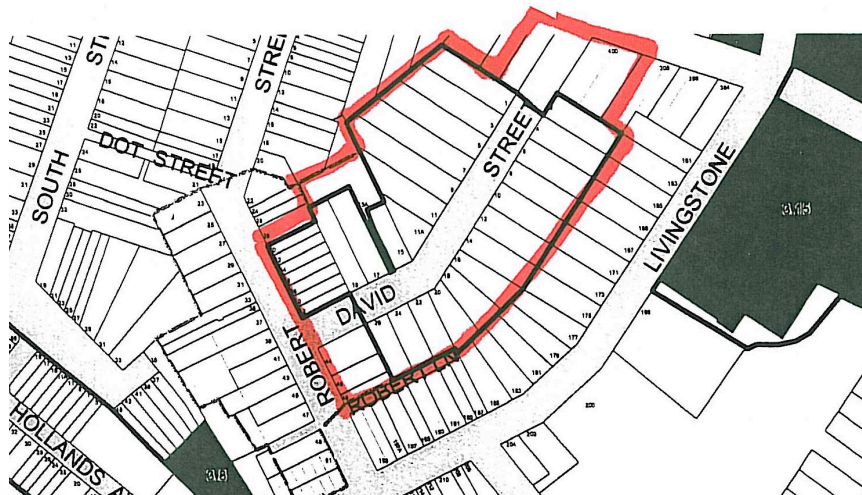
Figure 31.1 HCA 31 – David Street Heritage Conservation Area

The David Street Heritage Conservation Area is located to the south-west of the intersection of Marrickville and Livingstone Roads, Marrickville.

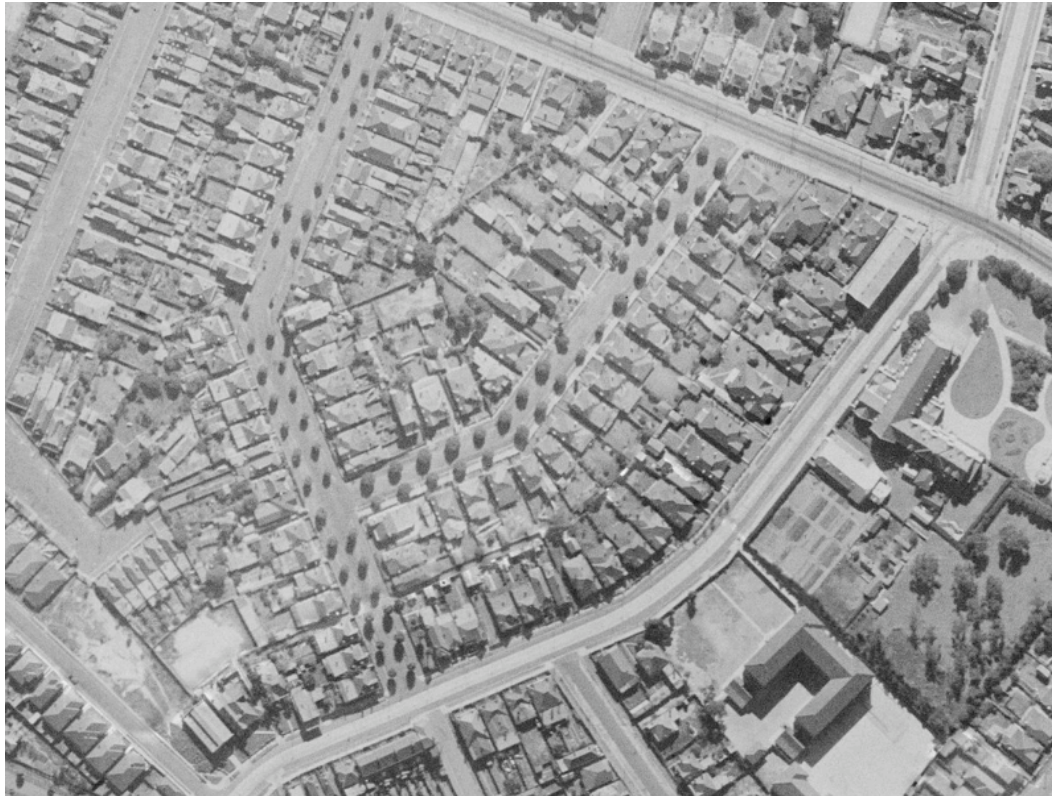
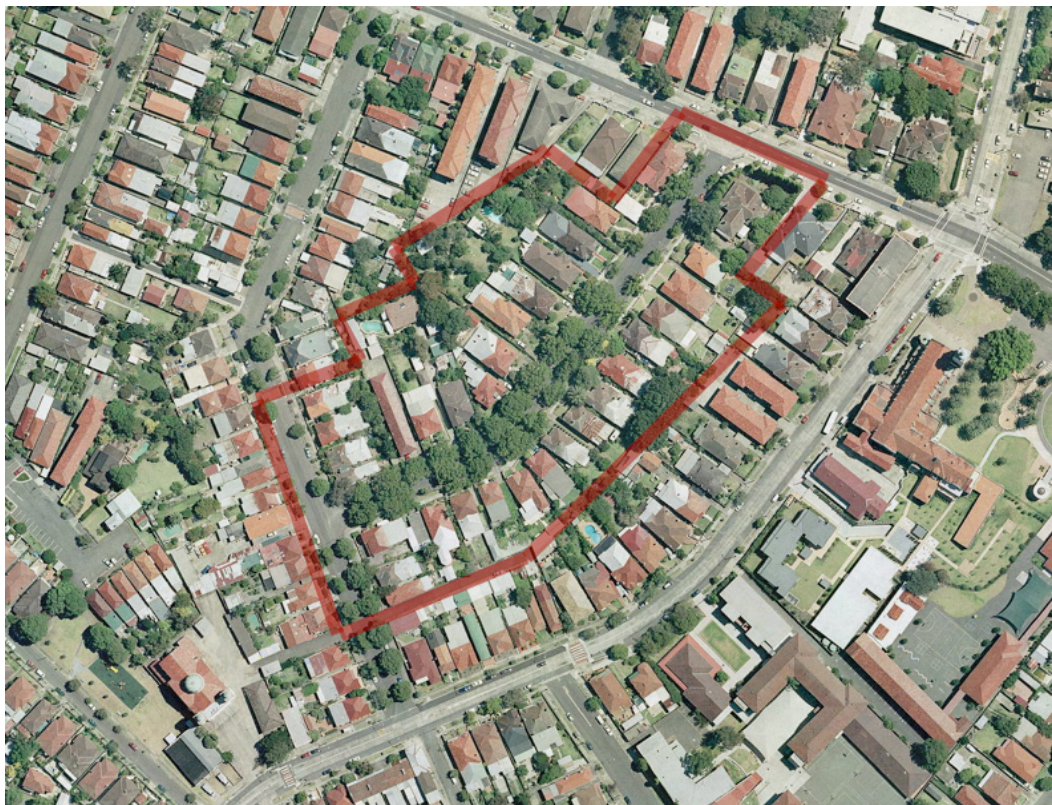
Figure 31.2 The Area in 1943 and 2009 (source: NSW Lands Department SIX Viewer) The young street tree plantings can be seen clearly.

The David Street Heritage Conservation Area is of aesthetic significance for its substantial Federation period detached housing in David Street within generous gardens and mature brush box street planting planted early (shown as fully grown in 1943 aerial photos), giving the appearance of a Federation period "Garden suburb" (though built on more than one subdivision). The Robert Street Federation period semi-detached housing, with asymmetrical frontages designed to resemble single houses are also of aesthetic significance, for their adaptation of fashionable Federation period designs to provide more modest housing and the continuation of the Brush Box planting into this more modest streetscape.

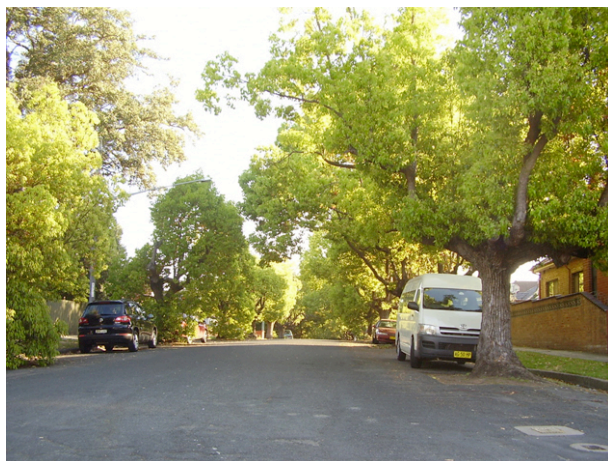
Figure 31.3 The entry to the area from Marrickville Road is distinguished by its mature plantings of large Brush Box street trees.

The most distinctive element of the area is the avenue of mature Brush Box trees (*Lophostemon Confertus*) in David Street which continues into the eastern end of Roberts Street. Planted in the road pavement and reaching heights not found elsewhere in Marrickville, they impart a strong sense of unity and enhance the streetscape quality of the area. The trees have been pollarded when young but allowed to grow unimpeded in more recent years. Some have suffered from heavy pruning for overhead cabling. Verges are wide and footpaths concrete.

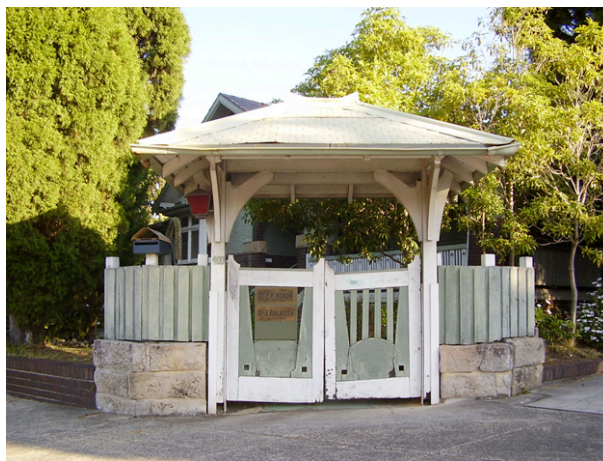
Figure 31.4 The original lynch gate to the property at the corner of Marrickville Road and David Street is an important local feature.

Also notable are the original front fences to properties, including the rare (in the context of the Marrickville area) decorative ironwork panels set on low brick walls (approximately 5-7 courses) with bullnosed coping and slender pillars (many with rendered and painted capitals) at the property boundaries and gateposts. The lynchgate at the entrance to the property on the eastern corner of David Street at 400 Marrickville Road adds to the distinctive streetscape quality of the David Street area.

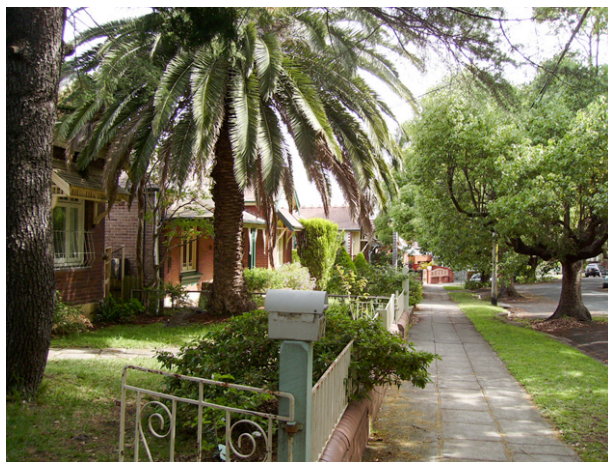
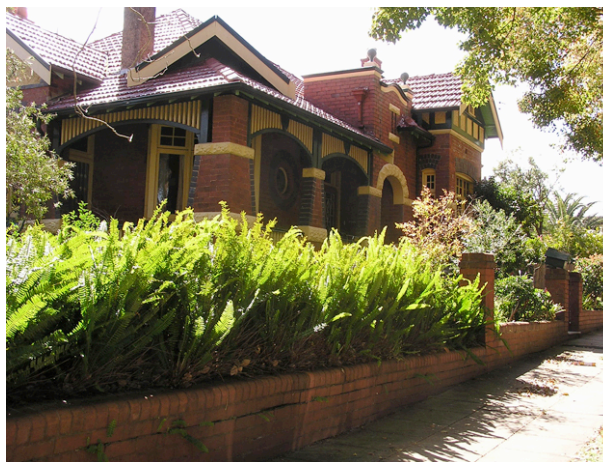
Figure 31.5. The houses to David Street set well back from the street alignment and allow for the planting of a reasonable front garden.

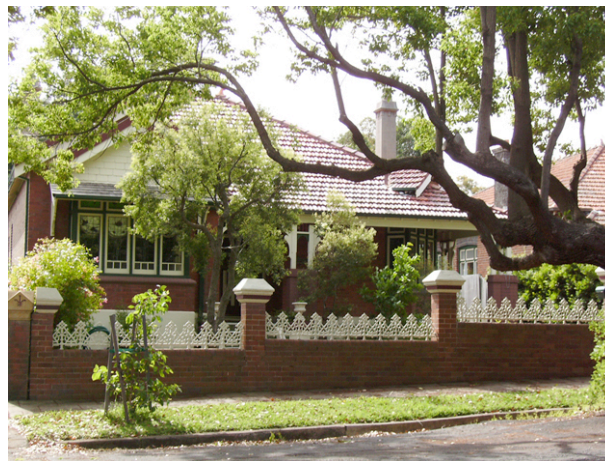
Figure 31. 7 . Note the original decorative iron lace panels to the front fence

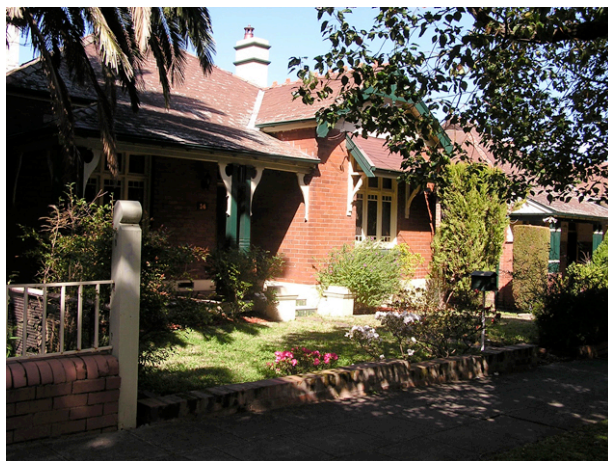
Figure 31. 8. A more modest house, but highly contributory to the local streetscape.

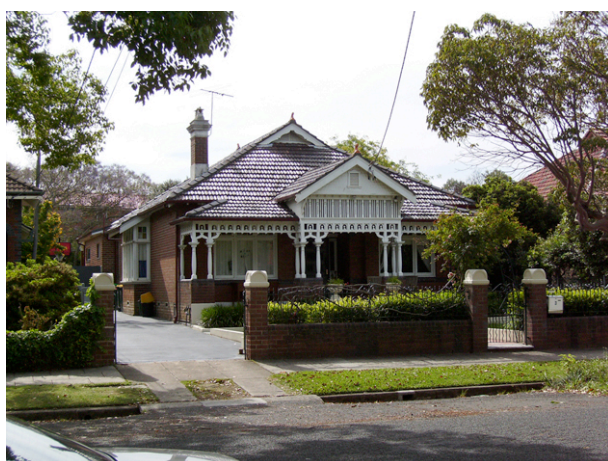
Figure 31.10. The Federation filigree style, with its finely worked timber screening is rare in Marrickville's heritage conservation areas.

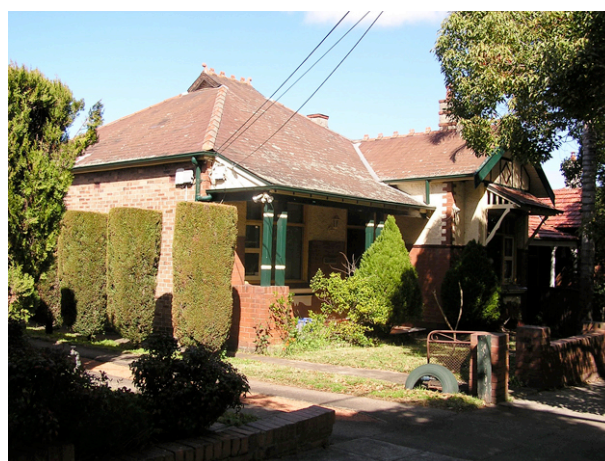
Figure 31.11. Many of the houses in David Street have retained their original slate roofs, which contributes strongly to the aesthetic qualities of the Area..

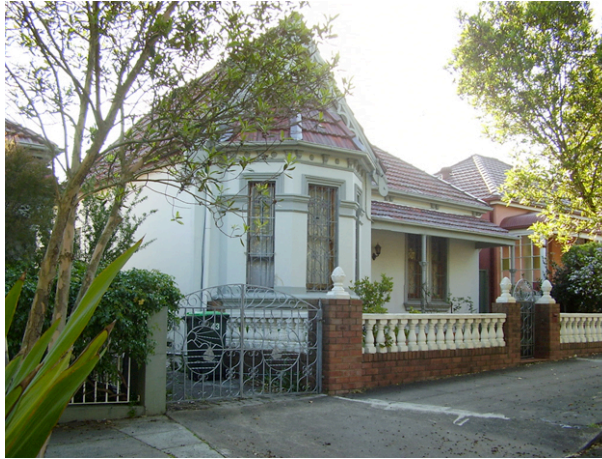
Figure 31.12. Although developed after the Victorian style of architecture had been superseded by the Federation, the Area includes some Victorian style houses.

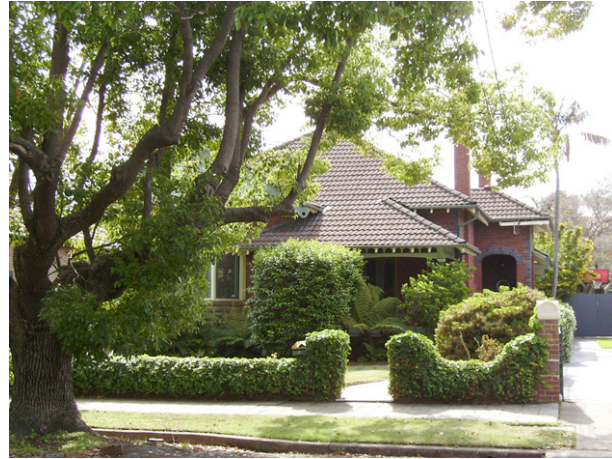
Figure 31.13. A late Federation/early bungalow form.

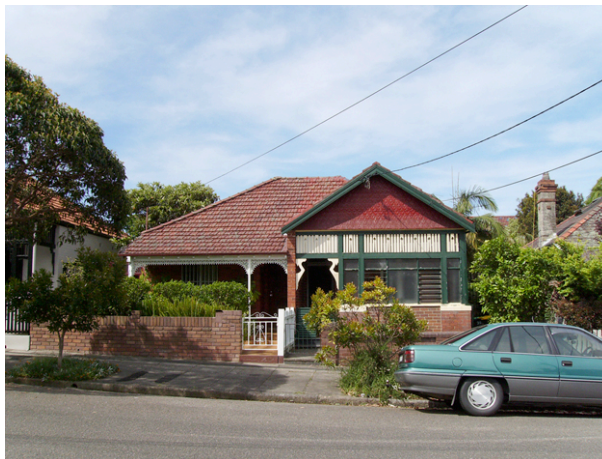
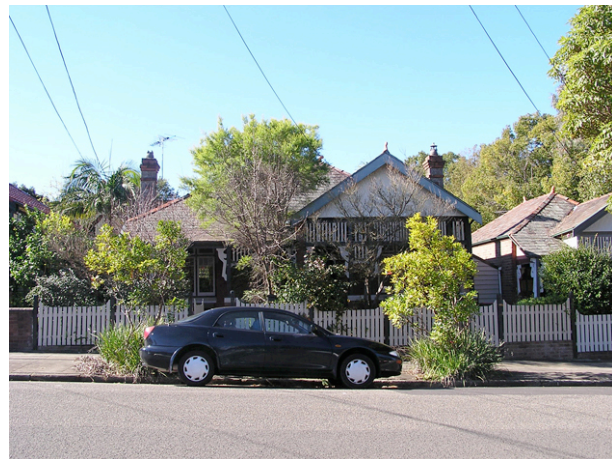
Figure 31.14 the houses within the conservation area in Robert Street contribute to the David Street group through their scale, form and detailing. The street trees also continue along Roberts Street towards Livingstone Road.

The properties on the northern side of Roberts Street demonstrate values consistent with those in David Street, including substantially intact fabric (including some with original slate roofs) and spatial relationships consistent with David Street.

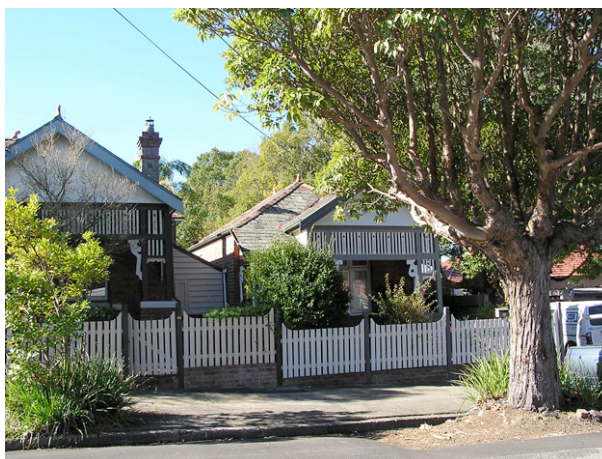
Figure 31.16 Robert Street. Note the simpler built forms and flat topped timber picket fences instead of the more elaborate brick and iron fences within David Street.

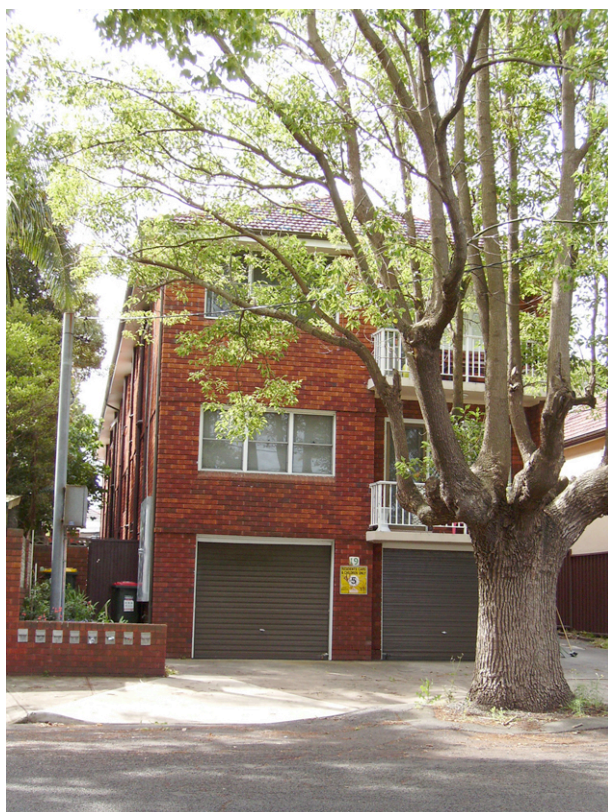
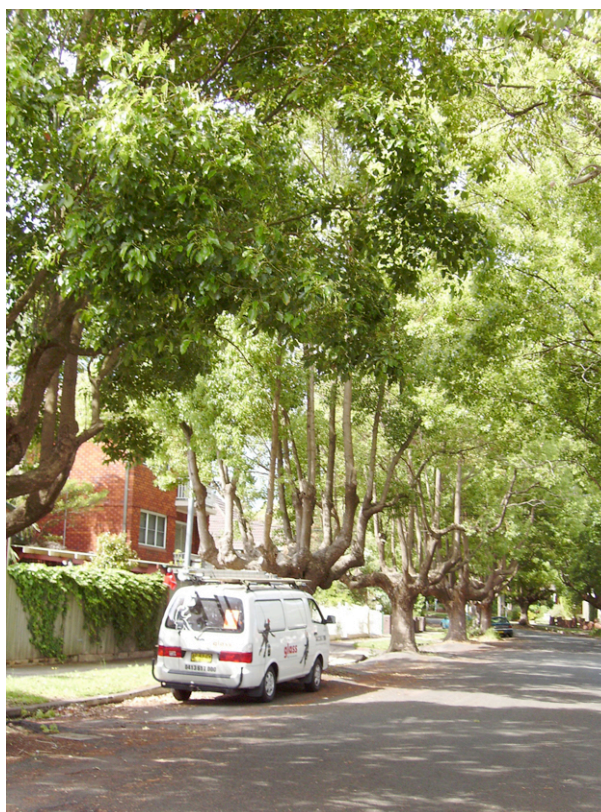
Figure 31.20. The main non-original element within the David Street group is this 1960s red texture-brick residential flat building. Although considerably larger in scale and unsympathetic in form to the original buildings in the area its impacts on the streetscape are ameliorated by the unusually lush growth of the Brush Box trees.

The main non-original element in the Area is the 1960s three storey walk-up flats in red texture brick near the southern end of the street. The impact of this building in oblique and street views is minimised by the screening effect of the street trees, although the building is clearly visible from its immediate setting. Several houses have been rendered/painted white and have undergone extensive
