## HCA 33 Wells Avenue Heritage Conservation Area (Tempe)

Figure 33.1 HCA 33 – Wells Avenue Heritage Conservation Area

### 33.2 DESCRIPTION

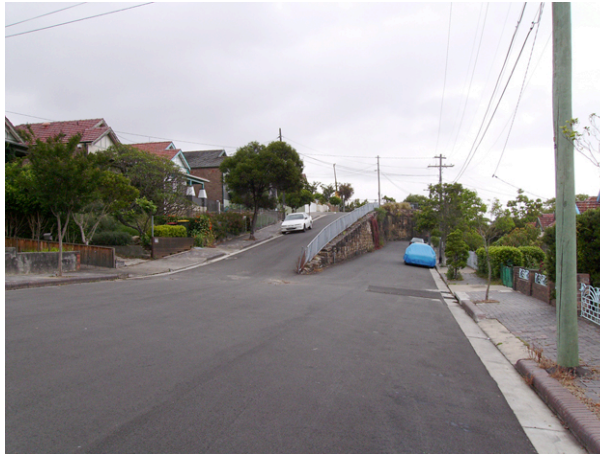
Figure 33.3 The streetscape of Wells Avenue is a distinctive one due to the split-level roadway across the steep fall of the land from Unwins Bridge Road towards the railway line.

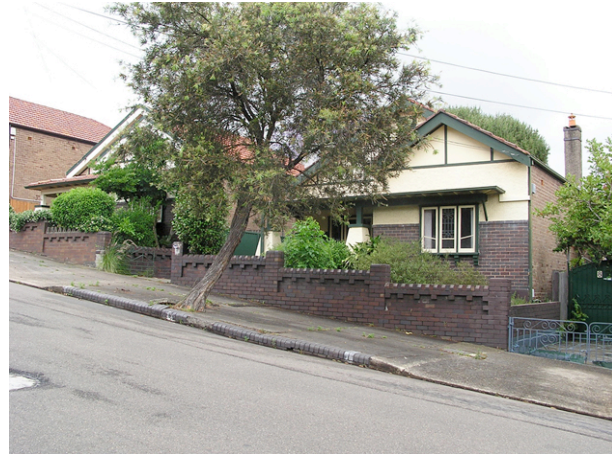
Figure 33.4. The houses on the southern side of Collins Street also step down to accommodate the fall of the land.

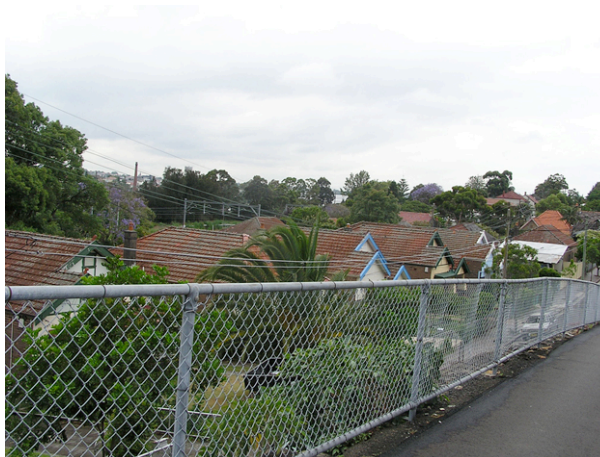
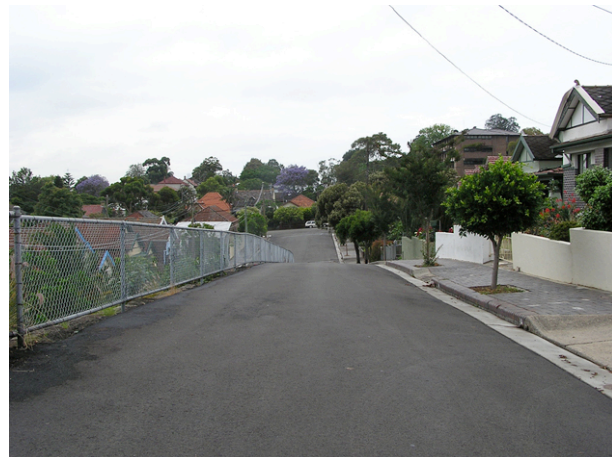
Figure 33.5 and 33.6. The split-level street configurations provides opportunities for appreciation of the consistent roofscape provided by a row of intact Californian bungalows from a perspective not often available.

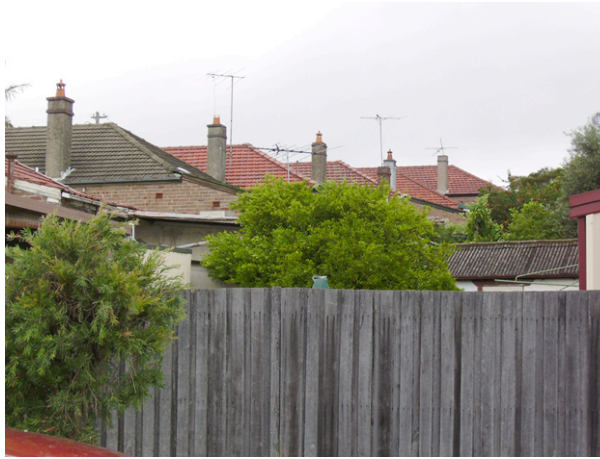
Figure 33.7 the sloping topography also provides opportunities for views over the rear roofscape of the houses Collins Street. The consistent design of the cottages without major additions to the rear and survival of the chimneys enhances the aesthetic quality of this view. The modest scale and form of the Californian bungalow is appreciated readily within the Wells Avenue Heritage Conservation Area.

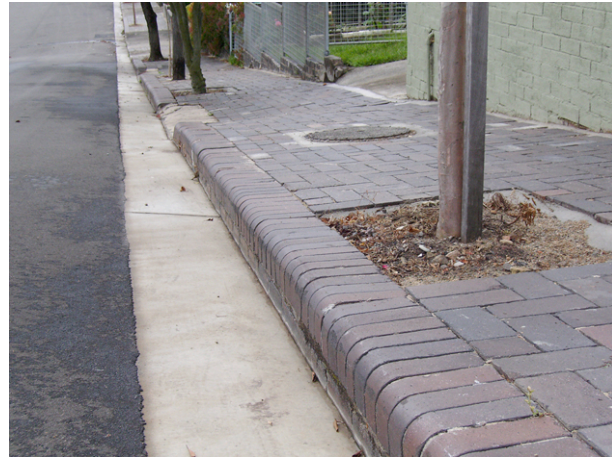
Figure 33.8. An important element of the Wells Avenue streetscape is the survival of the 1930s Depression Employment Relief Scheme brick paving with bull nosed edging. Although patched in places its herringbone patterning adds an important texture to the streetscape.

The kerbing to both streets is dark bullnosed brickwork, and the footpaths to Wells Avenue are paved in bricks laid in the herringbone pattern. Some driveway crossings have been re-laid in brick although others have been cut-through in concrete – which interrupts the continuity of the streetscape. Openings have been created in the brickwork for street trees, which are 1970's period native plantings. The main significant trees in the area are the mature Frangipani in the front garden of number 6 Wells Street and the large Camphor-laurel behind houses in Wells Avenue which provides a soft backdrop to the roofscape, and the relatively young Canary Island Palm in the front garden of 9 Wells Avenue.

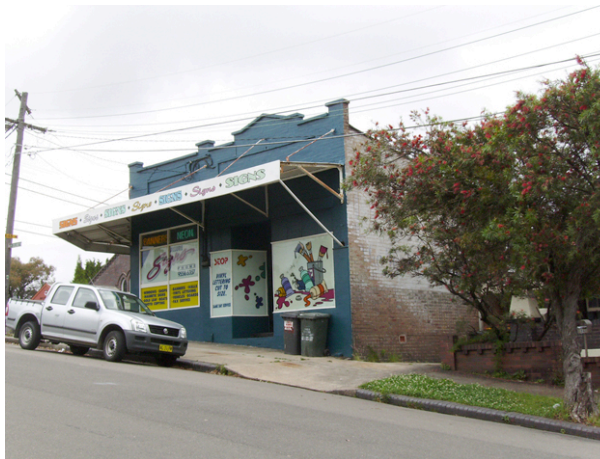
Figure 33.9 A modest shop contemporary with the houses is located at the top of Collins Street at the intersection with Unwins Bridge Road. Although occupied by a site writer and heavily decorated, the configuration of the original shopfront is substantially intact.

The area also includes two single-storey shops at the corner of Collins Street and Unwins Bridge Road which although now painted for use as signwriting business have retained their original scale and form, including the ingo shopfront to Collins Street.

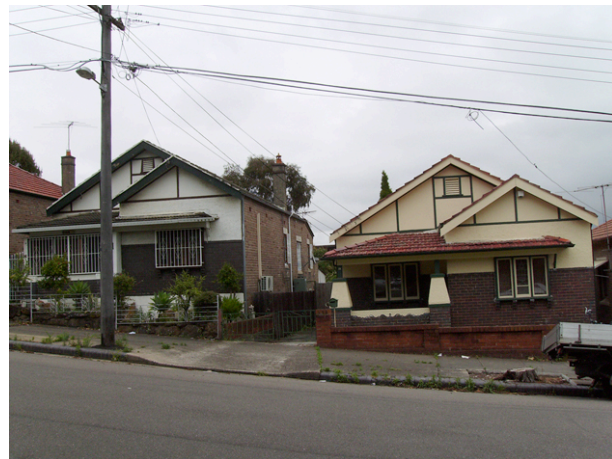
Figure 33.10. Most of the houses within the area are a simplified version of the usual Californian bungalow, with a hipped roof over the porch and front window instead of the more common triple gable form. Their access is provided through a door on the side façade – both a space-saving device for these small cottages as no central hallway was required; and reflecting the emerging importance of the motor car as the primary method of arrival. Each is offset on its lot to allow a side driveway.

The houses are modest in scale and likely to have been built by the same builder as they demonstrate a strong consistency in their design and detailing. Most are the smaller variant of the Californian (or Sydney) bungalow, with only two gables to the street elevation and a lower-pitched roof over the porch which is accessed from a side-opening door from the front room only. The low-pitched roofs to the porches are supported by heavy splayed pillars which are characteristic of the bungalow style. The front door is situated mid-way down the side (driveway) elevation.

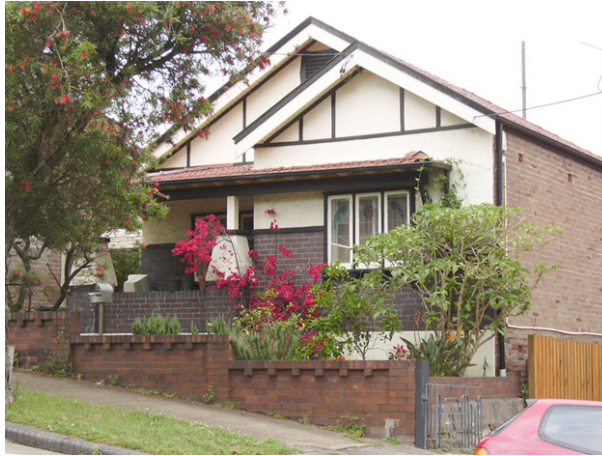
Figure 33.11. Note the splayed and rendered verandah posts and the oblique glazing bars to the casement windows. Note also the use of plain common brickwork to the 'blind' side elevations.

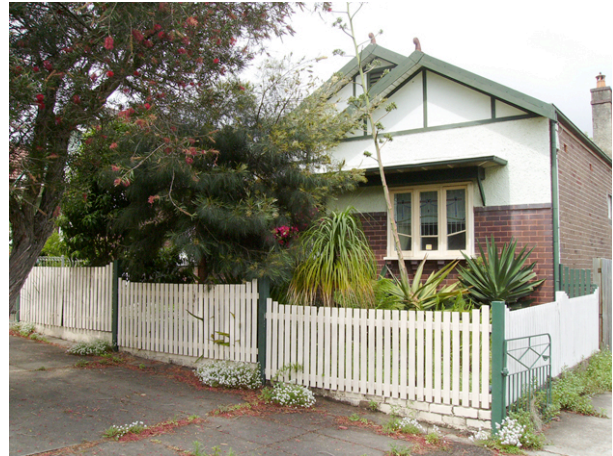
Figure 33.12. Although substantially identical, the houses in the group are distinguished by minor differences in detail such as the pattern of gable strapping.

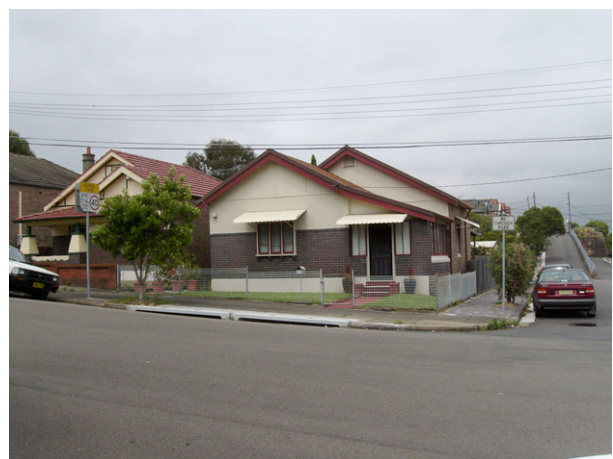
Figure 33. 16. The house on the corner of Collins Street and Wells Avenue is different in design to the others in the group. Before the verandah was enclosed it would have addressed the corner.

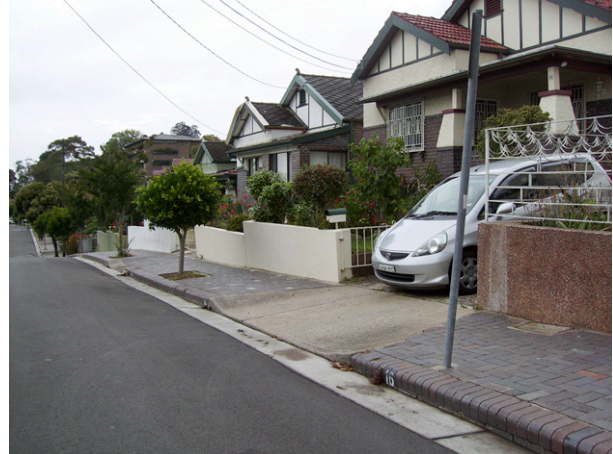
Figure 33.18. Wells Avenue. Although early driveway crossings were formed from brick and read as part of the main footpath, later crossings are concrete and interrupted the visual continuity of the paving.

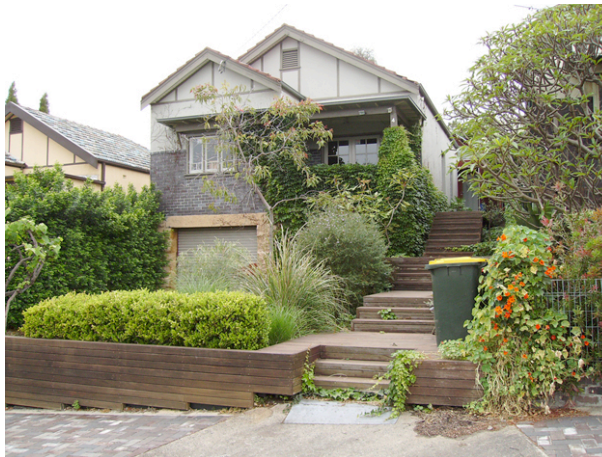
Figure 33.19.. This house is situated high above Wells Avenue and a garage has been created below the house.

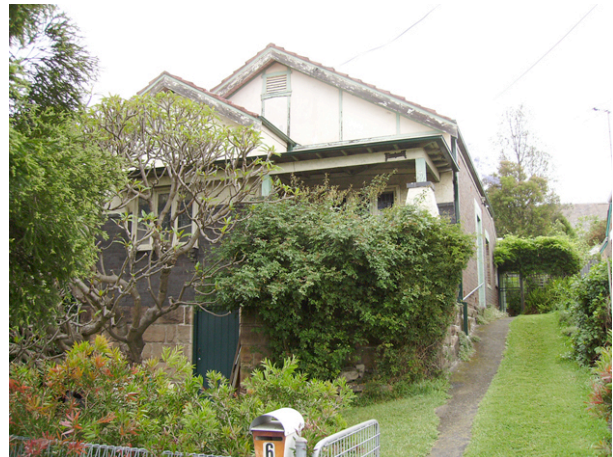
Figure 33.20. This house is highly intact to the extent where the original pedestrian width concrete path to the front door has never been converted to a driveway. The retention of such an ephemeral feature is very rare.

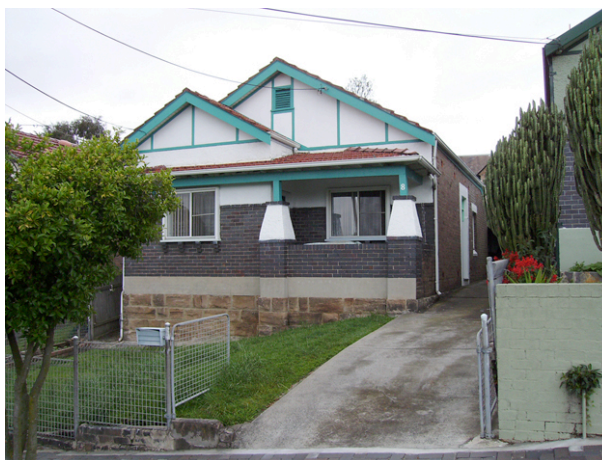
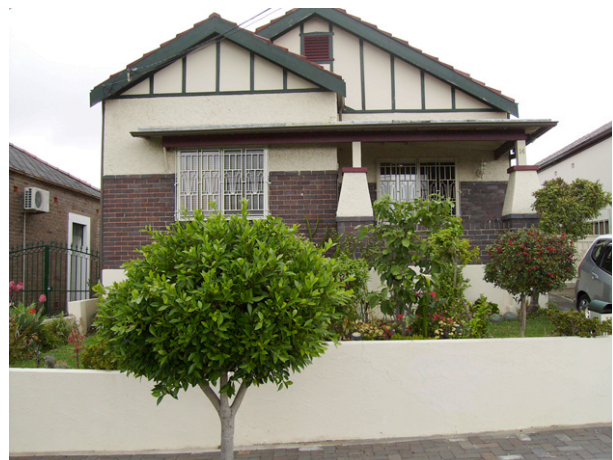
Figure 33.21 and 33.22. These two examples have both been modified by the replacement of timber windows with aluminium frames but otherwise demonstrate a substantially intact exterior. The very modest scale of these bungalows has resulted in the main door being located on the side facade to save the space otherwise occupied by a central hallway. The side access can be seen in these photographs.

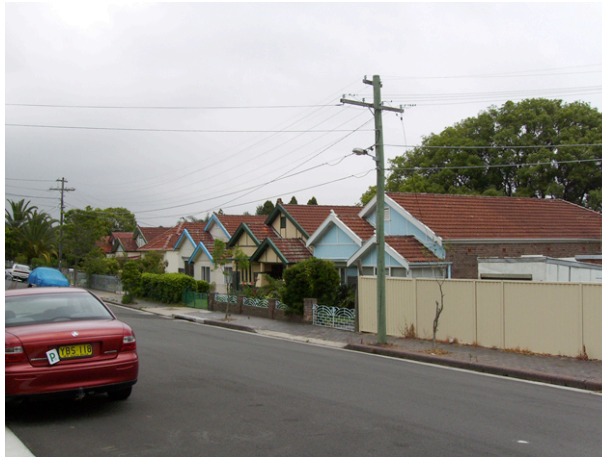
Figure 33.23. The contribution of repeated gable forms to the aesthetic quality of the streetscape can be seen through this photograph of the houses on the north-western side of Wells Street (low side) from Collins Street.

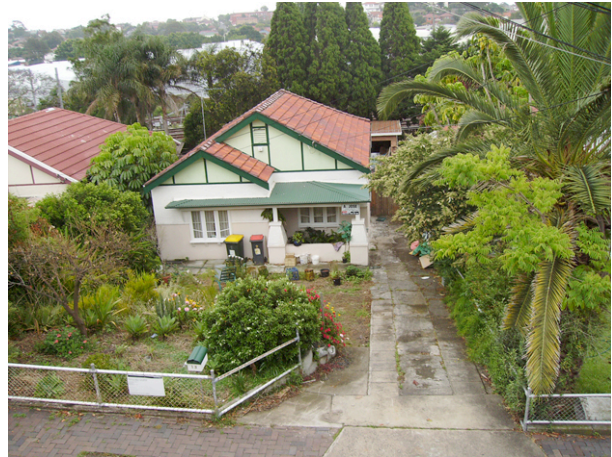
Figure 33.24. Although rendered and/or painted, the form of this cottage is substantially intact.

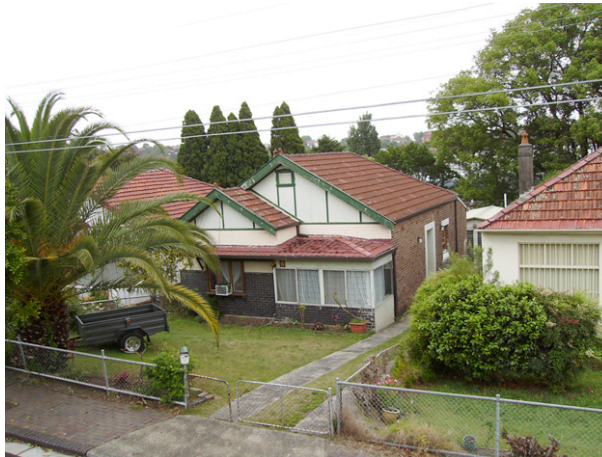
Figure 33.25. The houses on the low side of Wells Street were fenced by water pipe and wire fencing which was very popular as a low-cost alternative to the face brick fence.

Some houses have retained their original front fences, including low walls built of face brick to match the house and finished with exceptional attention to detail, with dentilation and castellation. Several of the houses on the western side of Wells Avenue have retained their original pipe and mesh fence with pedestrian/wide driveway gate, a form and material which is increasingly rare. The 'safety' fence to the upper level of Wells Avenue is of similar design although of later construction. Other fences are ARC welded utility fences, low flat-topped pickets and rendered brick with worked steel infill panels. One has been removed and replaced by a low wall of horizontal timber. All fences are low.

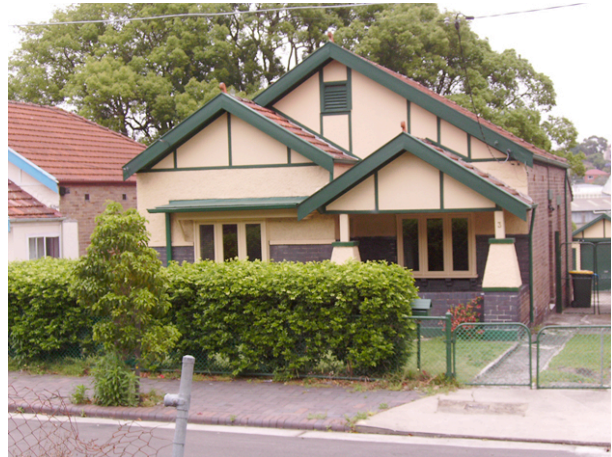
Figure 33.26. A well maintained and highly intact example which includes the more 'standard' configuration of a third gable over the porch, although the front door is still located on the side façade. The dual use of the driveway opening with pedestrian and vehicular width gates can be seen to this property

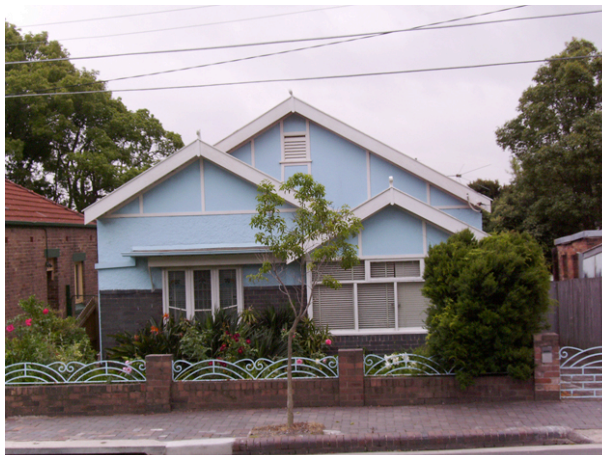
Figure 33.27. This house has been modified through the enclosure of the verandah and the painting of the plasterwork in a bright colour. The underlying form is intact however and the changes are potentially reversible.

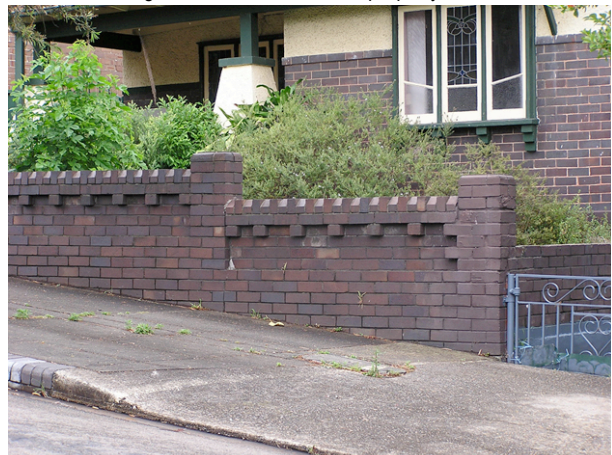
Figure 33.28. The sale of fencing to houses in Collins Street using decorative bricklaying techniques to create visual interest.
