HCA 35 Inter-War Heritage Conservation Area Group (Dulwich Hill and Marrickville)

Figure 35.1 HCA 35 – Inter-War Heritage Conservation Areas

35.1 LOCATION

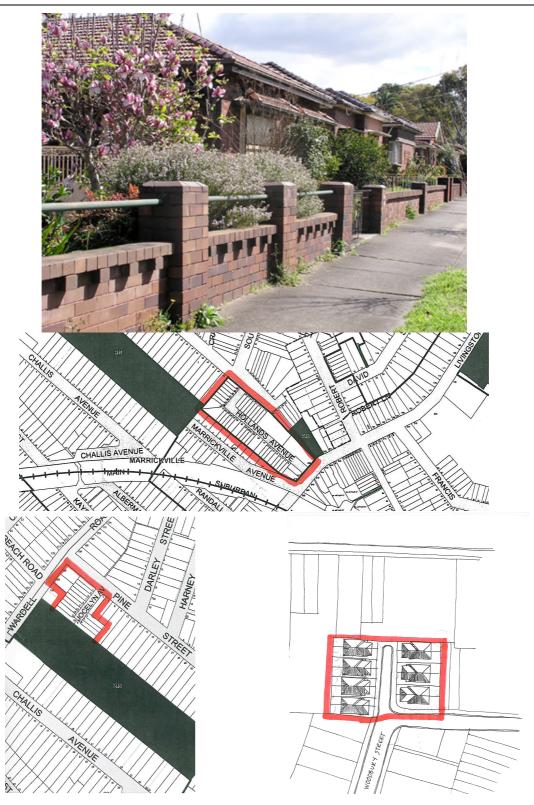
The Inter-War Heritage Conservation Area Groups are located in Jocelyn Avenue, Dulwich Hill and Woodbury Street and Hollands Avenue, Marrickville.
