Ashfield Heritage Study Review of Areas Zoned 2b & 2c

Name of Item Flats Other Names	Reference No 45																								
Address 03 Sunning Place Locality Summer Hill Postcode 2130	Land Title Lot 5 DP 18093																								
Item Type Group Group Name Sunning Place Flat Group	Zoning 2c

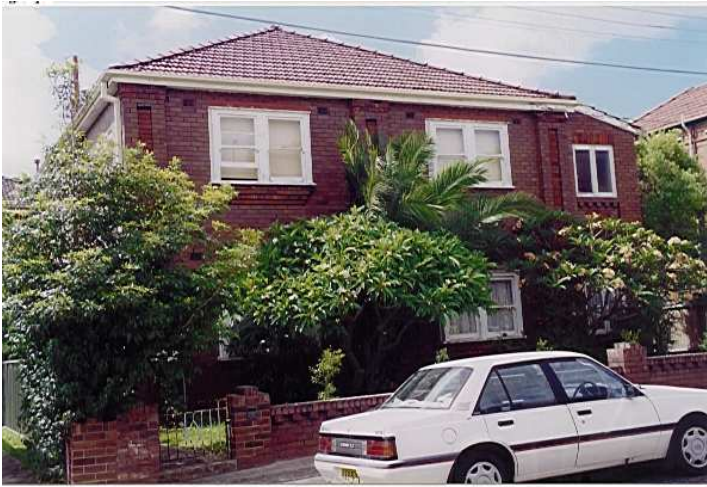
</div>																									
Photo roll 2000-3 Negative 25	Survey Date 1/13/2000 Surveyed by: TK

Two storey brick block of flats with some elements of Inter war Art Deco style. A hipped roof clad with Marseilles terra cotta tiles covers the building. The walls are of dark brown face bricks with lighter brown texture bricks used for contrast as skirts under windows. There are fluted pilasters set in the brickwork. Double hung sash windows are used around the building. A low fence of bricks identical to the building is at the front.
