Review of Environmental Factors The Cooks to Cove GreenWay (In-Corridor Works)

Appendix B: Geotechnical Investigation (GHD, 2020)

Inner West Council
The GreenWay Geotechnical and Contamination Services
Geotechnical Report

March 2020

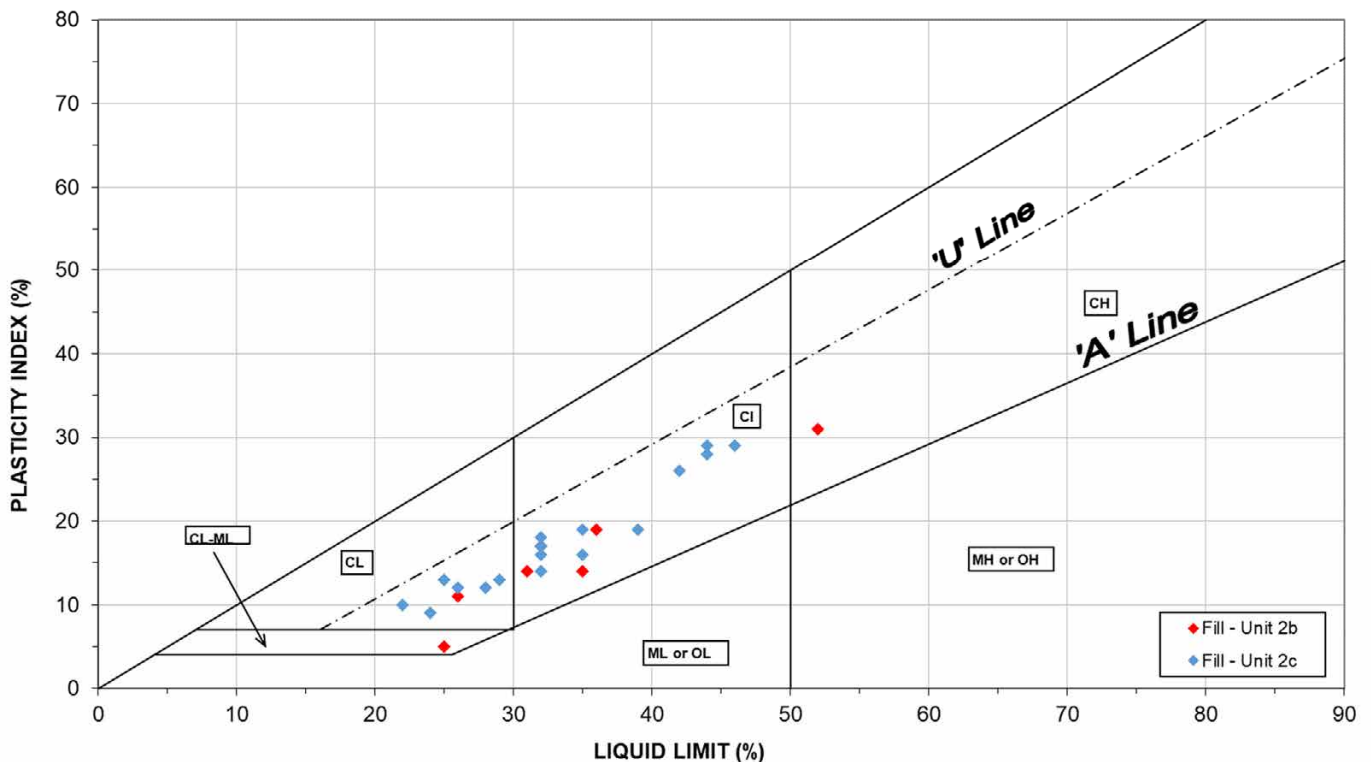
Figure 6-4 Atterberg limits plot – Fill

- Fill material tested ranged from low to medium plasticity.
- Alluvium typically is low to medium plasticity, with most values in the medium plasticity range. Testing of the marine sediments, Unit 3a, suggests plasticity ranges from low to high, with the Unit 3b falling within medium plasticity.
- The residual soils derived from the Ashfield Shale unit typically ranged from medium to high plasticity, as is expected in this geological setting. Residual soil found in areas where Hawksbury Sandstone bedrock is at shallow depths, is general coarse grained with a secondary clay component, tests indicate this is low to medium plasticity.

The results from Atterberg limits testing have been plotted in the Casagrande's plasticity chart. Figure 6-4, Figure 6-5 and Figure 6-6 below tend to indicate that:

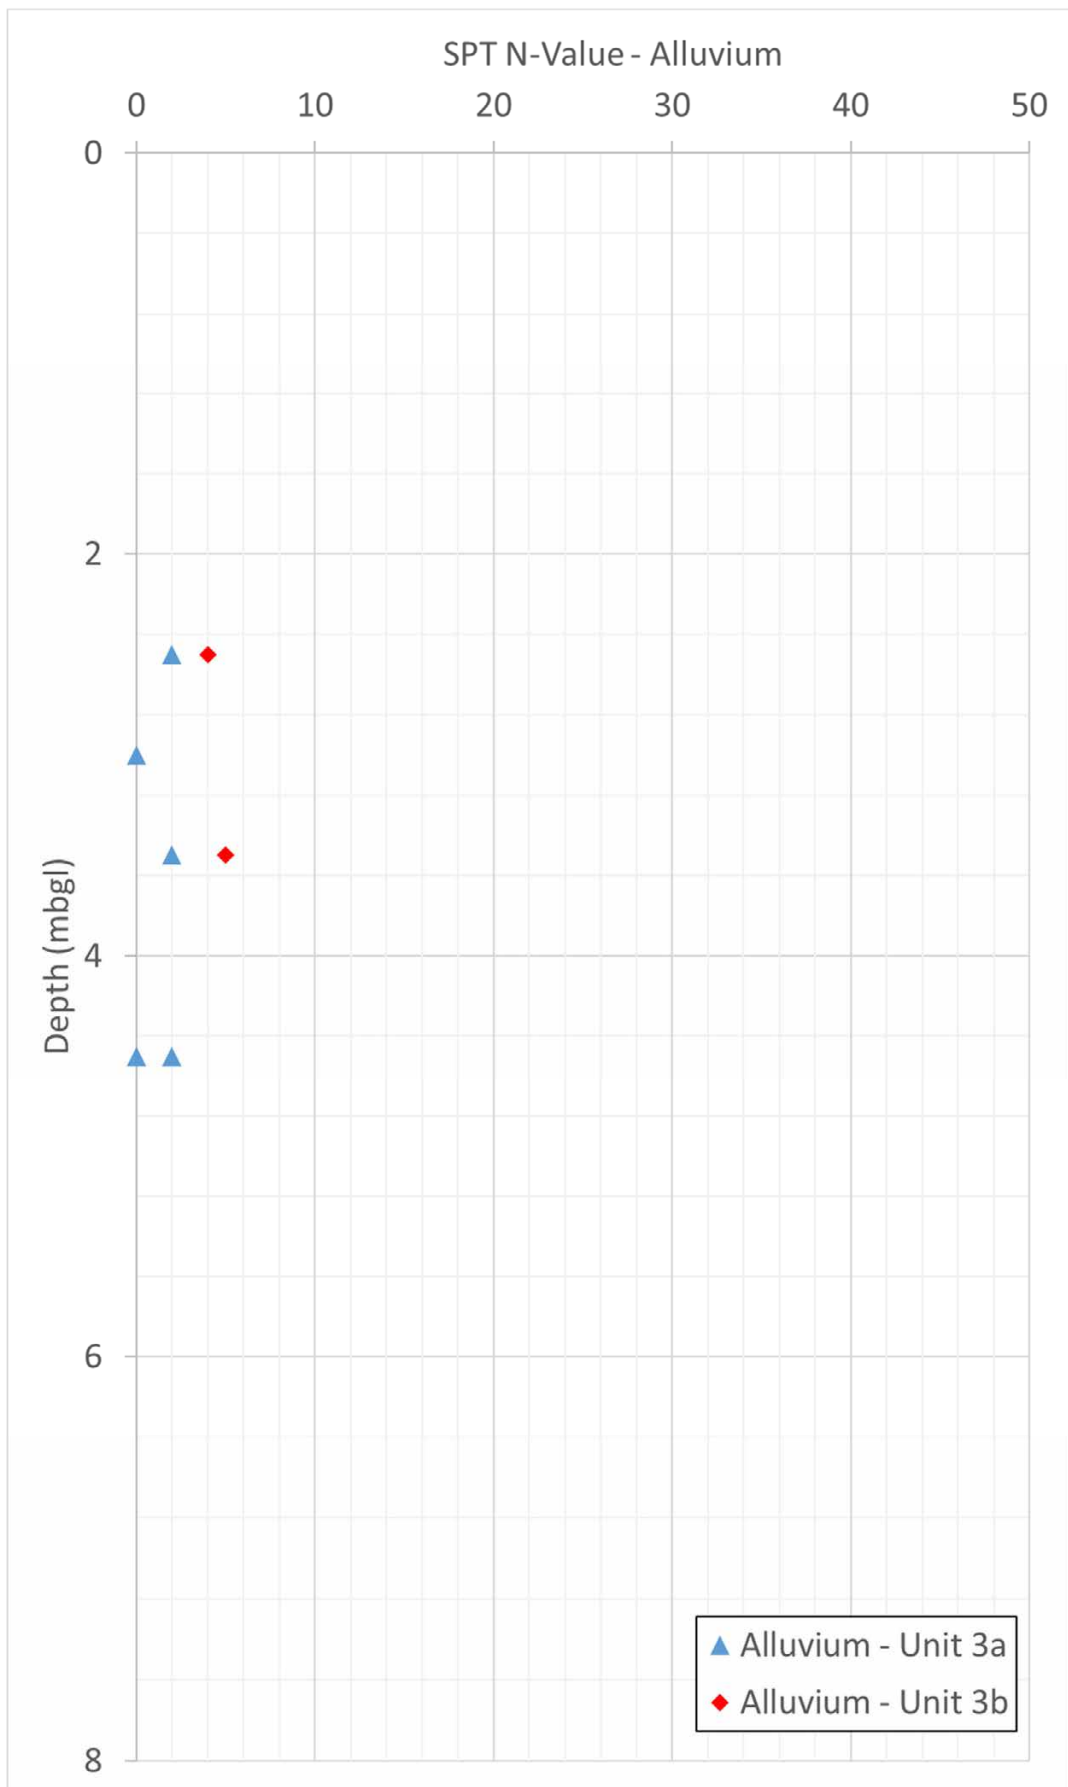
Figure 6-8 SPT N-value vs depth – Alluvium

SPT N -values in the Unit 3, Alluvium, typically range from 0 to 5, suggesting that this predominantly cohesive unit has a consistency of very soft to firm.

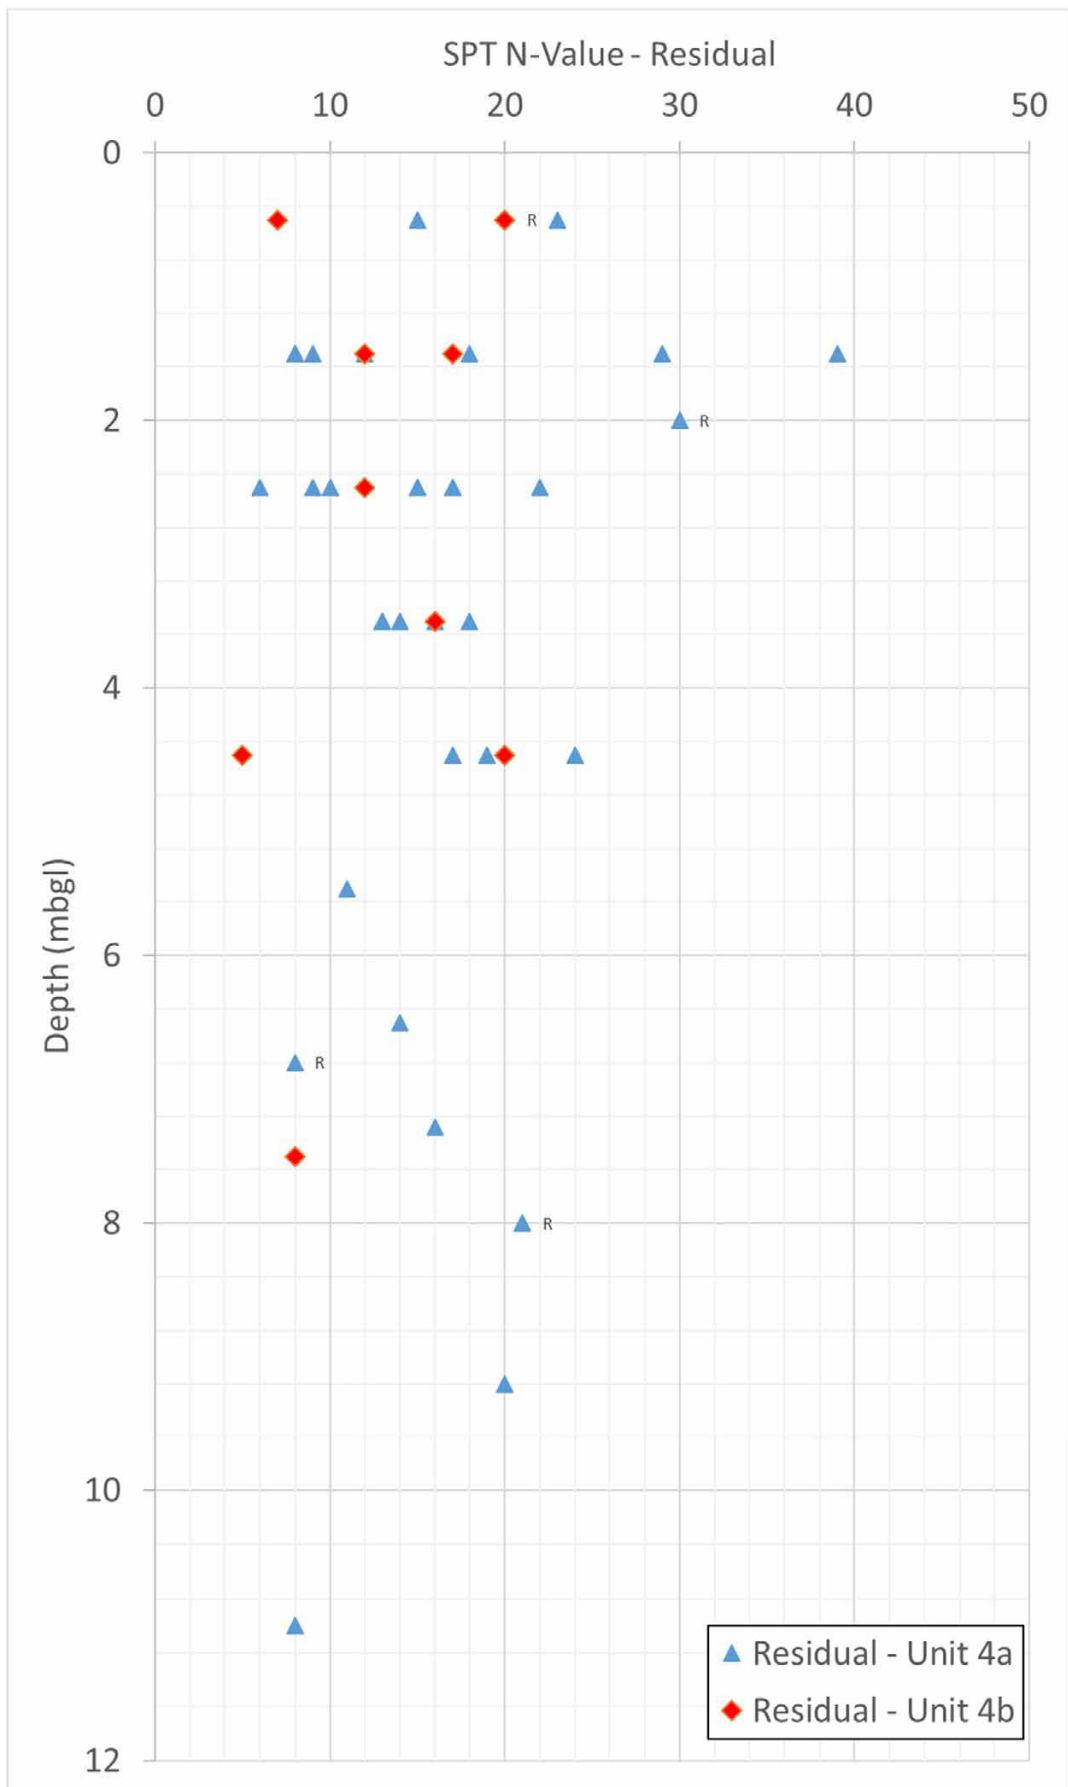
Figure 6-9 SPT N-value vs depth – Residual Soil

The N -values in tested Residual Soil ranged from 5 to refusal, with an average of 15. This wide variability of the N -value in the residual soils is expected due to the various degrees of weathering of the parent material, the highly variable depth to top of bedrock, and the potential presence of gravel (especially ironstones) as highlighted in some particle size distribution results. This unit is expected to range from a stiff to hard consistency.

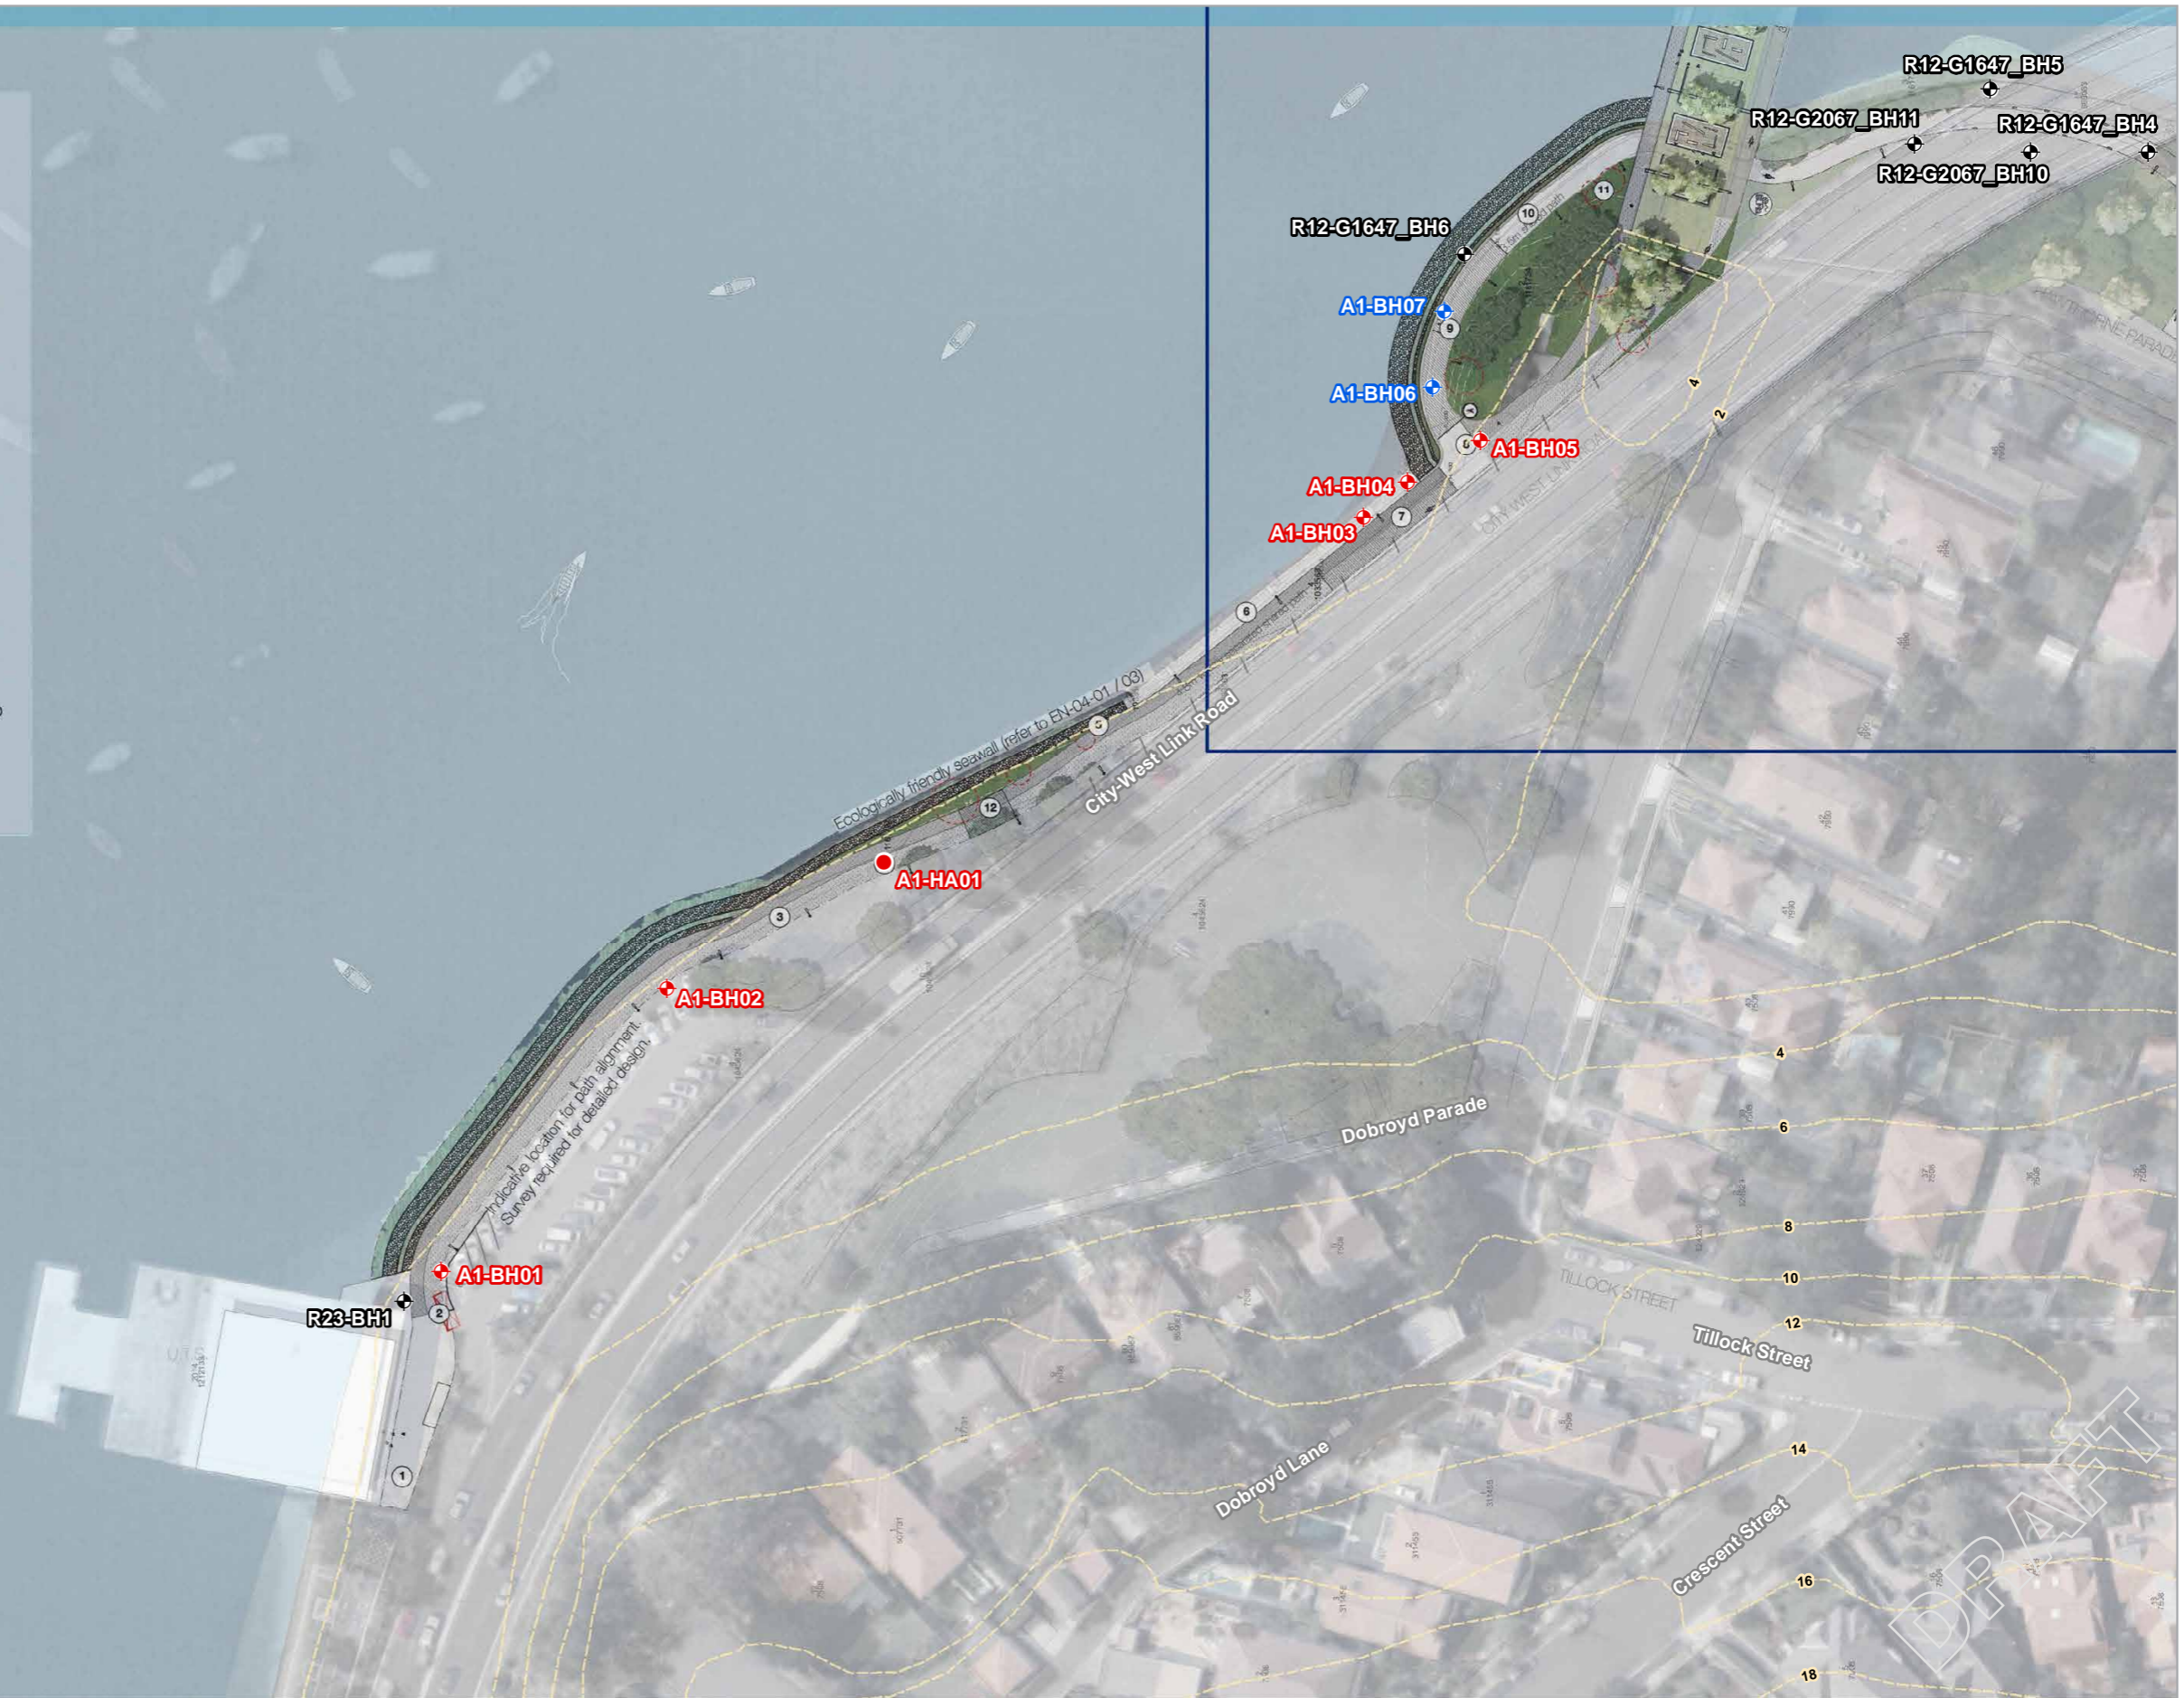
1. Pavement entrance UTS in one material as a 'shared space' for pedestrians and cyclists
2. Remove one parking space to widen pinch point and introduce loading zone.
3. 2.7 + 2.1m path. Keep seawall and widen to west in this section.
4. Change GPT cover to more bike friendly option
5. Remove three trees on NE side of path and step between seawall and path level
6. Retain seating steps
7. Ramp length increased to keep grade to 5%. Increase ramp width to 4.8m
8. Match existing levels
9. Ramp up from GreenWay to Bay Run
10. 3.5m wide shared path
11. Remove grove of four Casuarinas adjacent path to improve sightlines
12. Raised path past existing fig trees (to avoid roots damaging path)

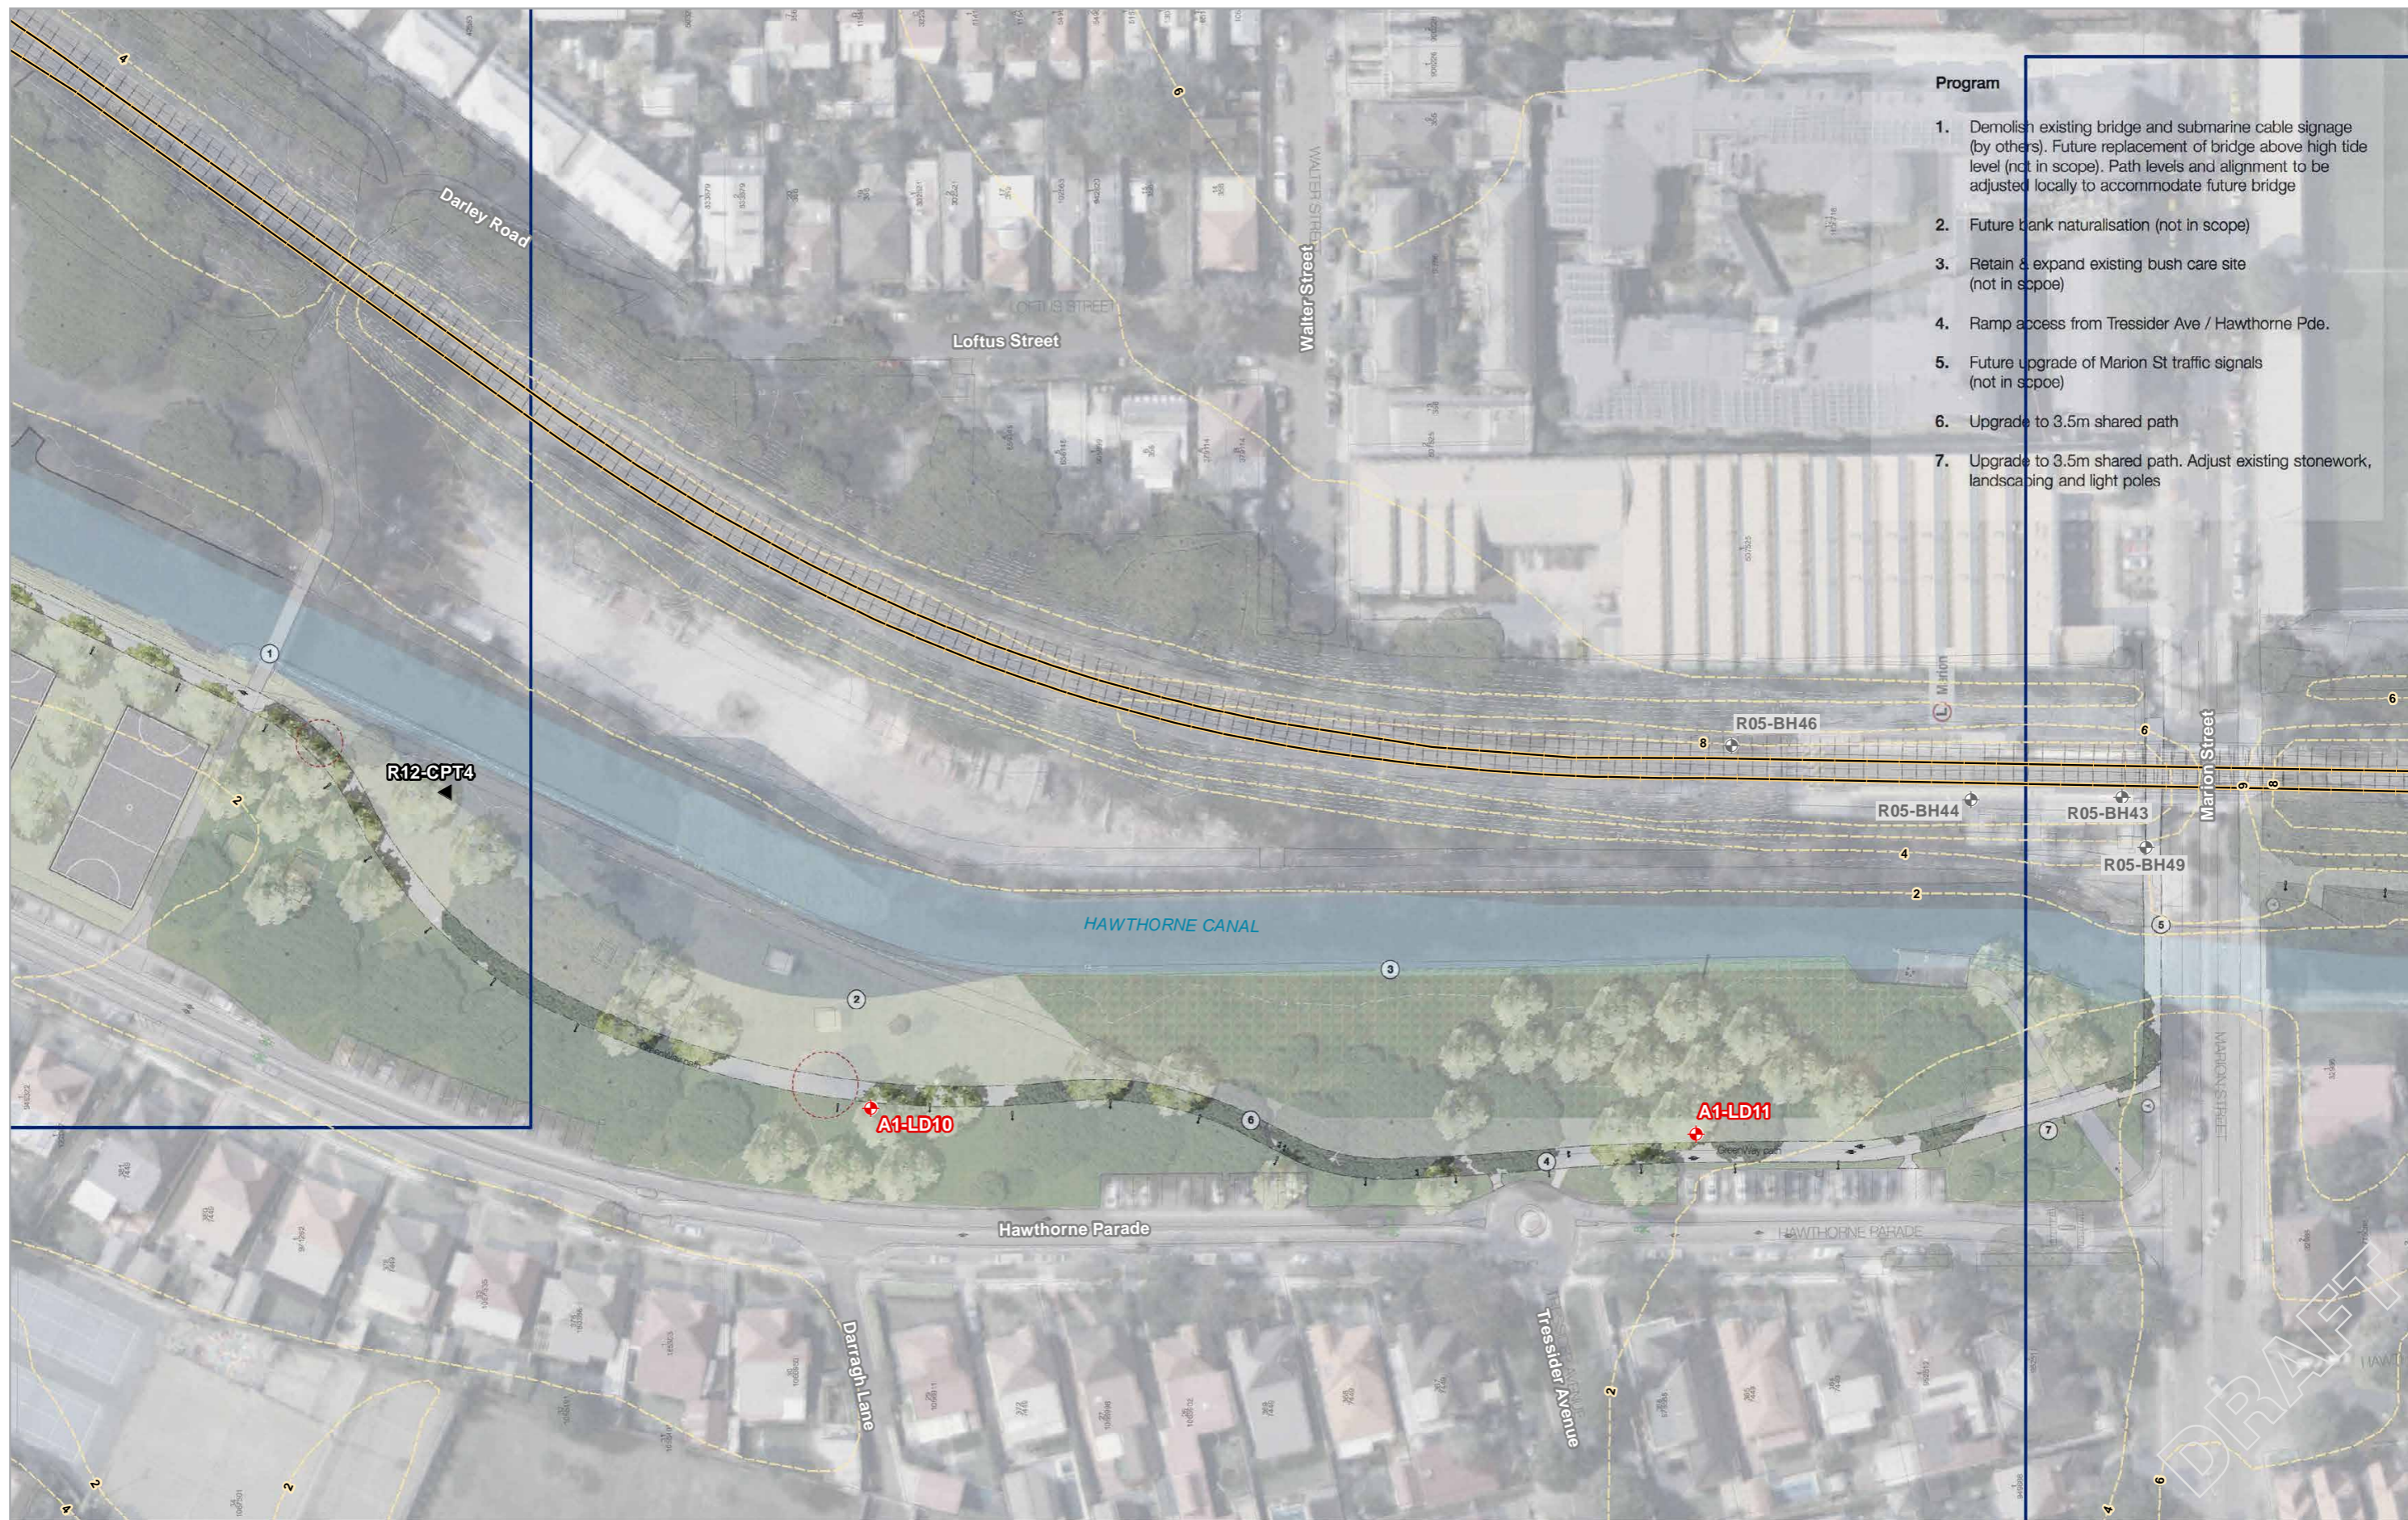
FIGURE 4

- Program**
1. Demolish existing bridge and submarine cable signage (by others). Future replacement of bridge above high tide level (not in scope). Path levels and alignment to be adjusted locally to accommodate future bridge
 2. Future bank naturalisation (not in scope)
 3. Retain & expand existing bush care site (not in scope)
 4. Ramp access from Tressider Ave / Hawthorne Pde.
 5. Future upgrade of Marion St traffic signals (not in scope)
 6. Upgrade to 3.5m shared path
 7. Upgrade to 3.5m shared path. Adjust existing stonework, landscaping and light poles

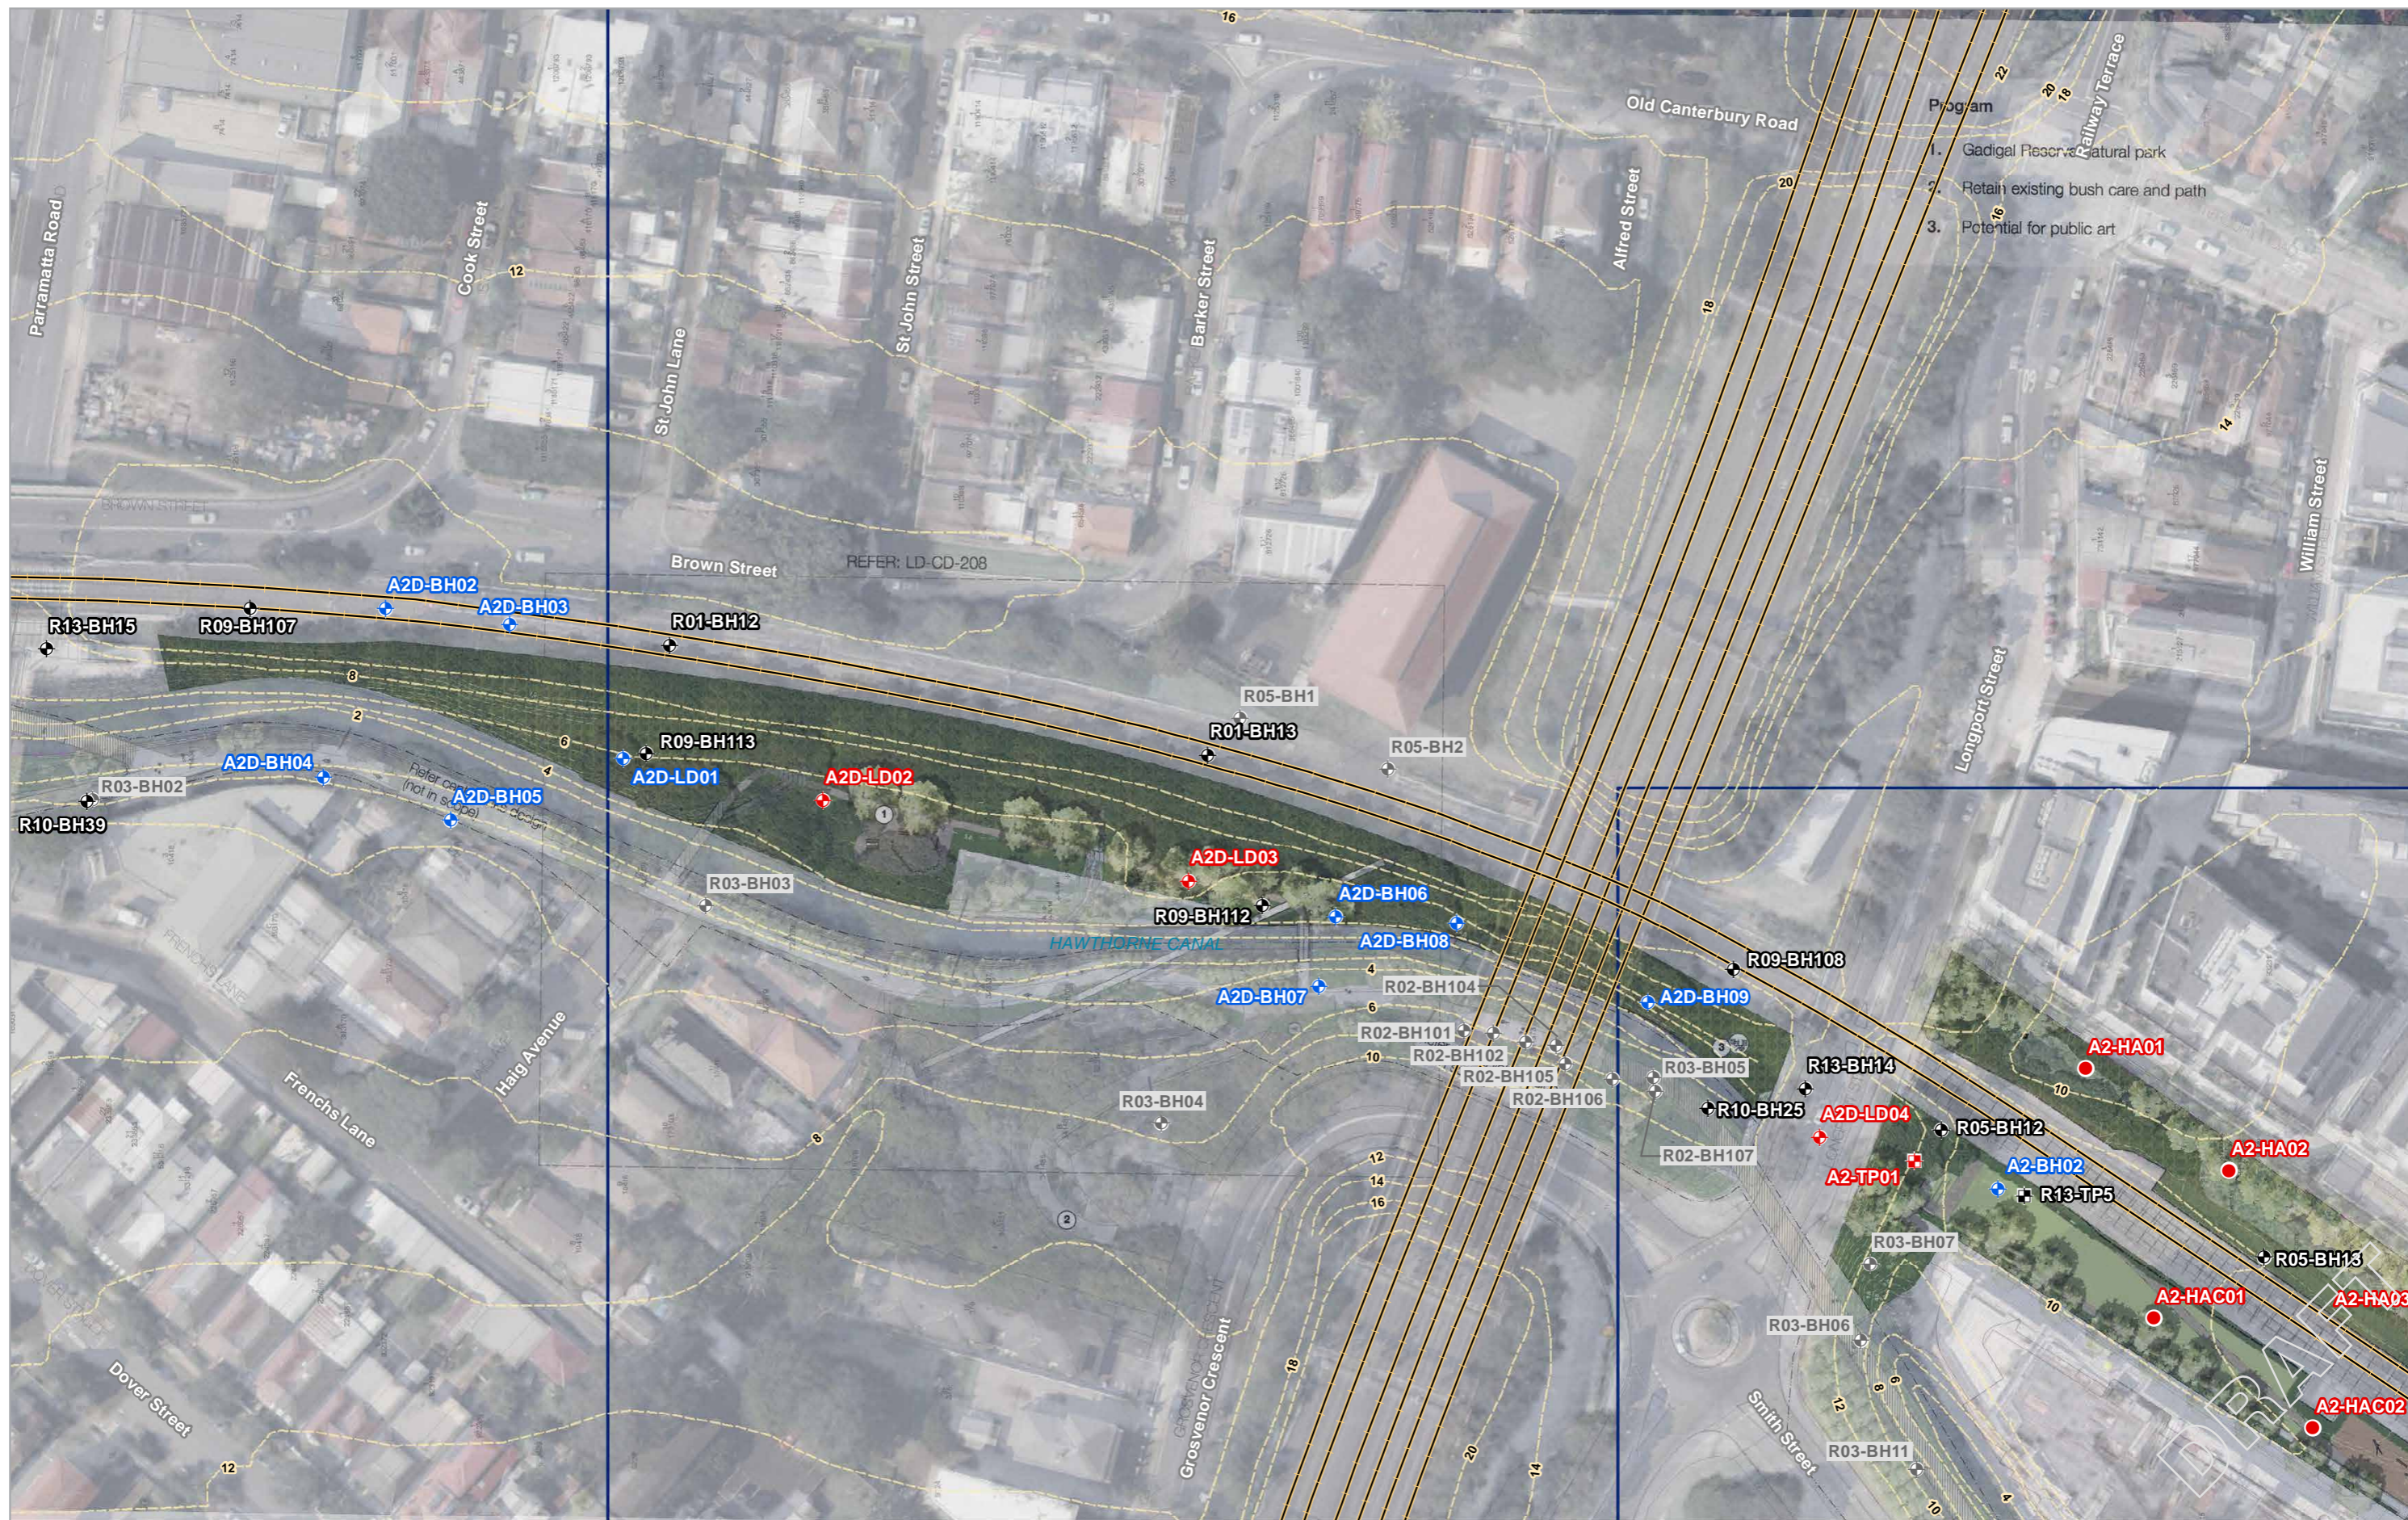
FIGURE 7

- Program
1. Gadigal Reserve Natural park
 2. Retain existing bush care and path
 3. Potential for public art

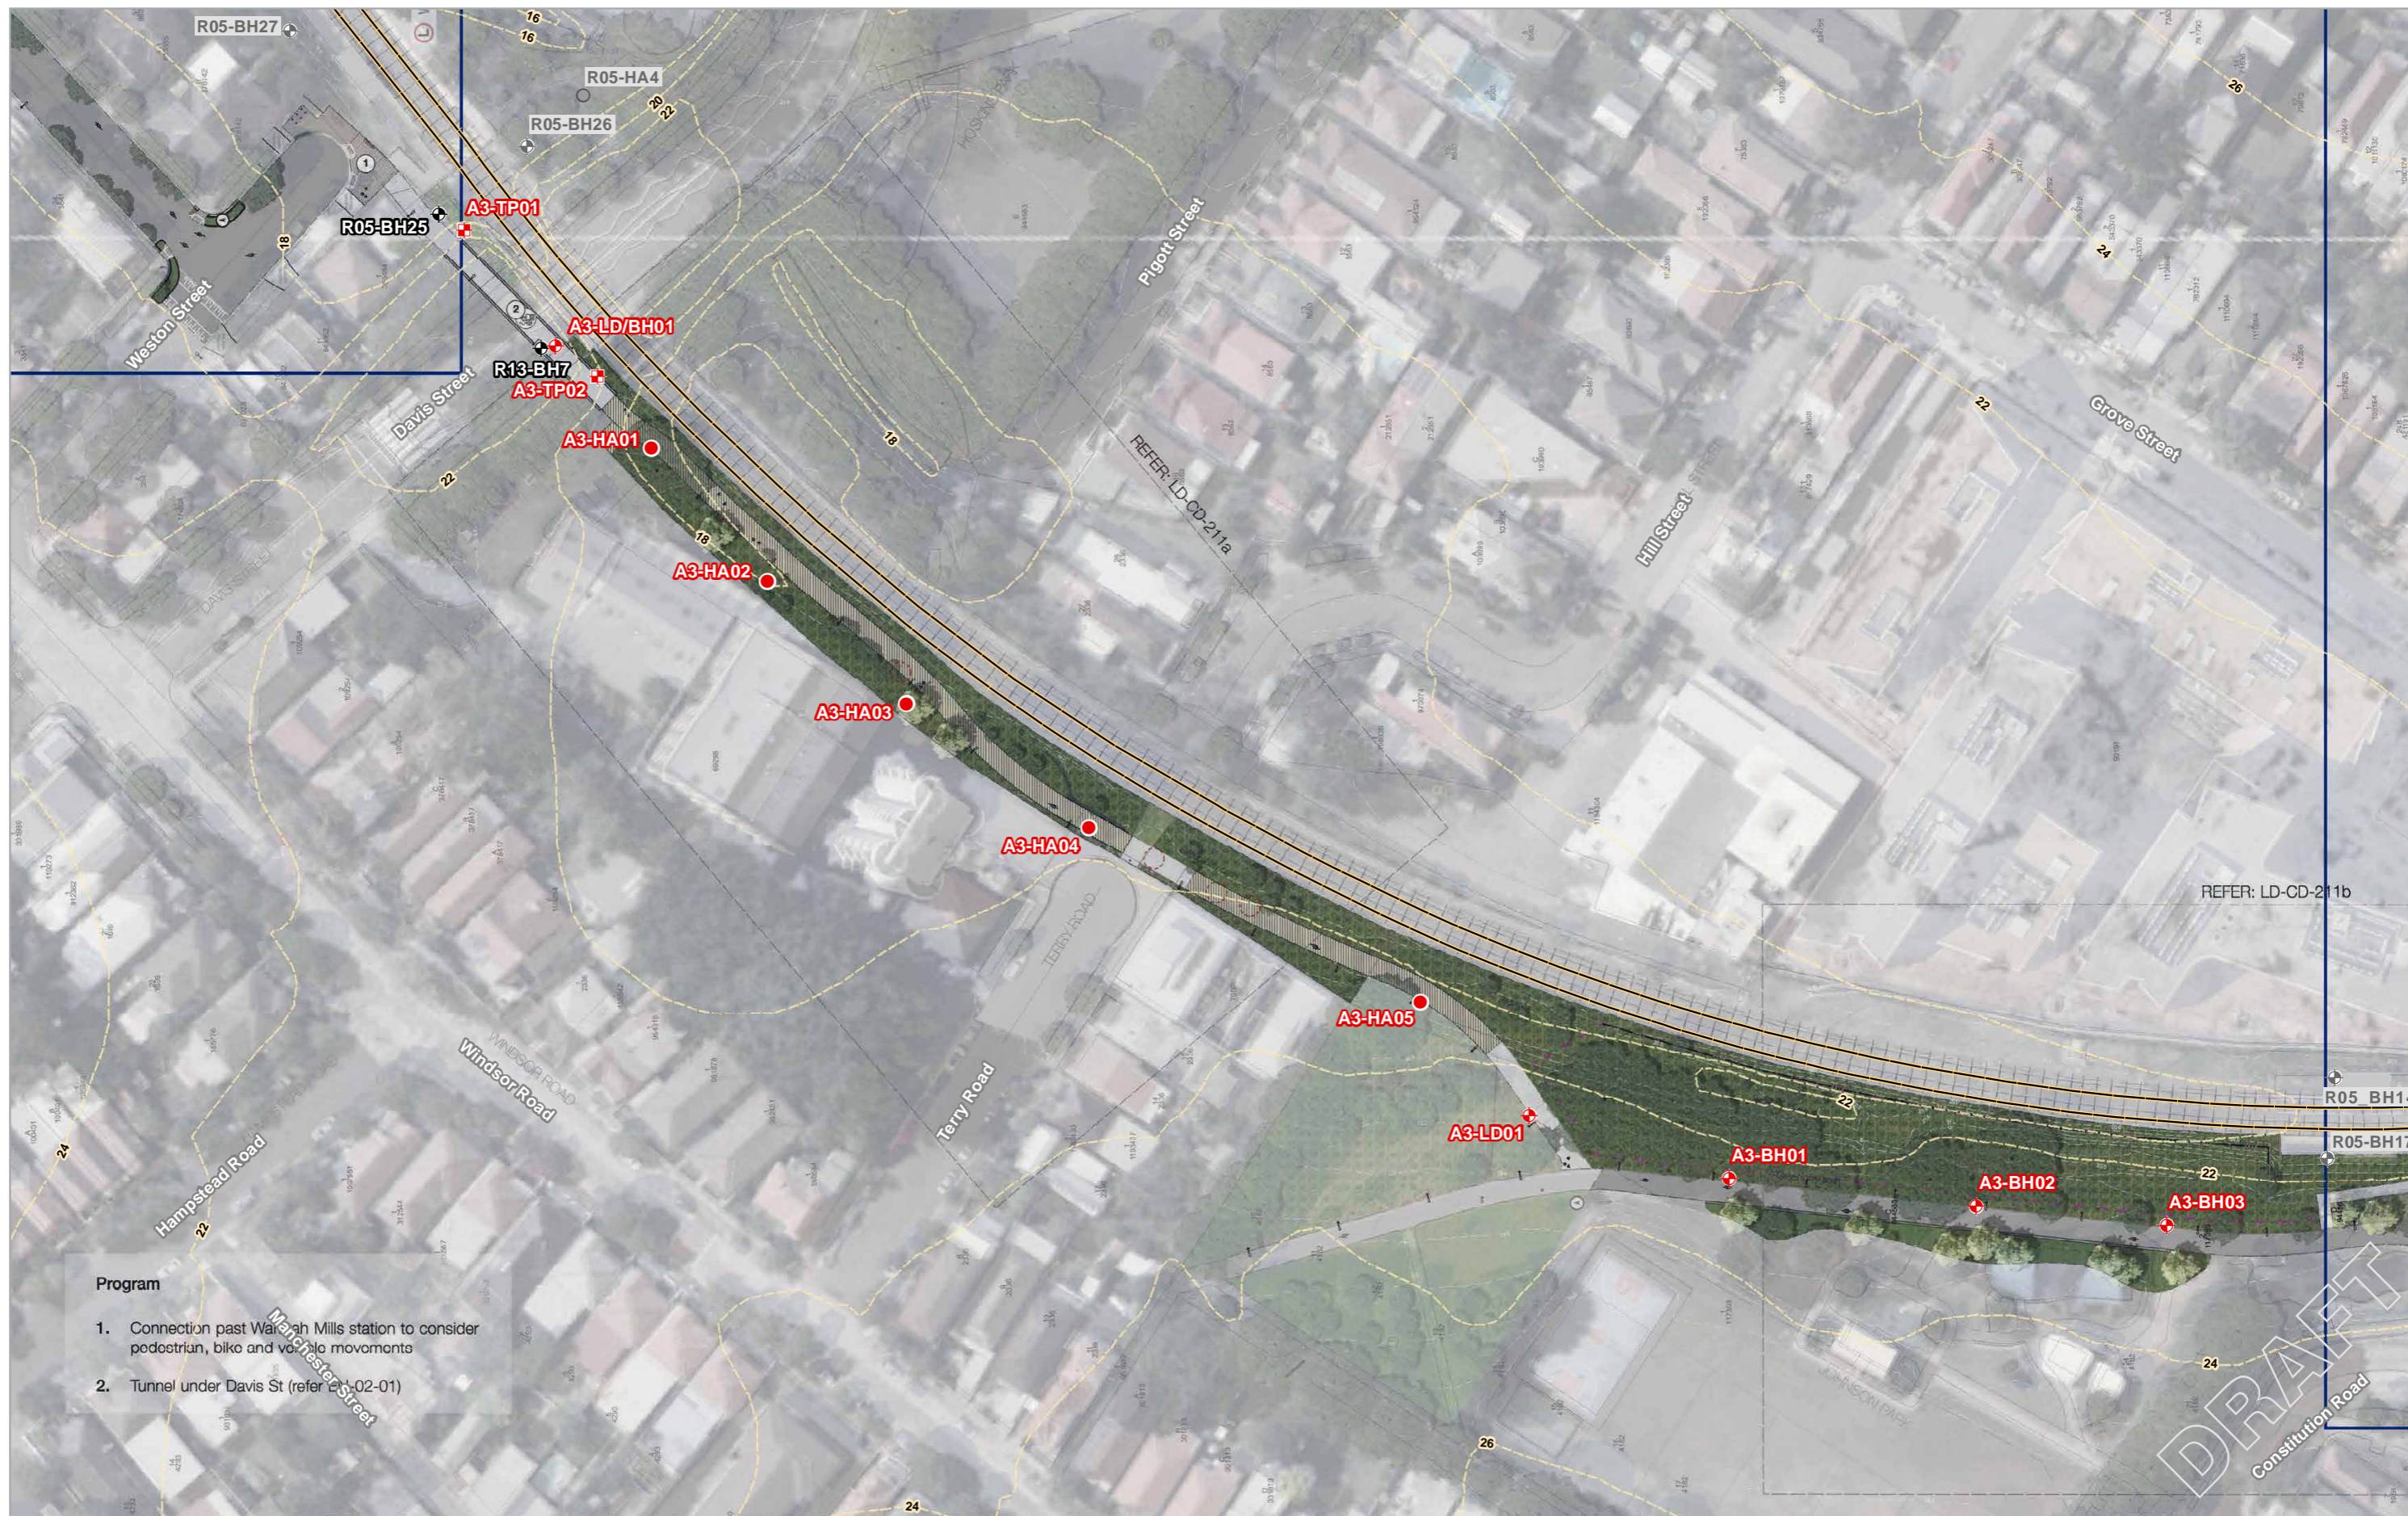
FIGURE 10

- Program**
1. Connection past Warrah Mills station to consider pedestrian, bike and vehicle movements
 2. Tunnel under Davis St (refer LD-CD-02-01)
