Review of Environmental Factors The Cooks to Cove GreenWay (In-Corridor Works)

Appendix B: Geotechnical Investigation (GHD, 2020)

Inner West Council
The GreenWay Geotechnical and Contamination Services
Geotechnical Report

March 2020

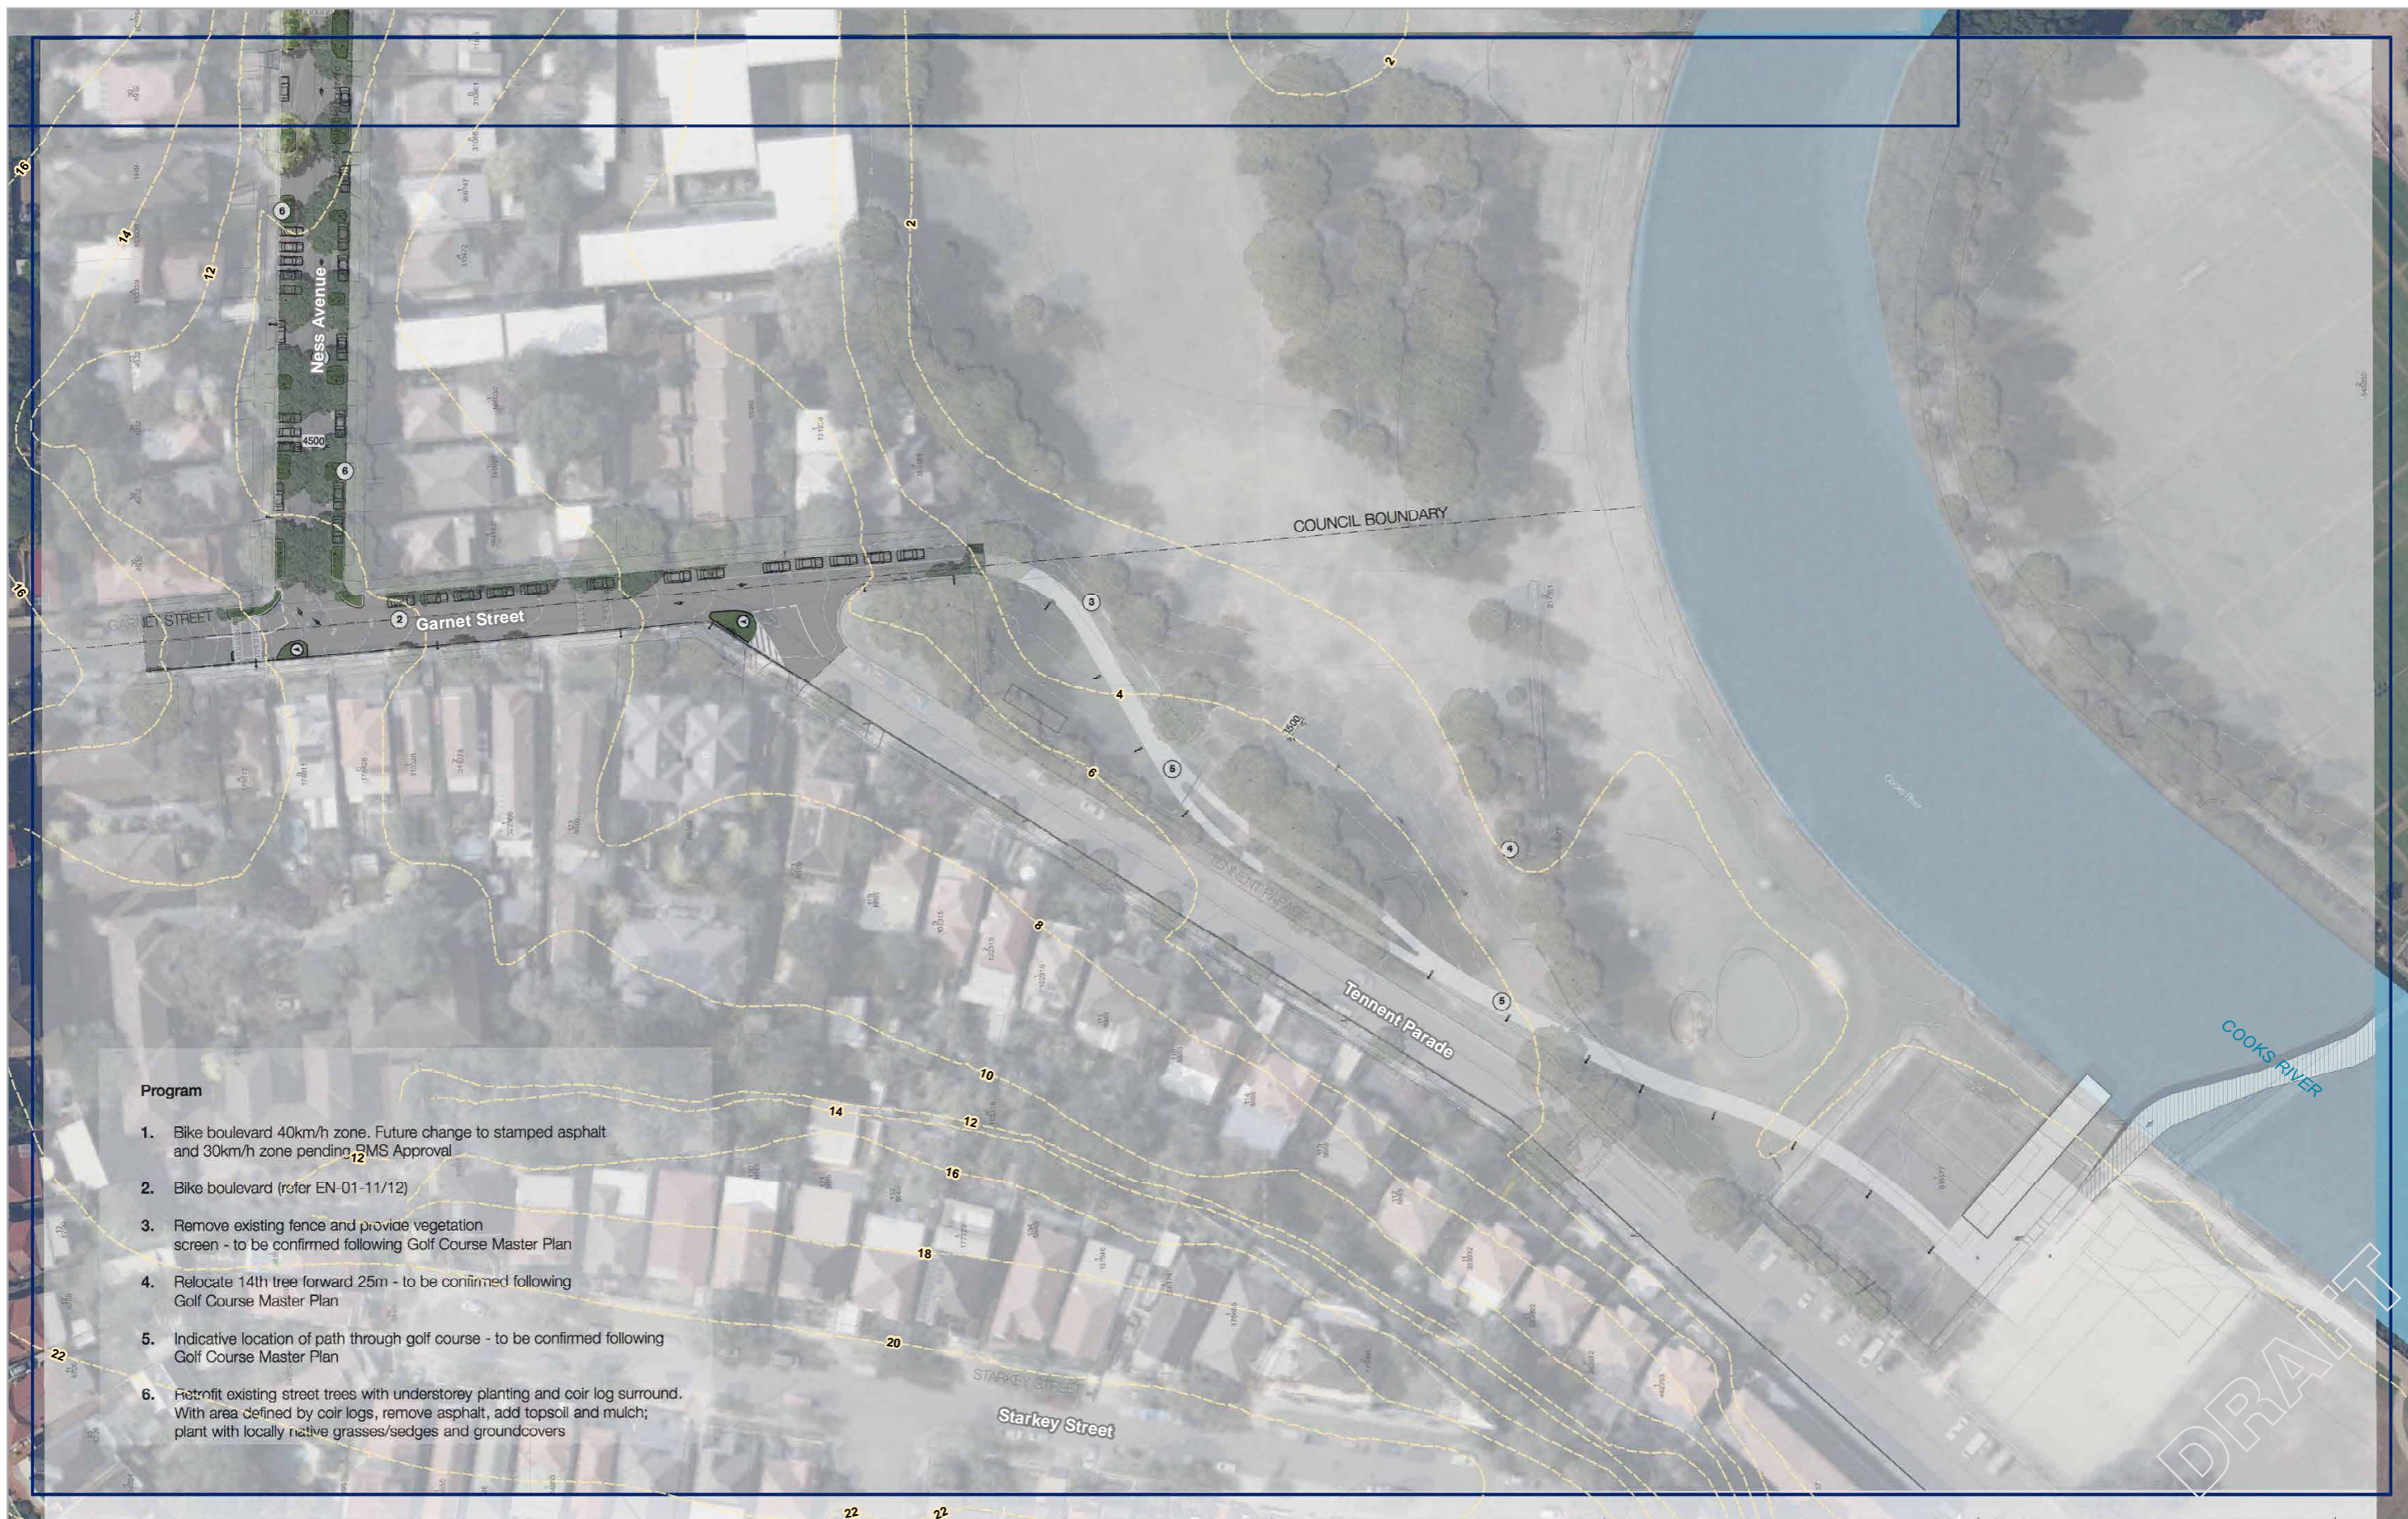
FIGURE 15

1. Bike boulevard 40km/h zone. Future change to stamped asphalt and 30km/h zone pending SMS Approval
2. Bike boulevard (refer EN-01-11/12)
3. Remove existing fence and provide vegetation screen - to be confirmed following Golf Course Master Plan
4. Relocate 14th tree forward 25m - to be confirmed following Golf Course Master Plan
5. Indicative location of path through golf course - to be confirmed following Golf Course Master Plan
6. Retrofit existing street trees with understorey planting and coir log surround. With area defined by coir logs, remove asphalt, add topsoil and mulch; plant with locally native grasses/sedges and groundcovers

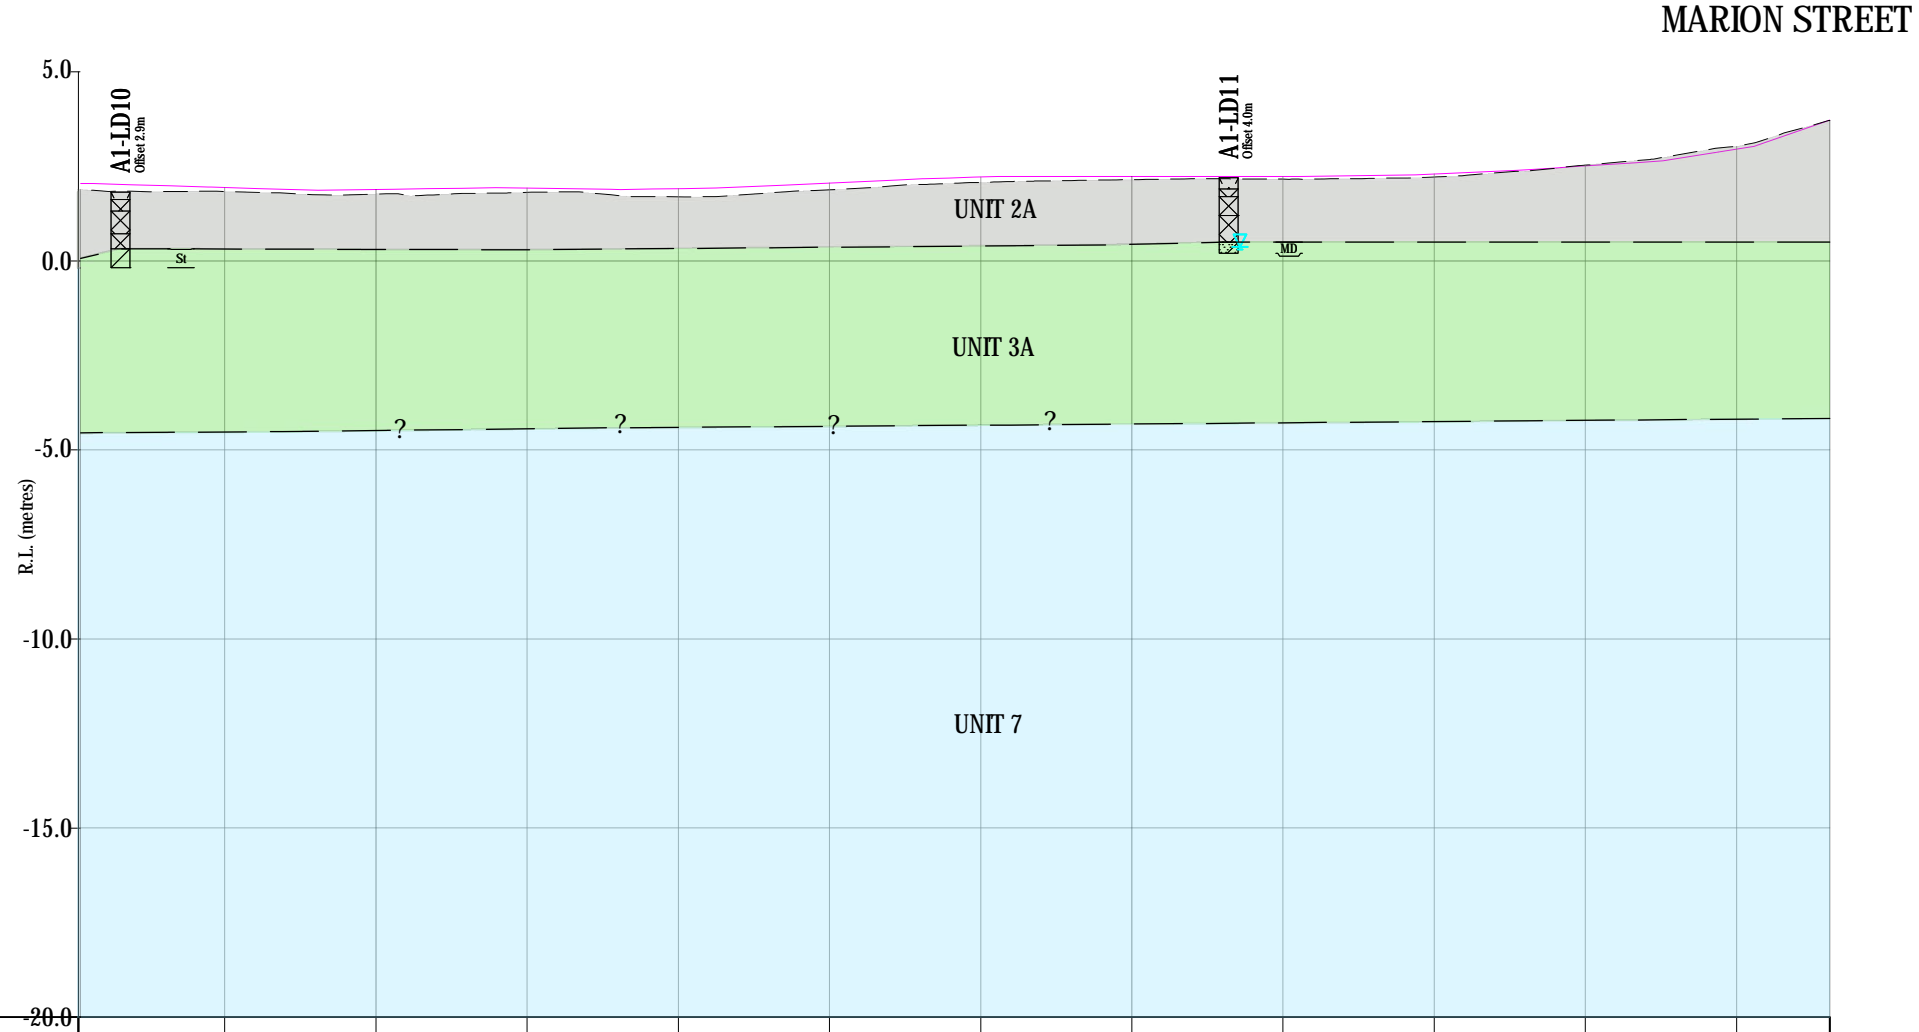
Client	INNER WEST COUNCIL
Project	THE GREENWAY GEOTECHNICAL/CONTAMINATION
Title	SITE 1 ALIGNMENT LONGITUDINAL SECTION A-A - SHEET 6 OF 6
Original Size	A3
Drawing No:	21-12515105-Q007
Rev:	A

DESIGN SURFACE LEVEL	1.941	1.890	1.925	1.910	2.061	2.218	2.232	2.232	2.301	2.511	2.956	3.720
EXISTING SURFACE LEVEL	1.837	1.768	1.813	1.695	1.879	2.077	2.150	2.161	2.220	2.533	3.031	3.718
CHAINAGE	1580.000	1600.000	1620.000	1640.000	1660.000	1680.000	1700.000	1720.000	1740.000	1760.000	1780.000	1792.311

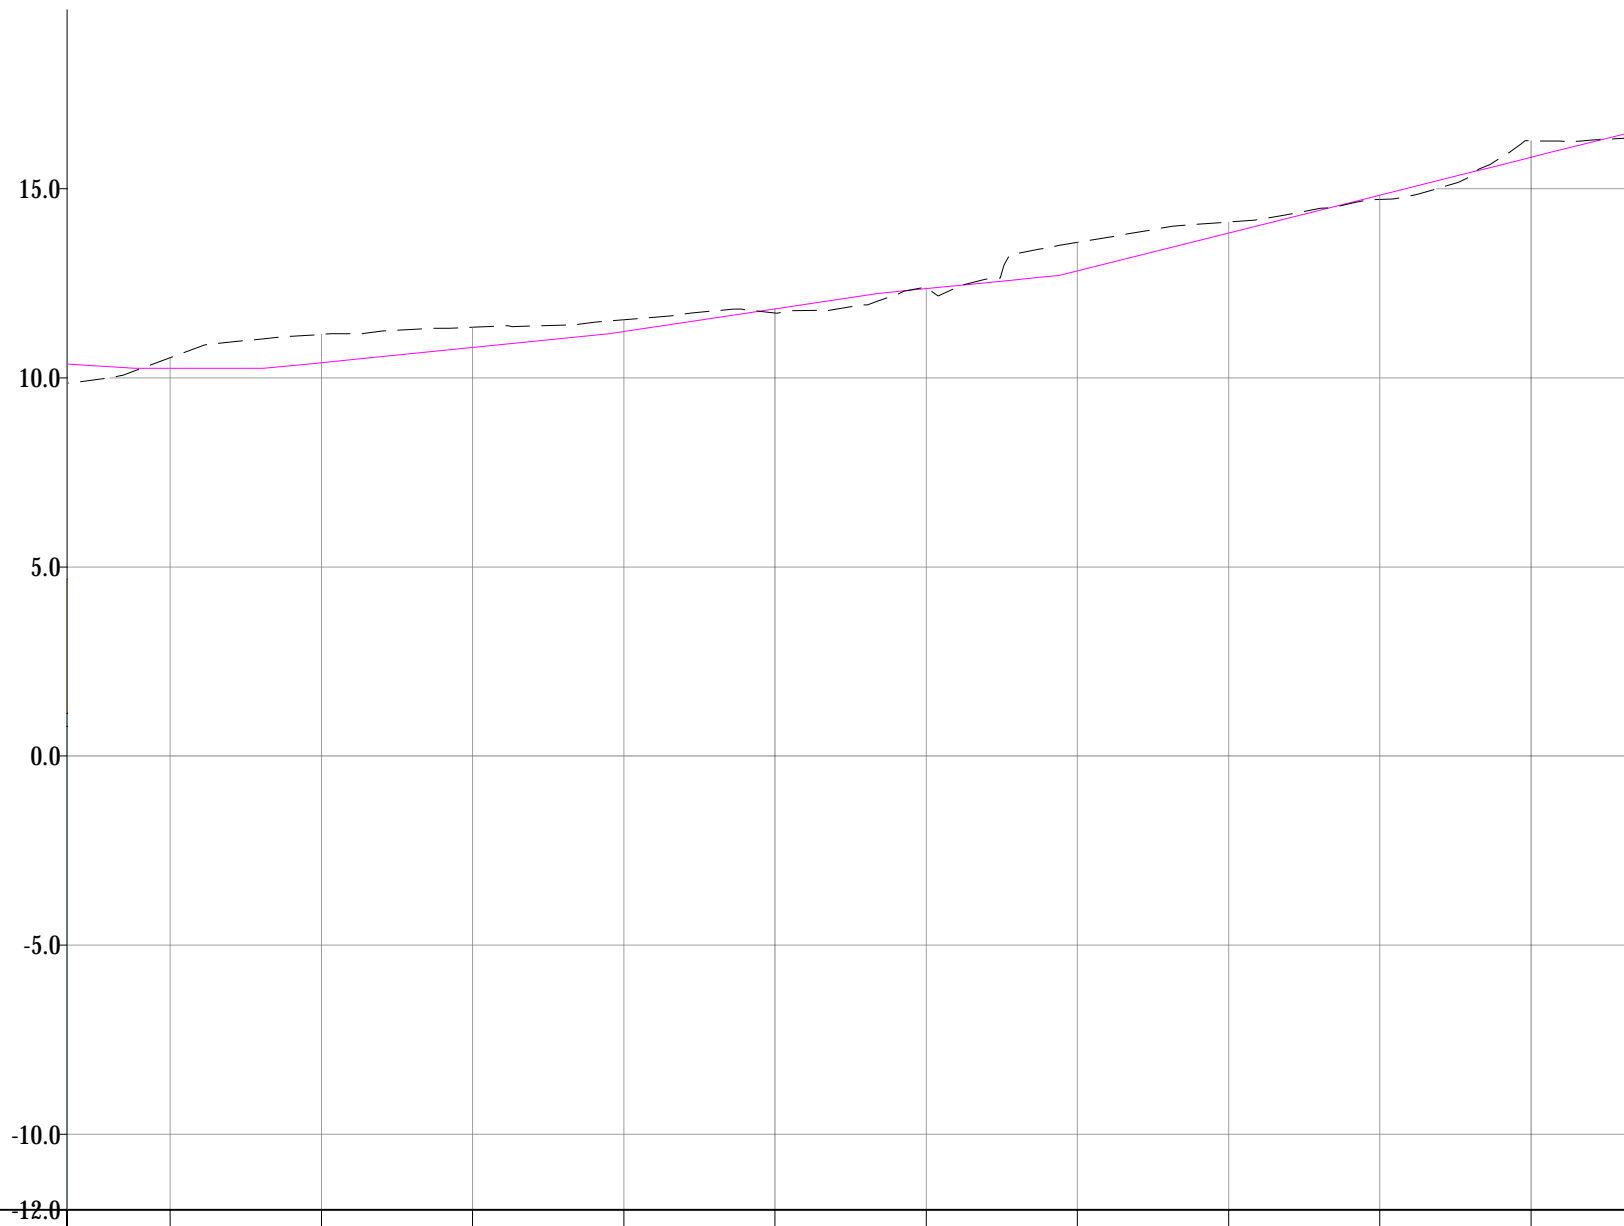
Client	INNER WEST COUNCIL
Project	THE GREENWAY GEOTECHNICAL/CONTAMINATION
Title	SITE 2 ALIGNMENT LONGITUDINAL SECTION B-B - SHEET 3 OF 3
Original Size	A3
Drawing No:	21-12515105-Q010
Rev:	A

<u>DESIGN SURFACE LEVEL</u>	10.250	10.403	10.803	11.222	11.822	12.360	12.833	13.833	14.832	15.833	16.512
EXISTING SURFACE LEVEL	10.534	11.150	11.338	11.538	11.719	12.386	13.582	14.123	14.719	16.272	16.342
CHAINAGE	620.000	640.000	660.000	680.000	700.000	720.000	740.000	760.000	780.000	800.000	813.592

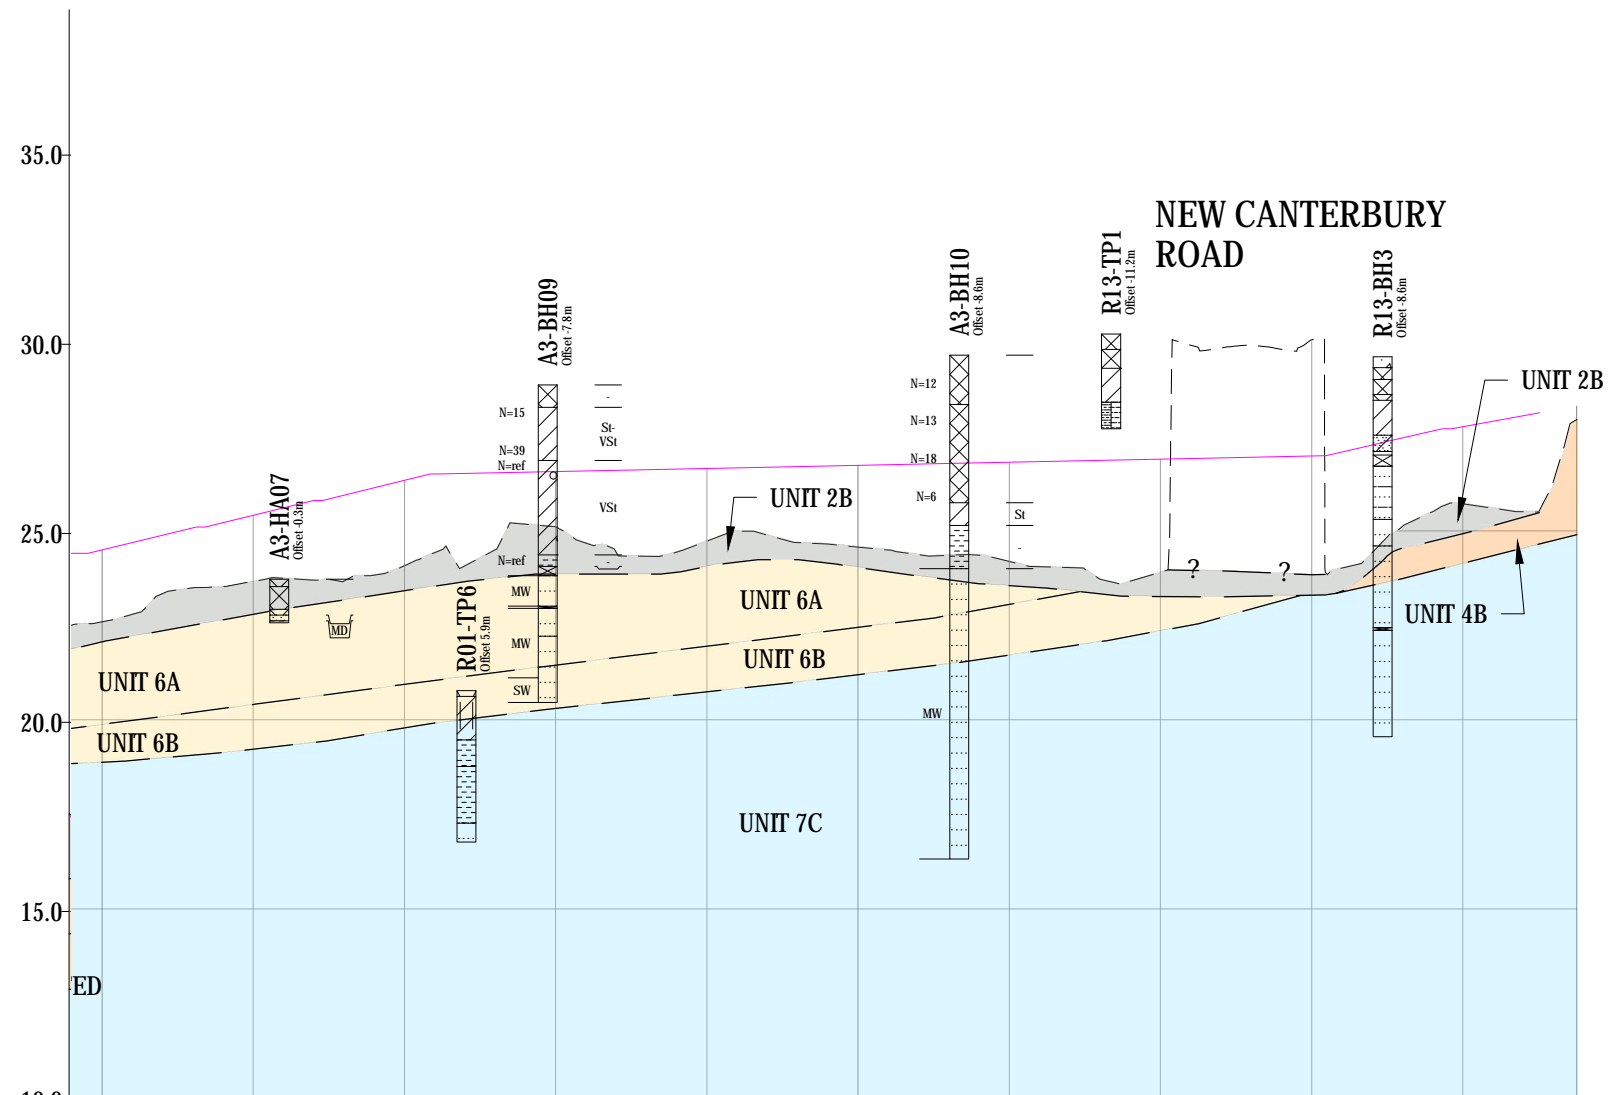
Client	INNER WEST COUNCIL
Project	THE GREENWAY GEOTECHNICAL/CONTAMINATION
Title	SITE 3 ALIGNMENT LONGITUDINAL SECTION C-C - SHEET 3 OF 3
Original Size	A3
Drawing No:	21-12515105-Q013
Rev:	A

DESIGN SURFACE LEVEL	17.500	24.490	25.410	26.330	26.563	26.645	26.728	26.810	26.892	26.974	27.755	28.300
EXISTING SURFACE LEVEL	22.587	23.659	24.070	25.100	24.724	24.569	24.188	23.902	30.056	25.713	27.942	
CHAINAGE	600.000	620.000	640.000	660.000	680.000	700.000	720.000	740.000	760.000	780.000	795.063

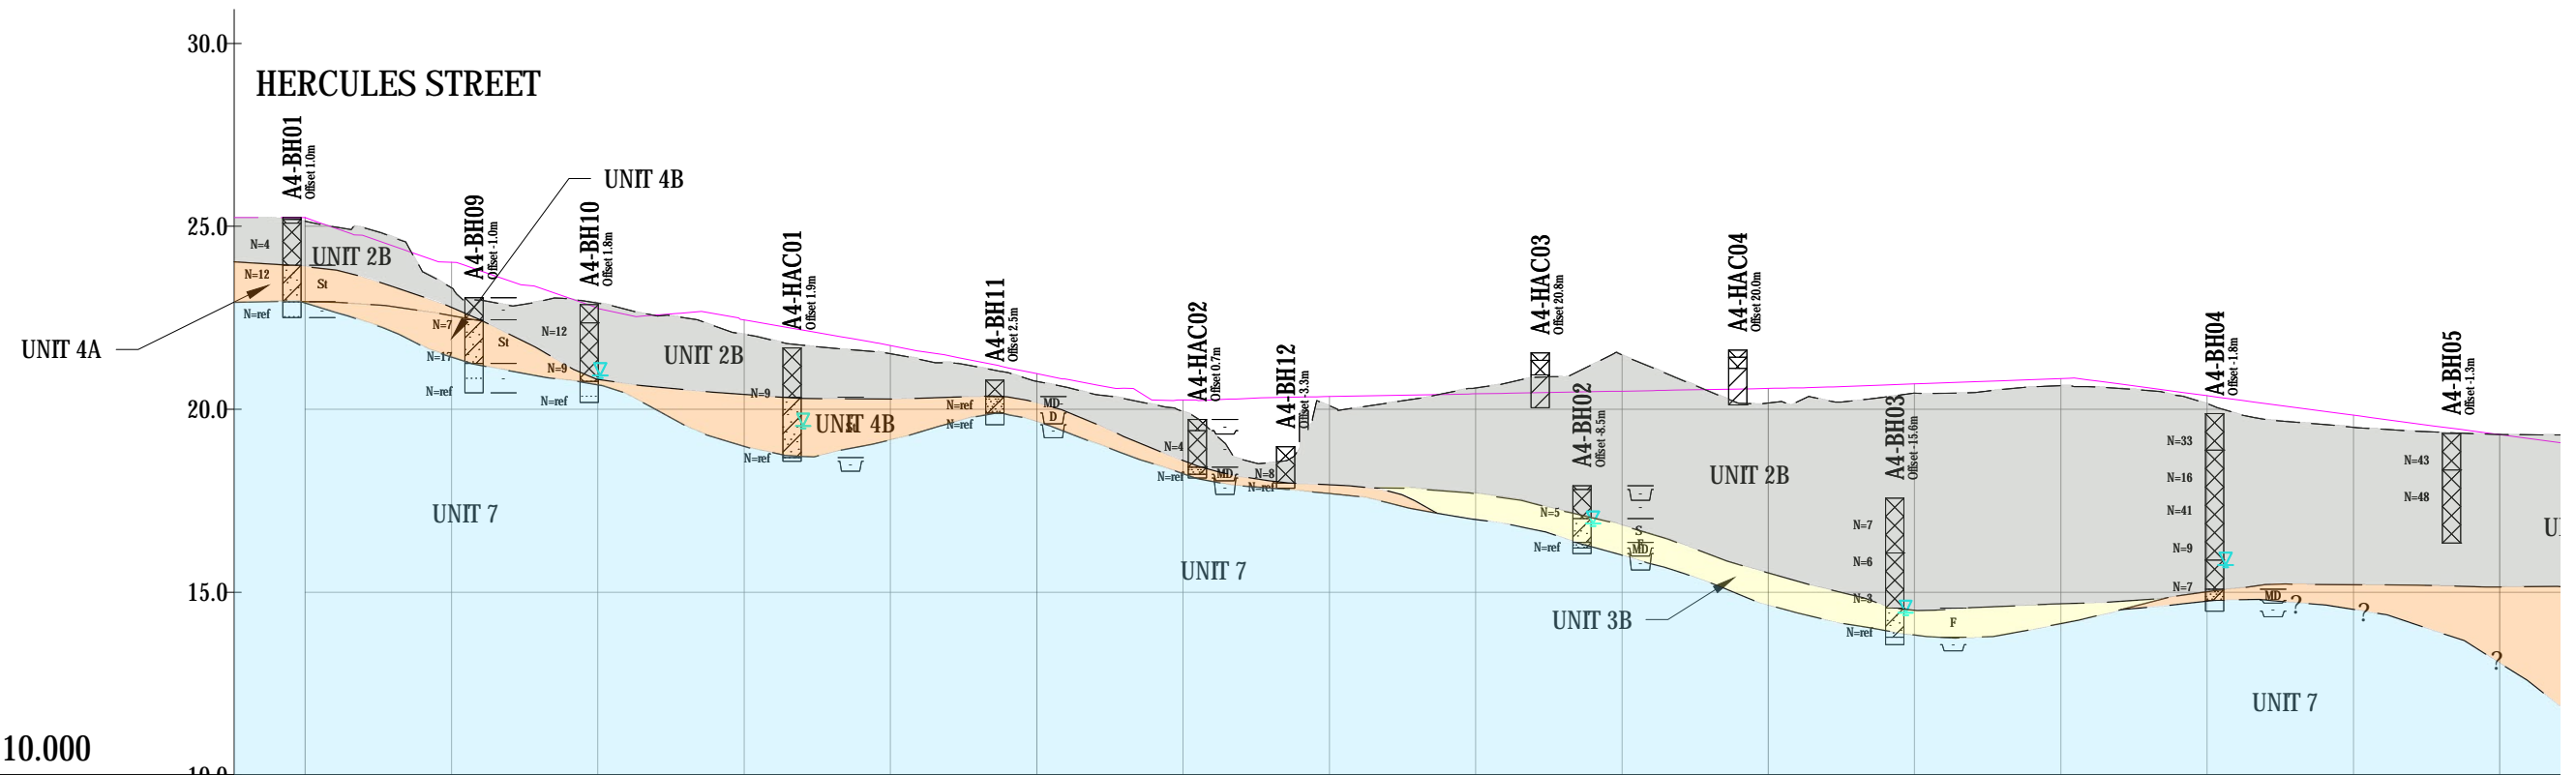
LONGITUDINAL SECTION D-D
SCALE 1:V200 H1000

25.238	24.020	22.765	22.440	21.743	20.975	20.252	20.349	20.422	20.496	20.370	20.696	20.842	20.372	19.839	19.307
DESIGN SURFACE LEVEL —————																
EXISTING SURFACE LEVEL - - - - -		23.317	22.904	22.049	21.520	20.764	19.940	20.094	20.584	21.482	20.172	20.438	20.646	20.152	19.507	19.310
CHAINAGE		20.000	40.000	60.000	80.000	100.000	120.000	140.000	160.000	180.000	200.000	220.000	240.000	260.000	280.000	300.000
