## Appendix C – Summary laboratory data

<p><b>Client:</b> Inner West Council PO Box 14 Petersham NSW 2049</p> <p><b>Project:</b> The GreenWay Geotechnical and Contamination Services Haberfield, Summer Hill, Lewisham and Dulwich Hill, NSW</p>	<p><b>Report No.:</b> SYD1902763.1</p> <p><b>Job No.:</b> 12515105</p> <p><b>Sample No.:</b> SYD19-0504-04</p> <p><b>Test Date:</b> 03.12.2019</p>
<p><b>Client Id.:</b> n/av</p>	<p><b>Borehole No.:</b> A2D-LD04</p>
<p><b>Depth (m):</b> 4.10 to 4.40</p>

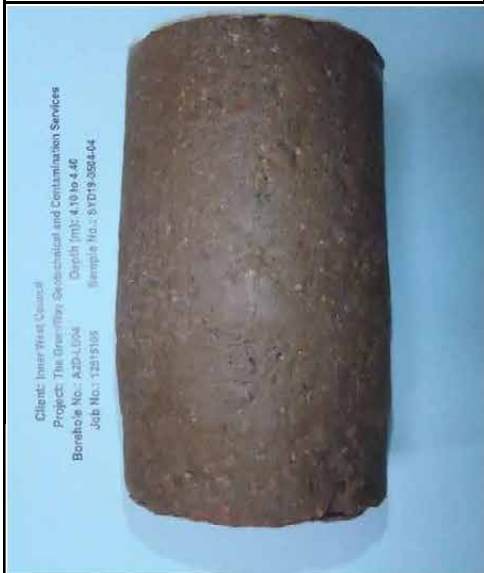
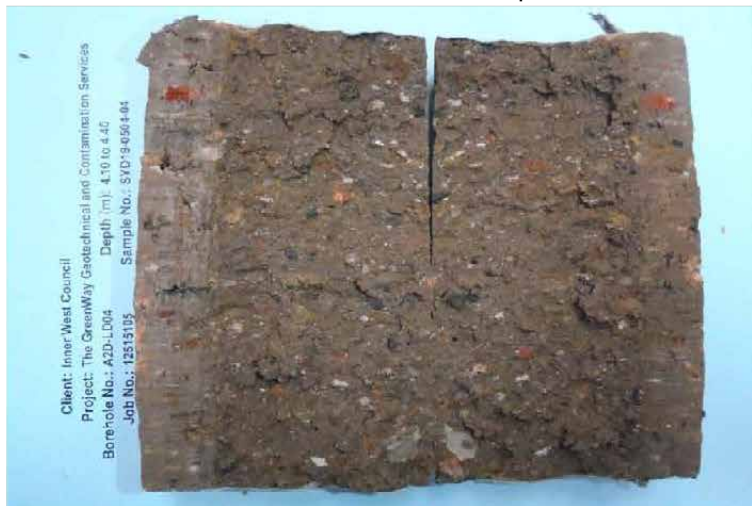
Stage No.:	1	2	3		
Back Pressure (kPa):	500	500	500		
Effective Consolidation Stress (kPa):	50	100	200		
Rate of Strain (mm/min):	0.00122	0.00122	0.00122		
Deviator Stress at Failure (kPa):	75	127	231		
Pore Water Pressure at Failure (kPa):	15	38	84		
Consolidation Volume Change (ml):	5.4	9.3	14.8		
Strain at Failure (%):	1.4	2.5	6.7		
$\sigma_1$ (kPa):	110	187	344		
$\sigma_3$ (kPa):	35	61	112

**Test Comments:** Side drains not used  
No visible shear failure plane
