# APPENDIX A INVENTORY OF ZONES AND ITEMS

# CALLAN PARK CONSERVATION MANAGEMENT PLAN

#### **ZONE 1 THE WATERFRONT AND CALLAN POINT**

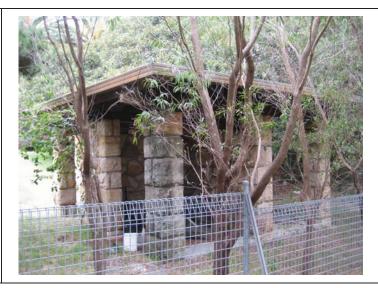
**BUILDING: B 486 GARDEN STRUCTURE**

Open garden structure with a flat roof supported off rectangular stone piers. Structure divided into compartments. Timber fascia to roof.

CONDITION:	Good
HISTORY:	Unresearched
REFERENCES:	Site inspection.
SIGNIFICANCE:	Neutral. Minimal significance as part of development of repatriation hospital. Potentially intrusive but now adequately screened.
GUIDELINES:	Retain, recycle, replace or remove as practicable. If removed, record prior to demolition and revegetate the area with appropriate planting

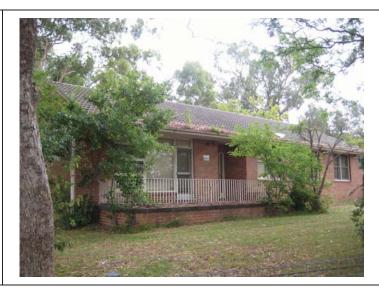
B 492 & B 493 BAYVIEW COTTAGES, B 490 & B 491 ASSOCIATED

Pair of light yellow-brown brick houses with pitched tiled roofs and brick gables, timber framed windows. Simple rectangular plan with patio enclosed by wrought metal balustrade at front of dwellings.

Similarly detailed simple garages associated with each residence.

CONDITION:	Good
HISTORY:	Built c. 1960-65.
REFERENCES:	Leong (80)
SIGNIFICANCE:	Intrusive
GUIDELINES:	Remove as practicable and revegetate the area. Take care to prevent damage to European rock carving and Aboriginal relics which may be hidden below the soil surface and contact the NPWS should any Aboriginal relics be found. If retained undertake maintenance of building fabric. If removed record prior to demolition. If replaced any new development must conform to the requirements of the Callan Park Act.

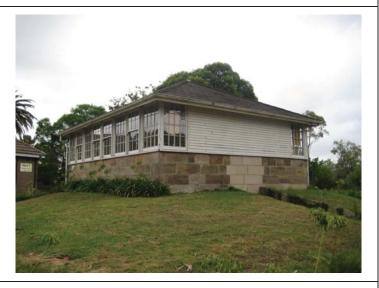
**BUILDING:** B494

Pleasant rectangular building, stone to sill height with multipaned timber windows above. Hipped roof covered in asbestos cement shingles with rare asbestos cement cappings. Vented timber eaves linings. Timber weatherboard wall lining above stone base east elevation, evidence of early opening below (cement render wall lining lined to resemble stone coursing.

CONDITION:	Good – general maintenance required
HISTORY:	Unknown but a building was in this location on the 1877 site plan. Garry Owen summer house was originally in this area. This building does not date from this early period (circa1840), however may be an early building altered or consist of the materials from an earlier building.
REFERENCES:	JTCW
SIGNIFICANCE:	High - requires further investigation. If found to be Garry Owen summer house is of greater significance.
GUIDELINES:	Retain and conserve using appropriate methodologies and materials.  Consider reconstruction of the door opening and windows in east elevation.  An appropriate use for the building should be found that does not compromise its heritage significance.

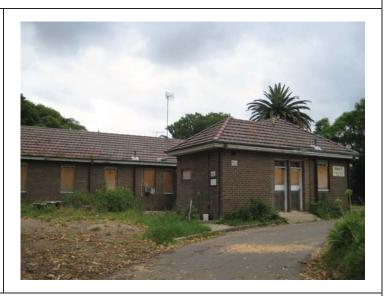
**BUILDING: B 495 FLANDERS HOUSE**

Single storey U-shaped brick building with hipped roof covered with terracotta tiles and vented timber eaves linings. Prominent location isolated from other buildings and screened by trees. Windows have been covered over. Garden with stone terracing on northern side.

CONDITION:	Fair – general maintenance required	
HISTORY:	Built c. 1933-35	
REFERENCES:	Leong (51)	
SIGNIFICANCE:	Low. Minimal significance as part of development of repatriation hospital. Potentially intrusive but now adequately screened.	
GUIDELINES:	Retain, recycle, replace or remove as practicable. The site is visually prominent and if replaced any new development must conform to the requirements of the Callan Park Act. If replaced, the new development should revegetate the area with appropriate planting or be in the form of a discreet building within a natural setting. If removed record prior to demolition.

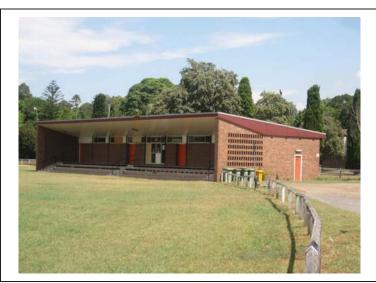
**BUILDING: B499 SPORTS PAVILION**

Brick structure with skillion roof. Provides seating, change room, storage.

CONDITION:	Good
HISTORY:	Built c. 1958-60
REFERENCES:	Leong (56), MH2/218-9, JTCW
SIGNIFICANCE:	Low. Although the building has little apparent significance when related to the history and development of Callan Park and the Rozelle Hospital, it is a distinctive example of a post World War II sports pavilion.
GUIDELINES:	Retain and conserve according to Burra Charter principles. Maintain present use.

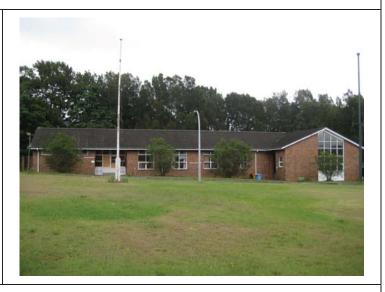
**BUILDING:** B 504 OCCUPATIONAL THERAPIST / RECREATION HALL

Single storey L shaped Brick building with gabled tile roof. Timber framed windows. balconettes on north and south sides of hall at northern end of building. Extensive areas of glazing in timber and aluminium frames on western side looking onto shallow terrace and grounds. Interiors appear to be intact.

CONDITION:	Fair. Timber fascias, bargeboards and other fabric are deteriorating.	
HISTORY:	Built 1960-65	
REFERENCES:	Leong (54) MH2/448	
SIGNIFICANCE:	Low.	
GUIDELINES:	Retain and conserve, adapt to new uses that do not compromise the building's intact fabric and spaces. In the short term ensure the building is weather tight. Repair damaged and deteriorating fabric using appropriate materials, profiles and methodologies. Conserve and sympathetically adapt interiors as required. Upgrade garden setting.

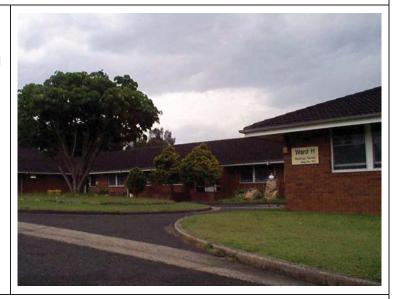
**BUILDING: B 505 HASTINGS HOUSE**

Single storey H shaped red brick building with hipped tiled roof. Deep eaves overhangs, timber framed windows.

Some consciously laid out landscaping on southern side of building.

CONDITION:	Fair. Roof is showing some structural deterioration.	
HISTORY:	Built 1960-65	
REFERENCES:	Leong (53) MH2/220-6 JTCW	
SIGNIFICANCE:	Intrusive in waterfront setting.	
GUIDELINES:	Retain, recycle, replace or remove as practicable. In any redevelopment landscape should be dominant. If removed record prior to demolition. If replaced any new development must conform to the requirements of the Callan Park Act.

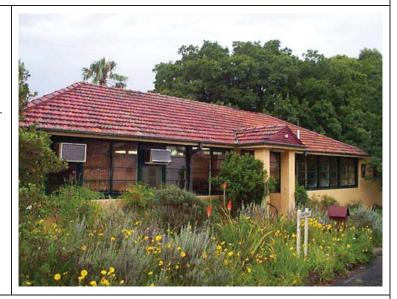
**BUILDING: B 512 CANE ROOM**

Single storey, painted brick walls, hipped roof covered with terracotta tiles, extensive runs of timber framed windows, timber eaves linings. Small porch on south side of building.

CONDITION:	Fair. Timber fabric such as eaves linings is deteriorating.	
HISTORY:	Pre 1931, additions 1948	
REFERENCES:	Leong (82) JTCW Aerial photo 1931	
SIGNIFICANCE:	Low.	
GUIDELINES:	Retain and conserve, adapt to sympathetic new use. Repair damaged and deteriorating fabric using appropriate materials, profiles and methodologies. Upgrade planting associated with the building.

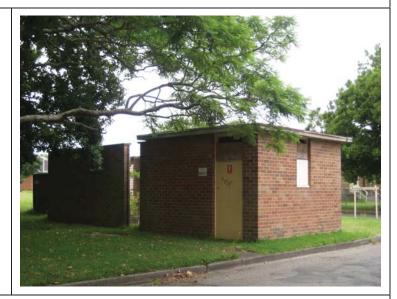
**BUILDING: B 513 SUBSTATION** LOCATION:

Pair of brick structures consisting of a square flat roofed building and an open court enclosed by high walls. Similar to Item B4C in Zone 4.

CONDITION:	Fair.
HISTORY:	Probably constructed in the 1960s around the same time as other buildings in the immediate vicinity (B504, B505, B512 and B514).
REFERENCES:	
SIGNIFICANCE:	Intrusive.
GUIDELINES:	Retain, recycle, replace or remove as practicable. If removed record prior to demolition.

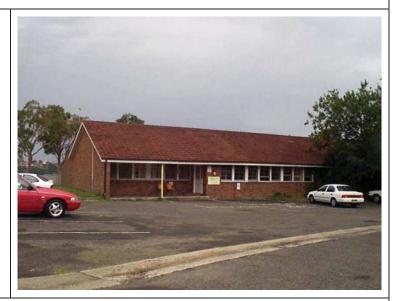
**BUILDING: PALM COURT**

Single storey L shaped brick building with tiled roof, gable ends. Timber framed windows. Modifications on north side of building.

CONDITION:	Fair
HISTORY:	Built 1960
REFERENCES:	Leong (52) MH2/448 JTCW
SIGNIFICANCE:	Intrusive in waterfront setting.
GUIDELINES:	Retain, recycle, replace or remove as practicable. In any redevelopment landscape should be dominant. If removed record prior to demolition. If replaced any new development must conform to the requirements of the Callan Park Act.

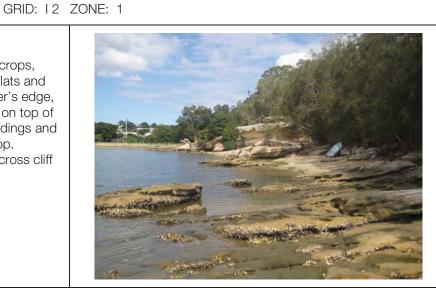
Rocky cliffs and outcrops, sandy beach, mud flats and rock shelves at water's edge, some fill introduced on top of cliffs and roads, buildings and gardens edge cliff top. Fitness track runs across cliff top.

CONDITION:	Substantially intact.
HISTORY:	-
REFERENCES:	1991 DPWS Heritage Study.
SIGNIFICANCE:	Significant as rare remnant of natural shoreline and landform and as original setting for asylum and Garry Owen Estate. Earth fill, building and garden developments are intrusive on its significance.
GUIDELINES:	Preserve. Remove intrusive fill, rubbish and building developments and restore natural profiles as far as possible. Take care to prevent damage to any rock carvings or Aboriginal relics which may be hidden beneath the soil surface. Contact the NPWS if any Aboriginal relics are found.
