ZONE 1 – THE WATERFRONT AND CALLAN POINT		
ITEM No. 6B	CONSTRUCTION DATE:	HERITAGE LISTINGS:
ORIGINAL NAME:	ARCHITECT / BUILDER:	<input type="checkbox"/> National Estate
CURRENT USE:		<input type="checkbox"/> S170 List
		<input type="checkbox"/> National Trust
		<input type="checkbox"/> Leichhardt LEP
		<input type="checkbox"/> State Heritage Inventory

ITEM:	6B INDIGENOUS VEGETATION	
LOCATION:	GRID: I 2, H2 ZONE: 1	
DESCRIPTION:	<p>Small group of indigenous She Oak, Rough Barked apple and Bangalay with possible indigenous shrub (unidentified sp) and areas of Kangaroo Grass, Lomandra and other native grasses above the cliffs.</p>

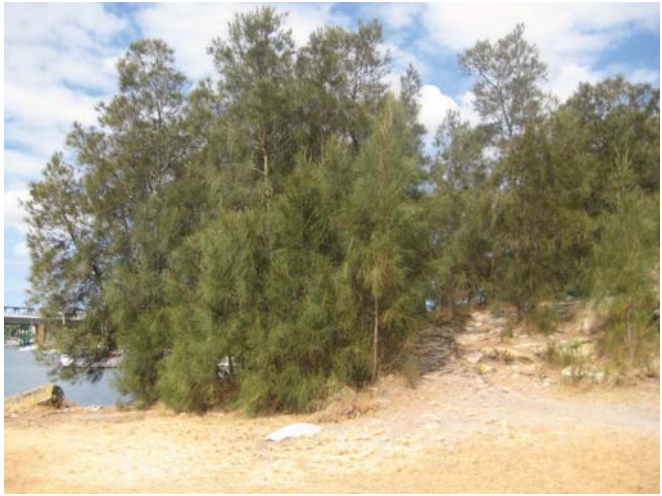
CONDITION:	Part intact. Modified and simplified communities through disturbance.	
HISTORY:	Regenerate from original species.	
REFERENCES:	1991 DPWS Heritage Study	
SIGNIFICANCE:	Significant as rare remnant of indigenous vegetation and representative components of original setting for the asylum and Garry Owen Estate.	
GUIDELINES:	Maintain. Remove weeds and regenerate/revegetate with seed from indigenous plants. Replace introduced species with indigenous species where appropriate throughout the point area. Encourage development of indigenous plant and animal communities. Note NPWS should be contacted prior to any disturbance on or near Aboriginal midden sites and care should be taken around European carvings to avoid damage.

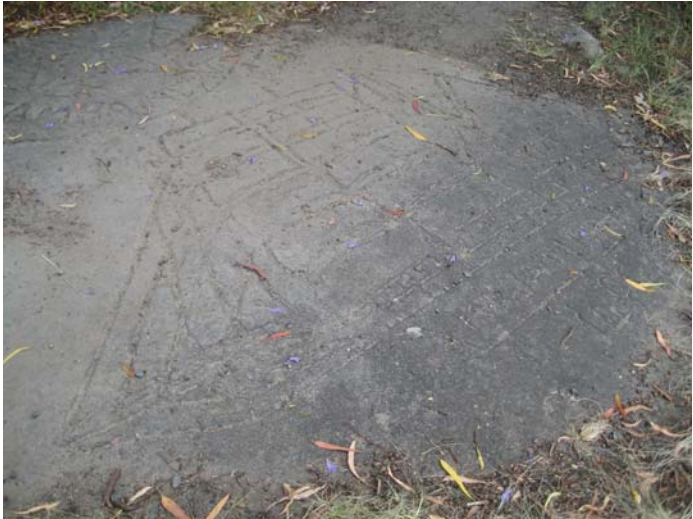
ITEM: LOCATION:	6D ROCK CARVINGS GRID: H2, I 2-3 ZONE: 1	
DESCRIPTION: Extensive range of subjects including ships, figures, globes, fish, an animal (possibly alpaca), heads, stars (similar to compass roses) and many numerals (possible dates) and hand lettering (some doesn't seem to make sense. Others possibly in French).

CONDITION:	Exposed carvings intact, some hidden beneath grass and gardens. Some exposed to foot traffic and vandalism.	
HISTORY:	Believed carved by one man who lived on a boat in Iron Cove. Patients may have been responsible for some carvings. It is possible that there were aboriginal carvings on the site but no evidence is visible.	
REFERENCES:	John Clegg. Sydney University. Article "Sydney Rock Art" by John Clegg pp119-122 in <i>The Moving Frontier</i> (edited by Peter Stanbury). Reed. Sydney 1977. <i>Sydney Morning Herald</i> Column 8 item and reply 1960s. J.S. Kerr, <i>Out Of Sight Out Of Mind</i> . 1991 DPWS Heritage Study

SIGNIFICANCE:	Significant as 'outsider art'; as record of social history; as a rare and exceptional item and as a factor in the local sense of place.	
GUIDELINES:	Preserve in accordance with Burra Charter. Redirect public path away from surface carvings and provide sensitively designed barriers to prevent foot traffic over the carvings. Protect hidden and exposed carvings during any clearing, revegetation, demolition or construction work. Before any disturbance of the area carry out assessment by qualified historical archaeologist. Consider careful installation of interpretive signage.

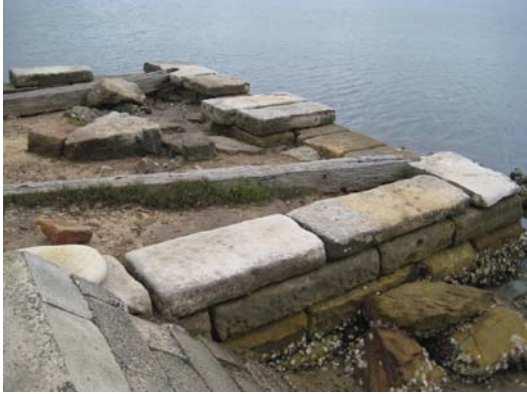
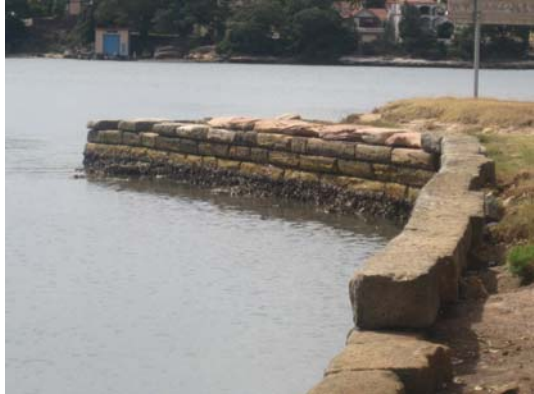
ZONE 1 – THE WATERFRONT AND CALLAN POINT		
<p>ITEM No. 6E</p> <p>ORIGINAL NAME: Sea wall and boat wharf</p> <p>CURRENT USE: Sea wall, wharf disused</p>	<p>CONSTRUCTION DATE:</p> <p>ARCHITECT / BUILDER: Unknown</p>	<p>HERITAGE LISTINGS:</p> <p><input type="checkbox"/> National Estate</p> <p><input type="checkbox"/> S170 List</p> <p><input type="checkbox"/> National Trust</p> <p><input type="checkbox"/> Leichhardt LEP</p> <p><input type="checkbox"/> State Heritage Inventory</p>
<p>ITEM:</p> <p>LOCATION:</p>	<p>6E SEA WALL & BOAT WHARF</p> <p>GRID: H2, G3 ZONE: 1</p>	
<p>DESCRIPTION:</p> <p>Battered sandstone block seawall edging land fill areas.</p>		
<div style="display: flex; justify-content: space-around;">

</div>		
<p>CONDITION:</p>	<p>Generally intact.</p>	
<p>HISTORY:</p>	<p>Age of wall unresearched. Possibly early 1900s construction added to or replaced in 1940s to 1960s.</p>	
<p>REFERENCES:</p>	<p>1991 DPWS Heritage Study. 1903 photo of original boatshed. Plate 46 Powell. Site plan 1893, Site plan 1931-51, Site plan 1965.</p>

<p>SIGNIFICANCE:</p>	<p>Significance as early site developments reflecting importance of water travel and relationship with Gladesville Hospital.</p>	
<p>GUIDELINES:</p>	<p>Restore damaged sections. Retain boat wharf as relic or redevelop for modern use reflective of its original purpose.</p>

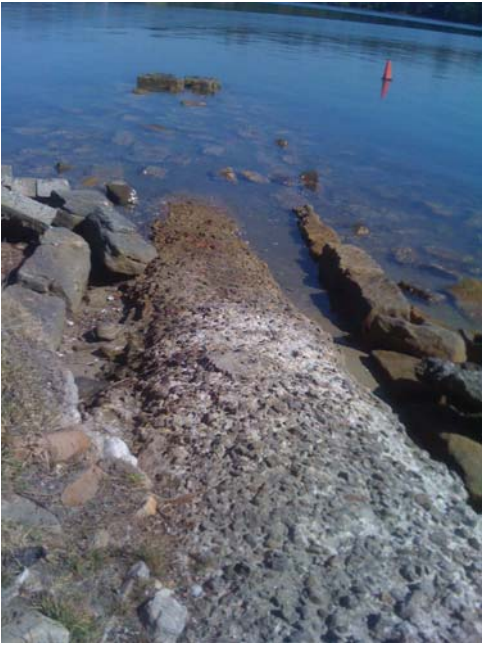
ZONE 1 – THE WATERFRONT AND CALLAN POINT		
ITEM No. 6f ORIGINAL NAME: Sewer outlet CURRENT USE: Disused	CONSTRUCTION DATE: Circa 1880 ARCHITECT / BUILDER: Unknown	HERITAGE LISTINGS: <input type="checkbox"/> National Estate <input type="checkbox"/> S170 List <input type="checkbox"/> National Trust <input type="checkbox"/> Leichhardt LEP <input type="checkbox"/> State Heritage Inventory
ITEM: LOCATION:	6F SEWER OUTLET GRID: H2 ZONE: 1	
DESCRIPTION: Ruins of sandstone sewer outfall extending into Iron Cove.

CONDITION:	In ruined state.	
HISTORY:	Originally asylum sewer discharging into Iron Cove. Later used for stormwater.	
REFERENCES:	1991 DPWS Heritage Study. 1877 site plan	
SIGNIFICANCE:	Significant as an item of original asylum design and early sewage system.	
GUIDELINES:	Preserve as ruins.

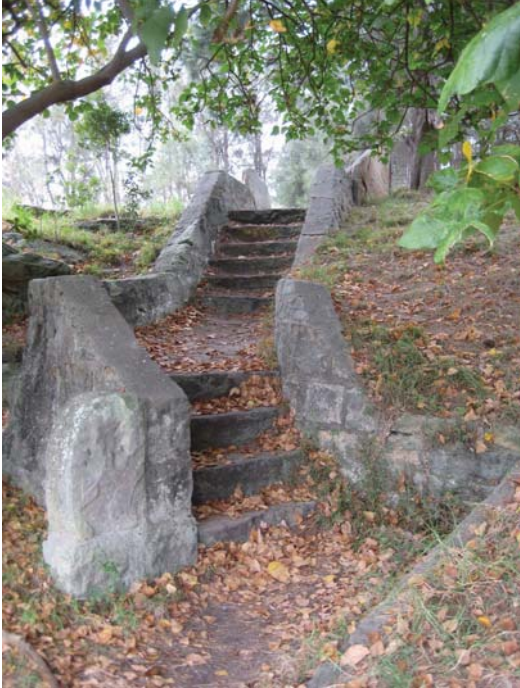
ZONE 1 – THE WATERFRONT AND CALLAN POINT		
ITEM No. 6G ORIGINAL NAME: CURRENT USE: Stair, retaining wall.	CONSTRUCTION DATE: Circa 1905 ARCHITECT / BUILDER: Unknown	HERITAGE LISTINGS: <input type="checkbox"/> National Estate <input type="checkbox"/> S170 List <input type="checkbox"/> National Trust <input type="checkbox"/> Leichhardt LEP <input type="checkbox"/> State Heritage Inventory
ITEM: LOCATION:	6G STONE STAIRS & WALLS GRID: H2 ZONE: 1	
DESCRIPTION: Dry stone wall and stone staircase.

CONDITION:	Intact	
HISTORY:	Likely to have been built in association with swimming pool construction in the mid 1900s.	
REFERENCES:	1991 DPWS Heritage Study. Site plan 1931 and site plan 1965.	
SIGNIFICANCE:	No evidence of heritage significance, however sympathetic with development area of the point.	
GUIDELINES:	Retain and conserve.

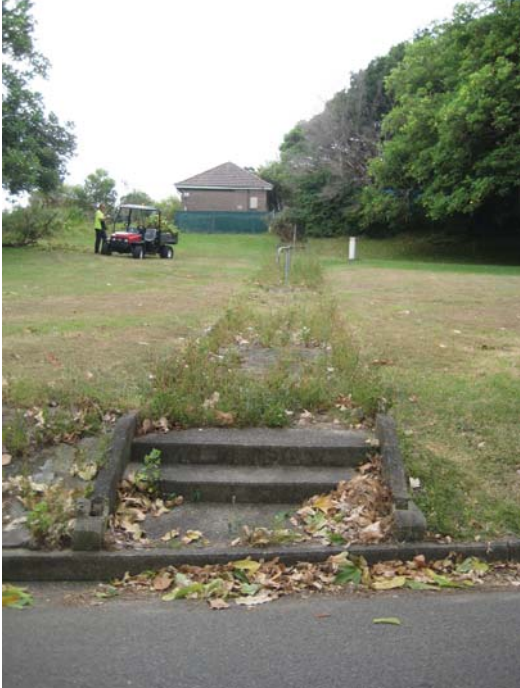
ITEM: LOCATION:	6J PATH GRID: H3 ZONE: 1
DESCRIPTION: Sandstone flagged path leading to building B495. Inscribed with date of construction.

CONDITION:	Fair condition, partly overgrown.
HISTORY:	-
REFERENCES:	1991 DPWS Heritage Study.
SIGNIFICANCE:	Some significance as work of patients illustrating involvement of patients as therapy (or economy!) however not an outstanding or rare example. Path is intrusive on the significant natural character of the point.
GUIDELINES:	Remove. Photographically record as evidence of patient work prior to removal.

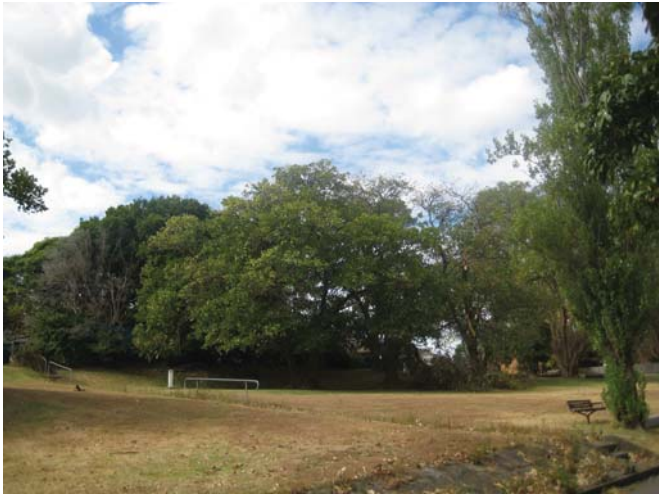
ZONE 1 – THE WATERFRONT AND CALLAN POINT	
ITEM No. 6K ORIGINAL NAME: CURRENT USE:	CONSTRUCTION DATE: ARCHITECT / BUILDER: HERITAGE LISTINGS: <input type="checkbox"/> National Estate <input type="checkbox"/> S170 List <input type="checkbox"/> National Trust <input type="checkbox"/> Leichhardt LEP <input type="checkbox"/> State Heritage Inventory
ITEM: LOCATION:	6K INDIVIDUAL TREES GRID: H3, I3 ZONE: 1
DESCRIPTION: Large introduced Eucalypt and Coral trees and other species planted throughout developed area of the point.

CONDITION:	Good.
HISTORY:	Larger trees probably planted in 1930s and 1950s with more recent additions.
REFERENCES:	1991 DPWS Heritage Study.
SIGNIFICANCE:	No identified heritage significance.
GUIDELINES:	Large trees may be incorporated into future development where appropriate or transplanted to alternate location.

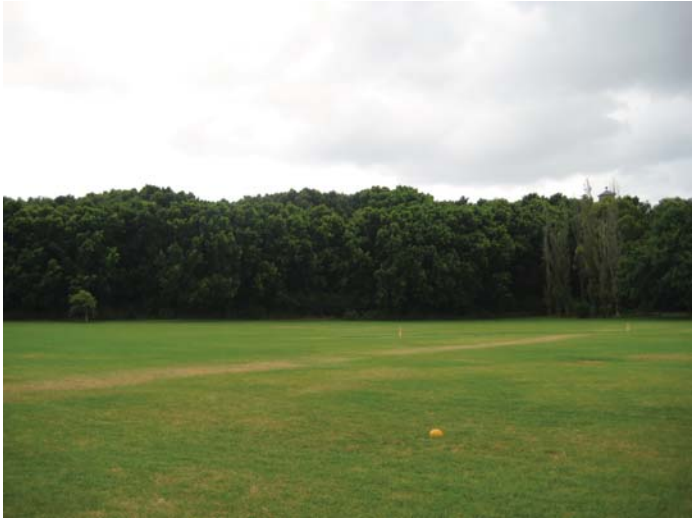
ZONE 1 – THE WATERFRONT AND CALLAN POINT	
ITEM No. 5B ORIGINAL NAME: CURRENT USE:	CONSTRUCTION DATE: 1980s ARCHITECT / BUILDER: Unknown HERITAGE LISTINGS: <input type="checkbox"/> National Estate <input type="checkbox"/> S170 List <input type="checkbox"/> National Trust <input type="checkbox"/> Leichhardt LEP <input type="checkbox"/> State Heritage Inventory
BUILDING: LOCATION:	5B EMBANKMENT PLANTING GRID: H 1-4 ZONE: 1
DESCRIPTION: Mass planted Hills Weeping fig, Cedar Wattle and other native shrubs (non-indigenous). May provide habitat for Grey-headed Flying Fox, which is threatened in Leichhardt Local Government Area.

CONDITION:	
HISTORY:	1980s mass planting.
REFERENCES:	1991 DPWS Heritage Study. Photo c. 1903, site inspection
SIGNIFICANCE:	Highly intrusive of outlook from and setting for cottages B401 and B404.
GUIDELINES:	Professionally assess significance as habitat for Grey-headed Flying Fox. If not significant as habitat, prune trees to regain views. As trees die remove and revegetate slope with low growing indigenous species such as grasses and groundcovers.

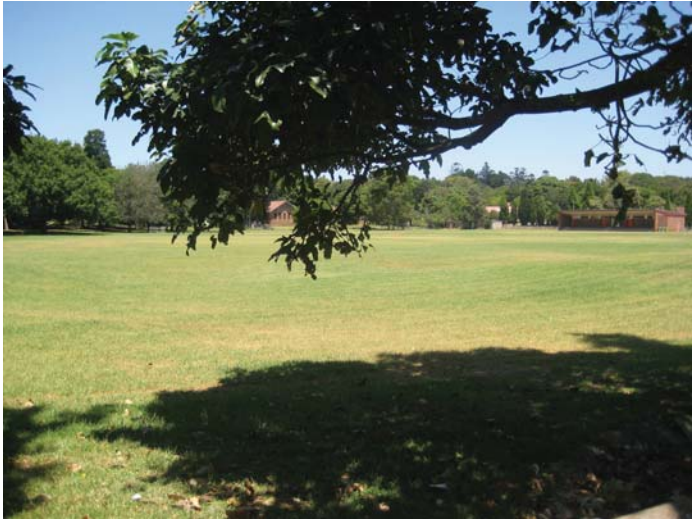
ITEM: LOCATION:	7A RECLAIMED LAND GRID: L4-H4, C4-D4 ZONE: 1
DESCRIPTION: Flat lawn area now used as football oval.

CONDITION:	Intact
HISTORY:	Area G4-H4 – former swamp and inlet reclaimed for vegetable growing in 1880s to early 1900s and canal formed in early 1900s. Area C4-D4 reclaimed in 1942.
REFERENCES:	1991 DPWS Heritage Study.
SIGNIFICANCE:	Early asylum development reflecting the need for large scale food production for asylum subsistence and representative of Charles Moore's design. Edge of reclaimed area reflects part of original shoreline. 1942 reclamation not of heritage significance.
GUIDELINES:	Preserve. Maintain open character. Future development should reflect original shoreline presently evident as a relatively natural embankment behind the oval, and maintain integrity of significance by revegetating with indigenous species. Current recreational use is sympathetic to significance.

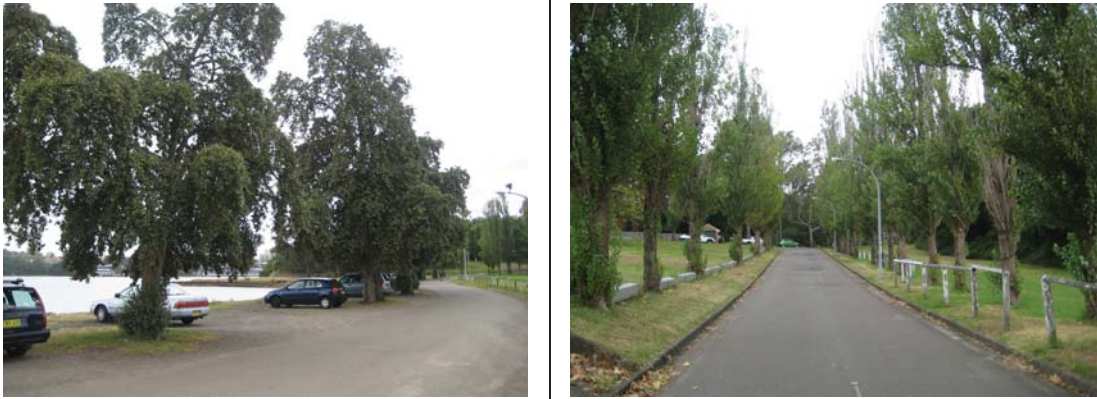
ITEM: LOCATION:	7E ROAD PATTERN GRID: G3-4 ZONE: 1
DESCRIPTION: Waterfront Drive is bitumen with no kerb and gutter. Other roads all kerbed and guttered bitumen roads.

CONDITION:	Intact
HISTORY:	Waterfront Drive overlays original early 1900s track. Others built as access roads to Repatriation Works from 1918 to 1965.
REFERENCES:	1991 DPWS Heritage Study. Site plans 1903, 1931-51, 1965.
SIGNIFICANCE:	Waterfront Drive alignment is significant as original asylum access track. No evidence of heritage significance for other roads. Generally complexity of later roads intrudes upon significant character.
GUIDELINES:	Preserve alignment of Waterfront Drive in future layouts but not necessarily as a road. Refer to open space management plan.

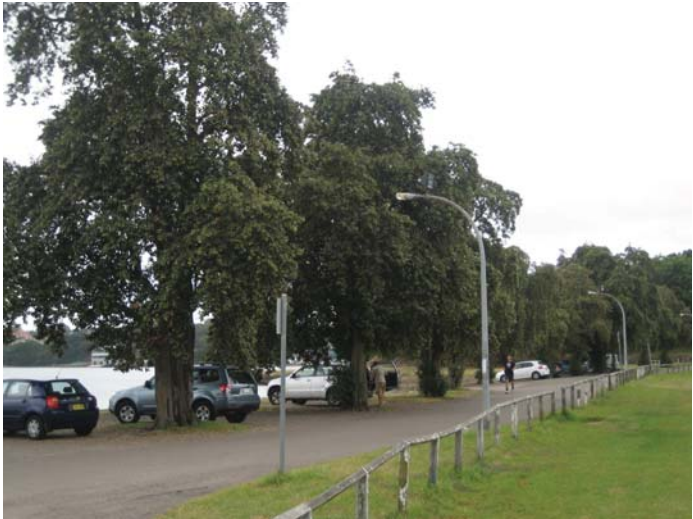
ZONE 1 – THE WATERFRONT AND CALLAN POINT	
<p>ITEM No.7M</p> <p>ORIGINAL NAME: Norfolk Island hibiscus</p> <p>CURRENT USE:</p>	<p>CONSTRUCTION DATE: Planted 1880s-1890s</p> <p>ARCHITECT / BUILDER: Charles Moore</p> <p>HERITAGE LISTINGS:</p> <p><input type="checkbox"/> National Estate</p> <p><input type="checkbox"/> S170 List</p> <p><input type="checkbox"/> National Trust</p> <p><input type="checkbox"/> Leichhardt LEP</p> <p><input type="checkbox"/> State Heritage Inventory</p>
<p>ITEM:</p> <p>LOCATION:</p>	<p>7M NORFOLK ISLAND HIBISCUS</p> <p>GRID: F4-G4 ZONE: 1</p>
<p>DESCRIPTION:</p> <p>Row with some of original trees missing.</p>

<p>CONDITION:</p>	<p>Fair to good</p>
<p>HISTORY:</p>	<p>Planted late 1880s to 1890s along newly formed shoreline.</p>
<p>REFERENCES:</p>	<p>1991 DPWS Heritage Study.</p>
<p>SIGNIFICANCE:</p>	<p>Significant as original asylum plantings representing the species selection of Charles Moore.</p>

<p>GUIDELINES:</p>	<p>Maintain. Remove carparking from beneath trees. Carry out tree surgery and improve growing conditions. Replant missing trees.</p>

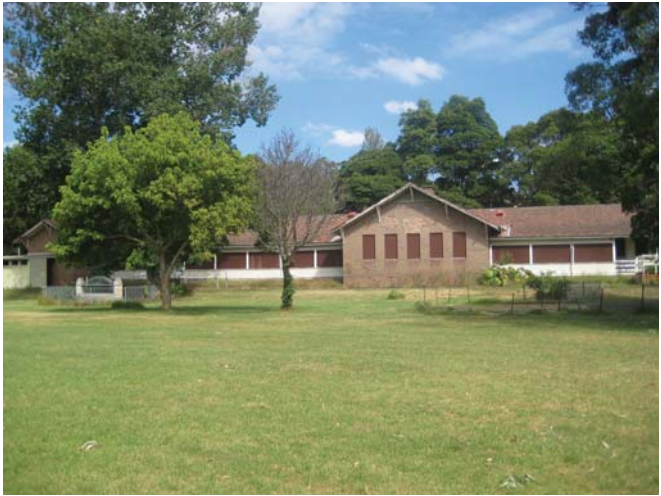
ITEM: LOCATION:	7N WILLOW ROWS GRID: H4-G5 ZONE: 1
DESCRIPTION: Double row willows on eastern edge of oval and screen planting partially covering front of Buildings B496 and B497.

CONDITION:	Generally good. Some poor specimens.
HISTORY:	Willow rows planted in 1970s. Willow screen planting in front of repatriation wards planted in mid 1980s.
REFERENCES:	1991 DPWS Heritage Study.
SIGNIFICANCE:	No heritage significance. Partially dense canopies hide significant former shoreline and physically isolate oval area from remainder of site. Intrusive in original asylum scheme.
GUIDELINES:	Over time replace with indigenous tree groups sympathetic to the landscape character of the early 1900s seen in plates 70, 72 and 83 in Powell.
