ZONE 2 – MANNING STREET PRECINCT		
<p>ITEM No. B399</p> <p>ORIGINAL NAME: Former Attendant's Cottage, R7</p> <p>CURRENT USE: Office (SHFA)</p>	<p>CONSTRUCTION DATE: 1879</p> <p>ARCHITECT / BUILDER: James Barnet</p> <p>Additions c.1897 Walter Liberty Vernon, further additions 1946.</p>	<p>HERITAGE LISTINGS:</p> <p><input checked="" type="checkbox"/> National Estate</p> <p><input checked="" type="checkbox"/> S170 List</p> <p><input checked="" type="checkbox"/> National Trust</p> <p><input type="checkbox"/> Leichhardt LEP</p> <p><input type="checkbox"/> State Heritage Inventory</p>
<p>BUILDING:</p> <p>LOCATION:</p>	<p>B399 MOODIE STREET COTTAGE</p> <p>GRID: L6 ZONE: 2</p>	
<p>DESCRIPTION:</p> <p>Single storey semi-detached pair of stone cottages, similar in style and detailing to Kirkbride Block. Hipped slate roof with terracotta dressings. Simple metal railings to verandahs and stair. Double hung timber windows and 4 panel doors, terracotta chimney pots. Holes around window openings suggest security grilles fitted in the past. Original iron railing intact, as are separate store and double toilet at rear. Addition (B399A) to south intrusive.</p>

LANDSCAPE ELEMENTS

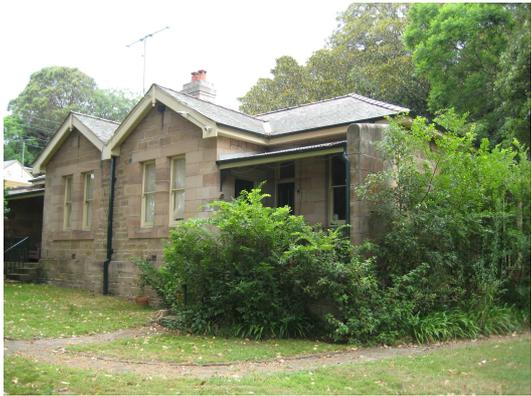
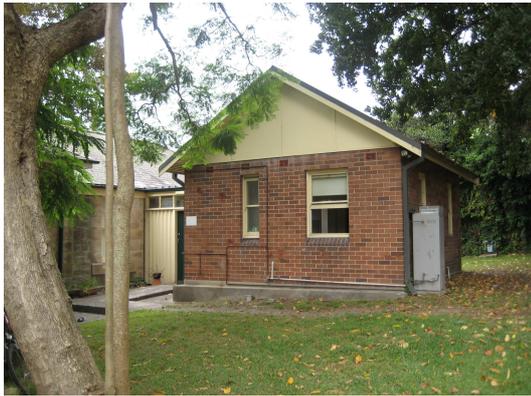
</div>		
<p>CONDITION:</p>	<p>Good – some maintenance required.</p>	
<p>HISTORY:</p>	<p>Built 1879 as part of original Barnet plan, various alterations (largely sympathetic) and large unsympathetic addition since. Previously accommodated patients.</p>	
<p>REFERENCES:</p>	<p>Leong (45), JTCW</p>	
<p>SIGNIFICANCE:</p>	<p>Exceptional. Part of James Barnet's original design. Excellent design and workmanship.</p> <p>Addition immediately to rear of original building is intrusive.</p>	
<p>GUIDELINES:</p>	<p>Conserve original cottages and outhouse according to the principles of the Burra Charter. Remove unsympathetic addition and record prior to demolition, restore building and undertake maintenance, including repointing of stonework.</p>

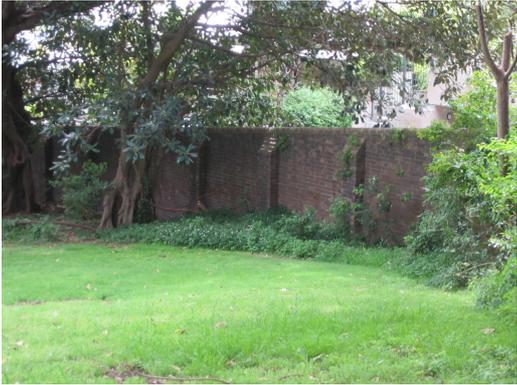
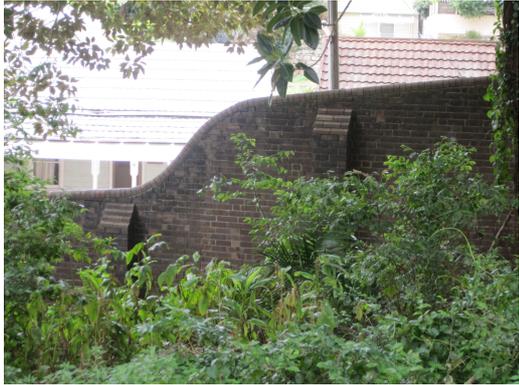
ZONE 2 – MANNING STREET PRECINCT		
<p>ITEM No. 1A</p> <p>ORIGINAL NAME: Boundary wall</p> <p>CURRENT USE: Boundary wall</p>	<p>CONSTRUCTION DATE: Circa 1890-1903</p> <p>ARCHITECT / BUILDER:</p>	<p>HERITAGE LISTINGS:</p> <p><input type="checkbox"/> National Estate</p> <p><input type="checkbox"/> S170 List</p> <p><input type="checkbox"/> National Trust</p> <p><input type="checkbox"/> Leichhardt LEP</p> <p><input type="checkbox"/> State Heritage Inventory</p>
<p>ITEM:</p> <p>LOCATION:</p>	<p>1A BOUNDARY WALL ON MANNING STREET</p> <p>GRID: L6-8 ZONE: 2</p>	
<p>DESCRIPTION:</p> <p>Buttressed brick wall with bullnose brick coping. Approx 2.0 m high. Curved sections accommodate changes in topography. Intrusive later openings.</p>		
<div style="display: flex; justify-content: space-around;">

</div>		
<p>CONDITION:</p>	<p>Substantially intact</p>	
<p>HISTORY:</p>	<p>Section south from Manning Street. Residence shown on 1897 plan, possibly built earlier in association with fig planting. Section north of residence added by 1903.</p>

<p>REFERENCES:</p>	<p>1991 DPWS Heritage Study. Site Plan 1897</p>	
<p>SIGNIFICANCE:</p>	<p>Significant as an original and major element in the asylum design representing the need for separation from the general community.</p>	
<p>GUIDELINES:</p>	<p>Conserve, Normal maintenance required especially repointing and replacing existing opening intrusive modern style gates with gates sympathetic to the period of the wall.</p>

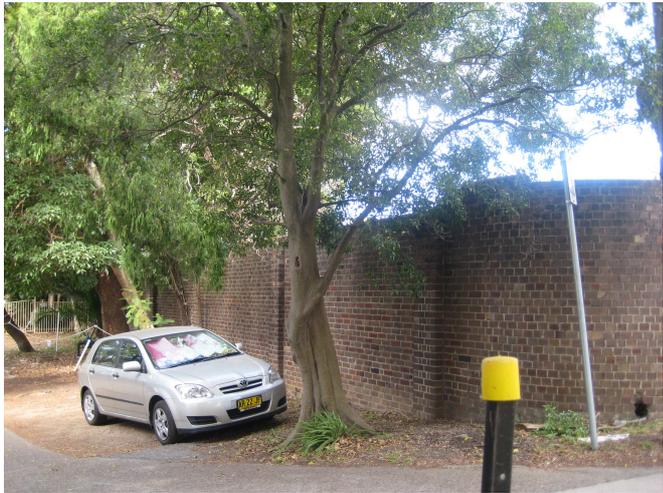
ZONE 2 – MANNING STREET PRECINCT		
<p>ITEM No. 1B</p> <p>ORIGINAL NAME: Boundary wall</p> <p>CURRENT USE: Boundary wall</p>	<p>CONSTRUCTION DATE: circa 1960 (low section)</p> <p>ARCHITECT / BUILDER:</p>	<p>HERITAGE LISTINGS:</p> <p><input type="checkbox"/> National Estate</p> <p><input type="checkbox"/> S170 List</p> <p><input type="checkbox"/> National Trust</p> <p><input type="checkbox"/> Leichhardt LEP</p> <p><input type="checkbox"/> State Heritage Inventory</p>
<p>ITEM:</p> <p>LOCATION:</p>	<p>1B BOUNDARY WALL ON BALMAIN ROAD</p> <p>GRID: L8-K9 ZONE: 2</p>	
<p>DESCRIPTION:</p> <p>Brick wall approximately 0.5 metres high with section approx 2.0 metres high east of the Cecily Street entrance and at the gateway opposite Alberto Street</p>

<p>CONDITION:</p>	<p>Intact</p>	
<p>HISTORY:</p>	<p>Original high timber paling boundary fence was replaced when boundary wall built and gates relocated. Wall height reduced in 1950s or 60s following a Royal Commission.</p>

<p>REFERENCES:</p>	<p>1991 DPWS Heritage Study. Plans 1912. Photos 1903</p>	
<p>SIGNIFICANCE:</p>	<p>Existing low wall is significant because it represents the design intent of the original wall/fence ie enclosing the hospital. The high sections of wall are significant as early replacements of the original fence.</p>	
<p>GUIDELINES:</p>	<p>Preserve high sections adjoining the Main Gates and at the entrance opposite Alberto Street. Preserve existing wall or construct new wall or fence to maintain the original design intent of a strong boundary definition and physical barrier.</p>

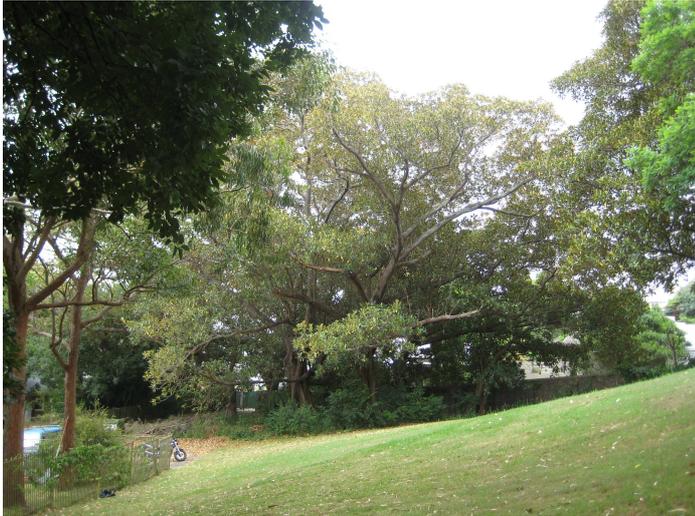
ITEM: LOCATION:	1E BOUNDARY PLANTATION ON MANNING STREET GRID: L6-8 ZONE: 2
DESCRIPTION: Double row <i>Ficus macrophylla</i> in 'spiny' (triangular) formation. Several trees removed for nurses' home extension.

CONDITION:	Fair
HISTORY:	Designed by Charles Moore. Planted between 1875/76 and 1897, probably during the construction of the new asylum in the 1880-5 period, if not earlier.
REFERENCES:	1991 DPWS Heritage Study. Deduction from <i>Evening News</i> 7.7.1876 and 1897 site plan.
SIGNIFICANCE:	Significant as original asylum design device to provide visual screening and a parkland setting representative of the work of Charles Moore.
GUIDELINES:	Maintain and carry out tree surgery urgently, improve growing conditions.

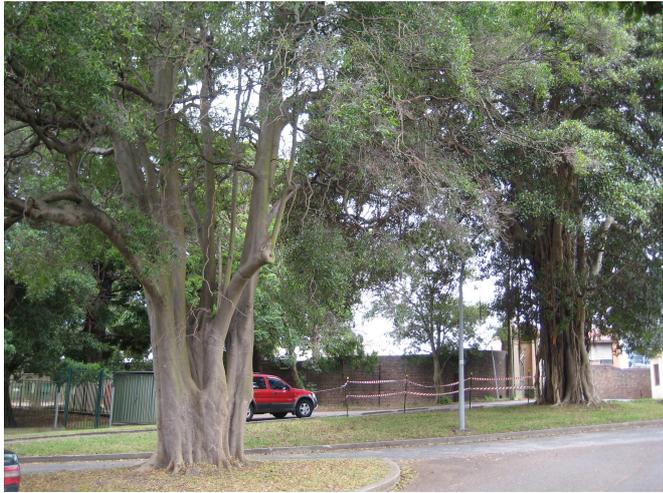
ITEM: LOCATION:	1F BOUNDARY PLANTATION ON BALMAIN ROAD GRID: L8-9 ZONE: 2 & 3
DESCRIPTION: Double row of Port Jackson Figs and Brush Box.

CONDITION:	Fair to good.
HISTORY:	Likely that Port Jackson Figs at 12 m centres added in 1890s to original Moore plantings of Pines and Moreton Bay Figs in 'spiny' formation (triangular or alternating row layout). Moore's plantation removed by 1912 tram line and remaining Port Jackson Fig row added
REFERENCES:	1991 DPWS Heritage Study. Craig Burton, c.1920 photo panorama
SIGNIFICANCE:	Significant because it represents the design intent of the original palntation, to provide visual screening and a parkland setting.
GUIDELINES:	Over time replace dying trees with Port Jackson Fig and some Radiata Pines throughout to reinstate height. Improve vigour of existing trees and carry out tree surgery. Further research recommended.

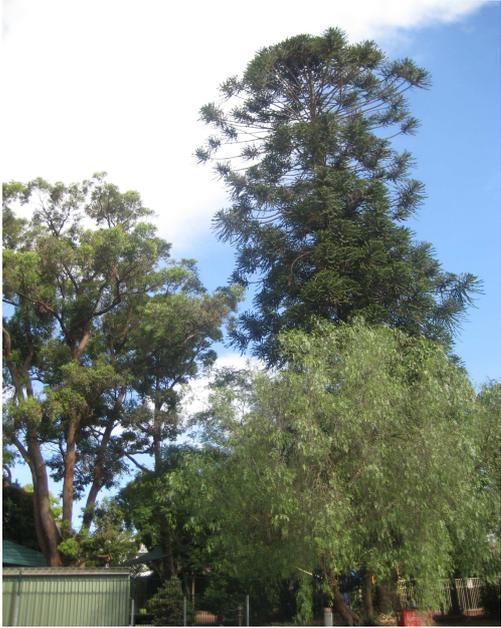
ITEM:	1H TREE GROUPS c.1880s	
LOCATION:	GRID: L8 ZONE: 2	
DESCRIPTION: Mixed species tree group near children's playground associated with B302. Species include Hoop Pine, Bunya Pine, Port Jackson Fig, Water Gum, Brush Box, Illawarra Flame, Plum Pine, Rose Apple and Jacaranda.

CONDITION:	Fair to good.	
HISTORY:	Garden bed laid out by Charles Moore. Originally planted with lawn borders, shrubs and trees with likely additions of Brush Box and Figs in 1890s and Jacaranda and Hoop Pine and possibly other trees added in the mid to late 1900s.	
REFERENCES:	1991 DPWS Heritage Study. Site Inspection, 1897 site plan, Plate 66L Thesis.	
SIGNIFICANCE:	Significant as surviving element of original design, representative of the species selection of Charles Moore and of his interest in Australian rain forest species. The proximity of nureses' home intrudes on integrity of group relative to main gardens.

GUIDELINES:	Maintain older trees and remove younger plantings which are intrusive of character or growth of older trees. Future development should preserve the integrity of these trees as a group. Further research recommended.

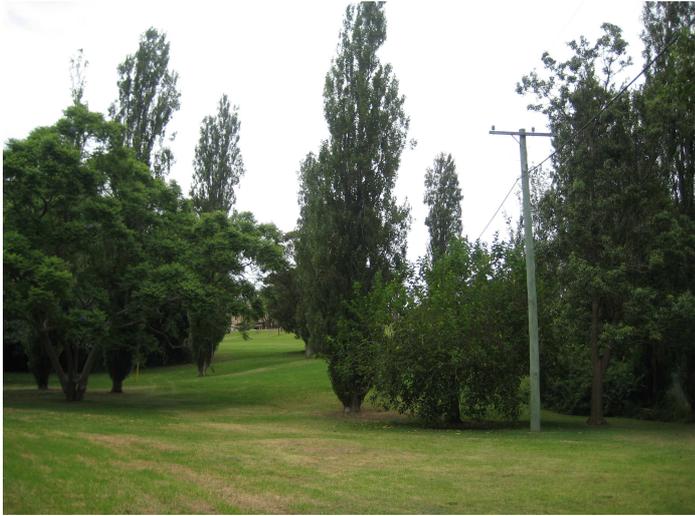
ITEM: LOCATION:	1L POPLAR AND PRUNUS ROWS GRID: L6 ZONE: 2
DESCRIPTION: Double poplar row against substation fence. Prunus avenue beside path to Manning Street Residence.

CONDITION:	Good
HISTORY:	Planted following building of electricity substation in 1953.
REFERENCES:	1991 DPWS Heritage Study. 1952 aerial photo.
SIGNIFICANCE:	Intrudes on open character of original design concept.
GUIDELINES:	Remove tree rows. Investigate potential setting back of substation fence to top of substation embankment to restore sight lines form Kirkbride Block to the Manning Street residence and plant either Port Jackson Fig and Brush Box groups or indigenous tree groups as appropriate in front of fence.

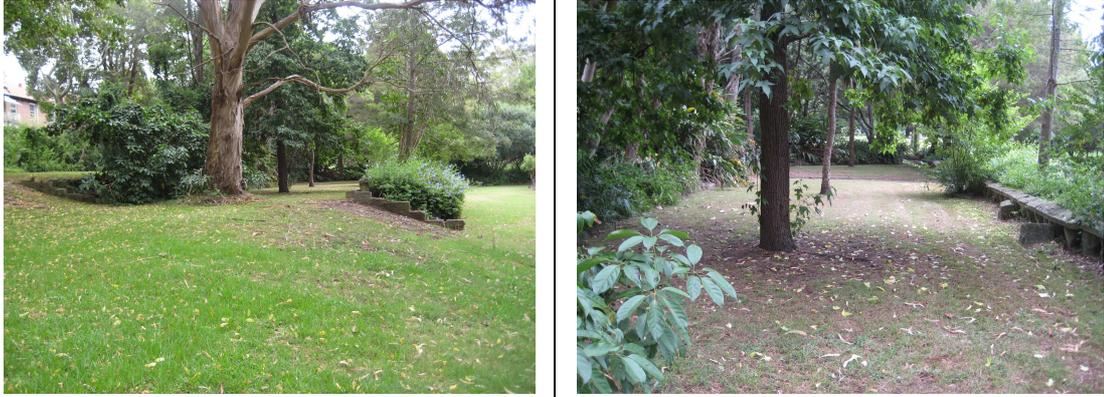
ITEM: LOCATION:	1M FORMAL GARDEN GRID: L7 ZONE: 2
DESCRIPTION: Lawn and garden terraces edged in stone, symmetrically laid out about a central path and stairs.

CONDITION:	Remaining area is substantially intact.
HISTORY:	Remaining portion of much larger garden possibly with tennis court built for the use of nurses in the 1930s and expanded up until the 1950s – 1960s buildings reduced it to current size.
REFERENCES:	1991 DPWS Heritage Study. 1952 aerial photo, 1930 aerial photo.
SIGNIFICANCE:	Some significance as a 1930-1950 formal garden built in relation to the nurses home and still used by nurses, however, its integrity is diminished by the imposition of later buildings. Minor intrusion on the Victorian picturesque gardens.
GUIDELINES:	Maintain as a discreet precinct within the Victorian picturesque gardens. If future development removes the earlier 1930s nurses' home or dramatically alters the use of the building, the integrity of the significance may alter. Photographically record the gardens prior to removal or alteration.
