ZONE 7 – BROUGHTON HALL		
<p>ITEM No. B199</p> <p>ORIGINAL NAME: Mortuary, Chapel, Building 22</p> <p>CURRENT USE: Disused</p>	<p>CONSTRUCTION DATE: c. 1927</p> <p>ARCHITECT / BUILDER: Unknown</p>	<p>HERITAGE LISTINGS:</p> <p><input type="checkbox"/> National Estate</p> <p><input checked="" type="checkbox"/> S170 List</p> <p><input type="checkbox"/> National Trust</p> <p><input type="checkbox"/> Leichhardt LEP</p> <p><input type="checkbox"/> State Heritage Register</p>
<p>BUILDING:</p> <p>LOCATION:</p>	<p>B199 BROUGHTON HALL CHAPEL</p> <p>GRID: D7 ZONE: 7</p>	
<p>DESCRIPTION:</p> <p>Small brick and tile building with windows boarded up on the east façade and bricked in on the north façade (also door). Verandah on east side.</p>

LANDSCAPE ELEMENTS

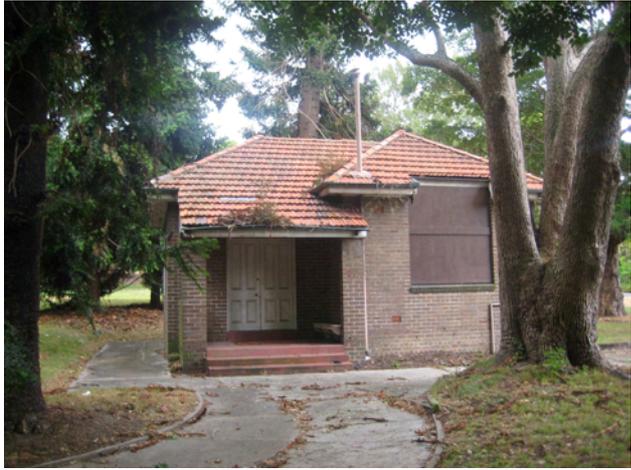
<p>CONDITION:</p>	<p>Poor. Roof is deteriorating.</p>	
<p>HISTORY:</p>	<p>Built c. 1927, altered 1960.</p>	
<p>REFERENCES:</p>	<p>Leong (57), MH1/159</p>	
<p>SIGNIFICANCE:</p>	<p>Low. Minimal heritage significance.</p>

<p>GUIDELINES:</p>	<p>Retain, recycle or remove as practicable. If replaced have regard to garden setting and record prior to demolition. Normal maintenance required.</p>

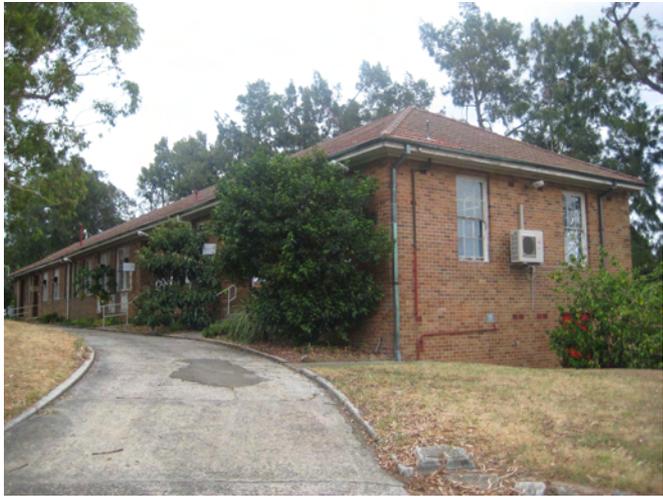
ZONE 7 – BROUGHTON HALL		
<p>ITEM No. B501</p> <p>ORIGINAL NAME: Former Occupational Therapy Unit, Building 23 patient accommodation.</p> <p>CURRENT USE: Aftercare, Rotary Ranfurly Library Service.</p>	<p>CONSTRUCTION DATE: c. 1952-53</p> <p>ARCHITECT / BUILDER: Unknown</p>	<p>HERITAGE LISTINGS:</p> <p><input type="checkbox"/> National Estate</p> <p><input type="checkbox"/> S170 List</p> <p><input type="checkbox"/> National Trust</p> <p><input type="checkbox"/> Leichhardt LEP</p> <p><input type="checkbox"/> State Heritage Register</p>
<p>BUILDING:</p> <p>LOCATION:</p>	<p>B501 RIVERSIDE / SEWING ROOM</p> <p>GRID: C-D6 ZONE: 7</p>	
<p>DESCRIPTION:</p> <p>Long rectangular brick and tile institutional building with timber multi-paned windows. Lower level with windows to the north only.</p>

<p>CONDITION:</p>	<p>Good. Maintenance required, especially roof and gutters where they are rusted and blocked.</p>

<p>HISTORY:</p>	<p>Built c. 1952-53.</p>	
<p>REFERENCES:</p>	<p>Leong (59) MH1/30 JTCW</p>	
<p>SIGNIFICANCE:</p>	<p>Neutral. Defines boundary of Broughton Hall Grounds.</p>	
<p>GUIDELINES:</p>	<p>Retain, recycle, replace or remove as practicable. If replaced have regard to garden setting and record prior to demolition.</p>

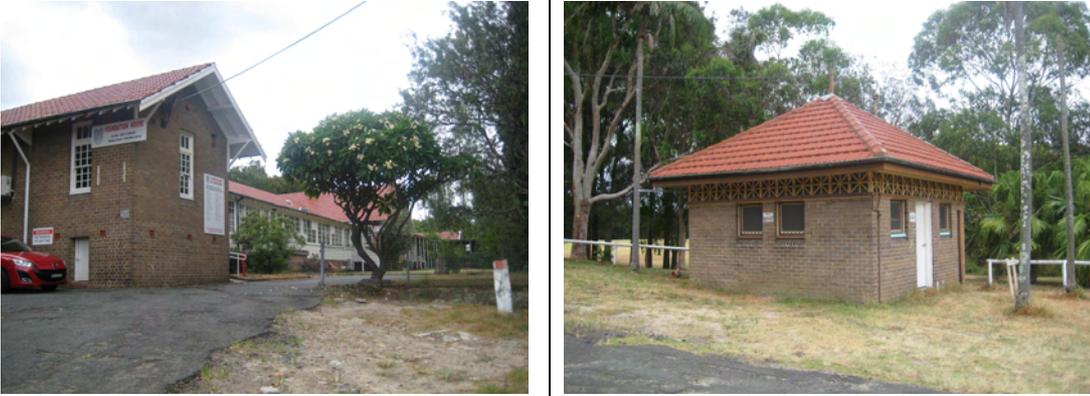
ZONE 7 – BROUGHTON HALL		
<p>ITEM Nos. B502, B502A and B503</p> <p>ORIGINAL NAME: Ward C, No. 3 Dormitory Ward, patient accommodation, Buildings 24, 24A and 24B</p> <p>CURRENT USE: B502 Intensive Psychiatric Unit, B503 Disused.</p>	<p>CONSTRUCTION DATE: 1920s</p> <p>ARCHITECT / BUILDER: Not identified.</p>	<p>HERITAGE LISTINGS:</p> <p><input type="checkbox"/> National Estate</p> <p><input checked="" type="checkbox"/> S170 List (24)</p> <p><input type="checkbox"/> National Trust</p> <p><input type="checkbox"/> Leichhardt LEP</p> <p><input type="checkbox"/> State Heritage Register</p>
<p>BUILDING:</p>	<p>B502 FOUNDATION HOUSE, B502A AMENITIES/STORE, B503 WC</p>	
<p>LOCATION:</p>	<p>GRID: D6 ZONE: 7</p>	
<p>DESCRIPTION:</p> <p>B502: (Pictured left) Long single storey brick building with tiled roof, gable ends, rafter exposed in eaves. Originally (almost) identical to Ward B (B497).</p> <p>B502A: Small, single storey rendered masonry shed with corrugated asbestos roof.</p> <p>B503: (Pictured right) Small, single storey brick masonry storage building, reminiscent of the Romanesque style. Timber lattice work decorates the continuous openings below the line of the terracotta tiled roof.</p>

<p>CONDITION:</p>	<p>Good, maintenance required especially gutters and downpipes.</p>	
<p>HISTORY:</p>	<p>Built between 1920 and 1930 (drawings dated 1918). Toilet blocks altered later and verandahs enclosed with fibre cement cladding.</p>	
<p>REFERENCES:</p>	<p>Leong (58) JTCW, aerial photo 1931</p>	
<p>SIGNIFICANCE:</p>	<p>Low. Associated with post WW1 development of repatriation hospital.</p>	
<p>GUIDELINES:</p>	<p>Retain, recycle, replace or remove as practicable. If retained conserve according to Burra Charter principles. If removed record prior to demolition.</p>

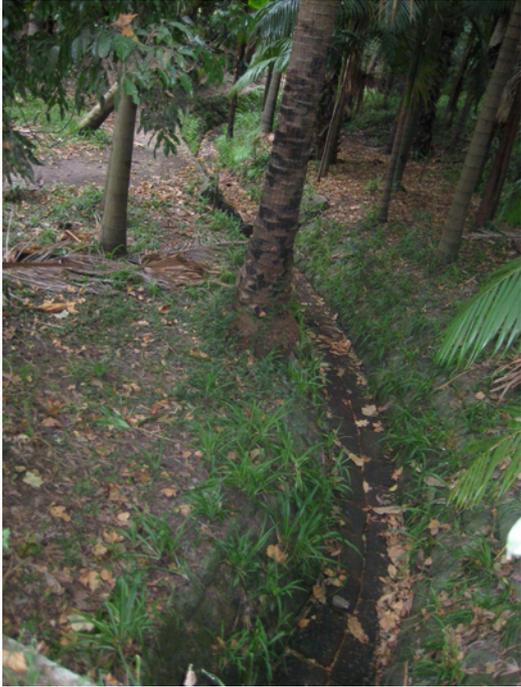
ZONE 7 – BROUGHTON HALL	
ITEM No. 11C ORIGINAL NAME: CURRENT USE:	CONSTRUCTION DATE: ARCHITECT / BUILDER:
HERITAGE LISTINGS: <input type="checkbox"/> National Estate <input checked="" type="checkbox"/> S170 List <input type="checkbox"/> National Trust <input type="checkbox"/> Leichhardt LEP <input type="checkbox"/> State Heritage Register	
ITEM: LOCATION:	11C STONE LINED CREEK GRID: D7-8 ZONE: 7
DESCRIPTION: Creek lined with battered sandstone block walls.

CONDITION:	Intact.
HISTORY:	Believed formed in mid to late 1800s.
REFERENCES:	1991 DPWS Heritage Study.
SIGNIFICANCE:	Significant as represents natural spring fed watercourse and as an element of early garden design.
GUIDELINES:	Preserve. Conserve according to Burra Charter principles.

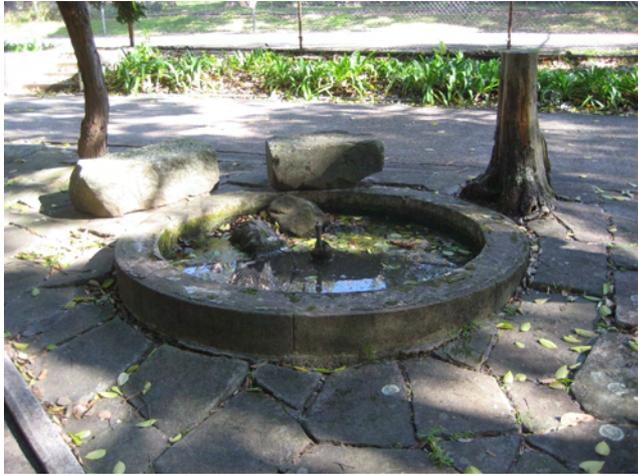
ZONE 7 – BROUGHTON HALL	
<p>ITEM No. 11E</p> <p>ORIGINAL NAME: Circular Stone Pond</p> <p>CURRENT USE: Disused</p>	<p>CONSTRUCTION DATE: Late nineteenth century</p> <p>ARCHITECT / BUILDER: Unknown</p> <p>HERITAGE LISTINGS:</p> <p><input type="checkbox"/> National Estate</p> <p><input checked="" type="checkbox"/> S170 List</p> <p><input type="checkbox"/> National Trust</p> <p><input type="checkbox"/> Leichhardt LEP</p> <p><input type="checkbox"/> State Heritage Register</p>
<p>ITEM:</p> <p>LOCATION:</p>	<p>11E CIRCULAR STONE POND</p> <p>GRID: D8 ZONE: 7</p>
<p>DESCRIPTION:</p> <p>Small circular pond built of individually shaped stone blocks. Formerly about two courses high, now one course high above pavement level. Single central water spout.</p>

<p>CONDITION:</p>	<p>Fair only. Appears to have had top course of stone removed.</p>
<p>HISTORY:</p>	<p>Believed to have been constructed in mid to late nineteenth century as part of the original Estate garden.</p>

<p>REFERENCES:</p>	<p>1991 DPWS Heritage Study; Powell.</p>
<p>SIGNIFICANCE:</p>	<p>Significant as a garden element from the early estate garden. Has the potential to be a fine example of its kind.</p>
<p>GUIDELINES:</p>	<p>Preserve. Restore missing stone. Where practicable upgrade existing surrounds to form a sympathetic context for the original character of the pond.</p>

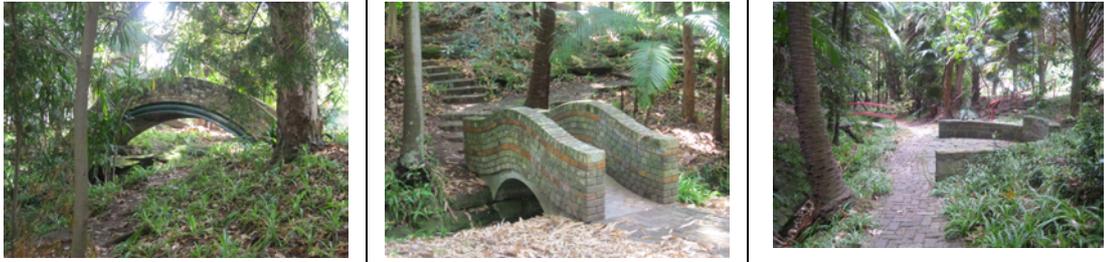
ITEM:	11F BRIDGES, PATHS AND PAVED AREAS IN GULLY	
LOCATION:	GRID: D7-8 ZONE: 7	
DESCRIPTION:		
<p>One large semicircular arch of brick and concrete over a side stream and one small decoratively shaped and patterned brick bridge, gently curved both over the main channel. Paths of compacted earth with series of winding narrow brick paths all informally laid out. (Bricks may be from demolition of Kalouan 1932). Several paved seating and viewing areas in brick and stone overlook the creek.</p>

CONDITION:	Intact.	
HISTORY:	Bridges, paths and seating bays probably added in 1920s and 1930s by Dr. Evan Jones as therapeutic walks.	
REFERENCES:	Powell. 1991 DPWS Heritage Study.	
SIGNIFICANCE:	Significant as a layout overlaid on earlier domestic gardens representing the change to institutional use and reflecting the 1920s interpretation of the principle that quiet gardens and walks were an aid in mental care.

GUIDELINES:	Preserve. Restore items as necessary. Carry out conservation plan of area to assess area in detail. New paving should match existing or be in keeping with it – i.e. brick or sandstone.

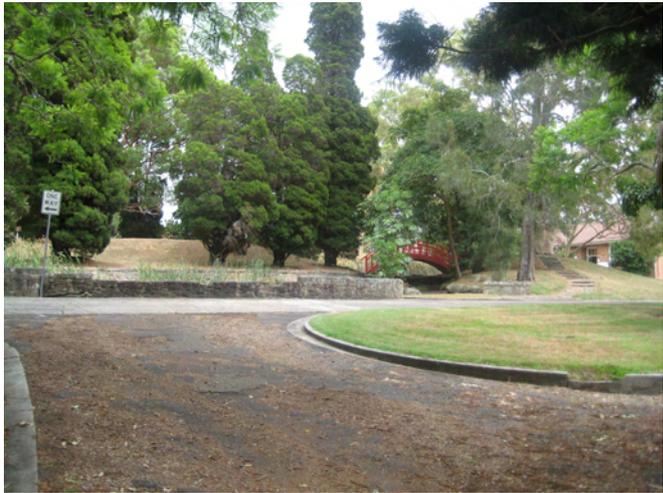
ZONE 7 – BROUGHTON HALL	
ITEM No. 11G ORIGINAL NAME: CURRENT USE:	CONSTRUCTION DATE: ARCHITECT / BUILDER:
HERITAGE LISTINGS: <input type="checkbox"/> National Estate <input checked="" type="checkbox"/> S170 List <input type="checkbox"/> National Trust <input type="checkbox"/> Leichhardt LEP <input type="checkbox"/> State Heritage Register	
ITEM: LOCATION:	11G ROAD NETWORK GRID: D7-9 ZONE: 7
DESCRIPTION: Kerbed and guttered bitumen access roads.

CONDITION:	Good to fair.
HISTORY:	Formed roads overlay what appear to be pathways in 1930 aerial photo.
REFERENCES:	1991 DPWS Heritage Study; Aerial photo.
SIGNIFICANCE:	Significant as an adaptation of earlier path network however the introduction of vehicles is intrusive on the significance of the gardens.
GUIDELINES:	Return to pedestrian use and resurface with suitable material, such as gravel.

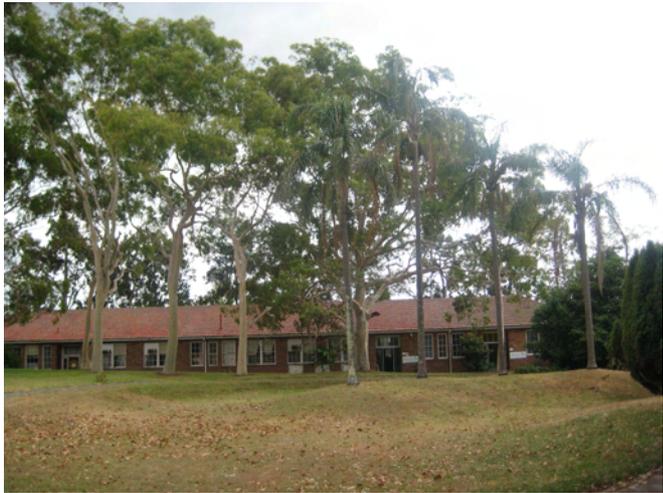
CONDITION:	Good	
HISTORY:	1980s plantings.	
REFERENCES:	1991 DPWS Heritage Study.	
SIGNIFICANCE:	Intrudes on significant character of Estate and clinic gardens.	
GUIDELINES:	Preferably remove. Future planting or development should reinforce significant character and fabric.

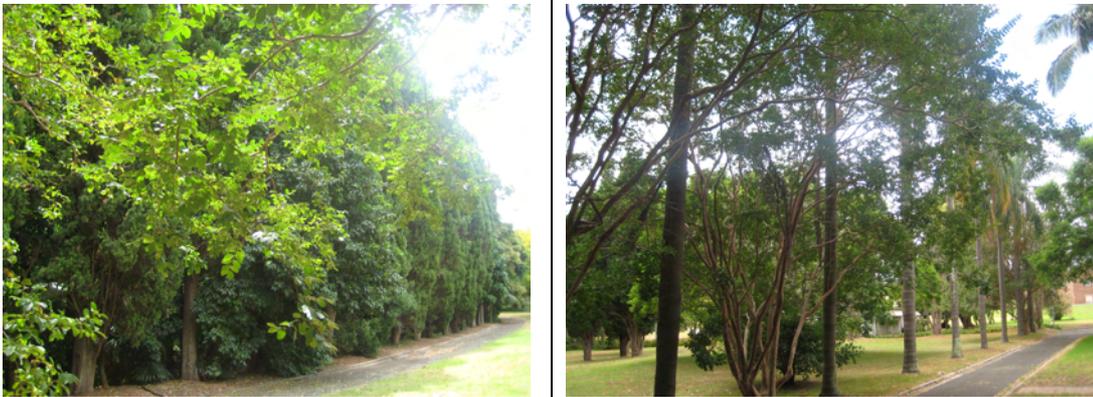
CONDITION:	Intact.
HISTORY:	Planted in the early 1900s. Mostly likely in association with the army (1915-1920) or early Clinic years (1920 onwards).
REFERENCES:	1991 DPWS Heritage Study; Powell plates 83 and 71.
SIGNIFICANCE:	Significant as representation of formal, early 1900s planting design which is a sympathetic development based on the earlier layout.

GUIDELINES:	Maintain tree rows and significant character of open lawn.

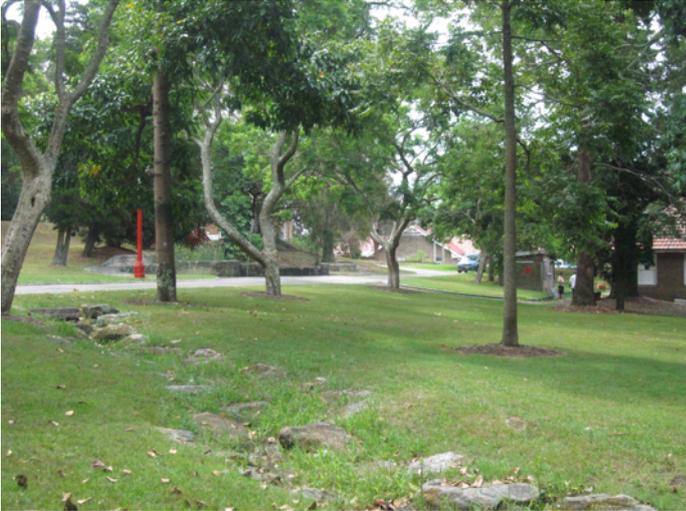
ITEM: LOCATION:	11J TREE GROUPS AND ROWS – 1930s GRID: D7 ZONE: 7	
DESCRIPTION: Row of Raphis Palms, Jacarandas, Illawarra Flame and Hoop Pine around a lawn area and a small rock edged stream.

CONDITION:	Good	
HISTORY:	Tree rows installed in 1930s overlaying original garden. Rainforest tree groups, some likely to be Estate plantings and others added in early Clinic years with additional rainforest species added in 1980s.	
REFERENCES:	1991 DPWS Heritage Study; Aerial photo 1930	
SIGNIFICANCE:	Significant as planting of early days of the clinic demonstrating early 1900s planting design – particularly the use of trees with bright flowers and the adaptation of older gardens to institutional use and concept of gardens are therapy. The stream is significant as a reflection of original water course and as a water theme used throughout the therapeutic gardens.	
GUIDELINES:	Maintain. Any future plantings should reflect significant character and fabric of layers of early Estate and Clinic gardens as separate layers of planting design.

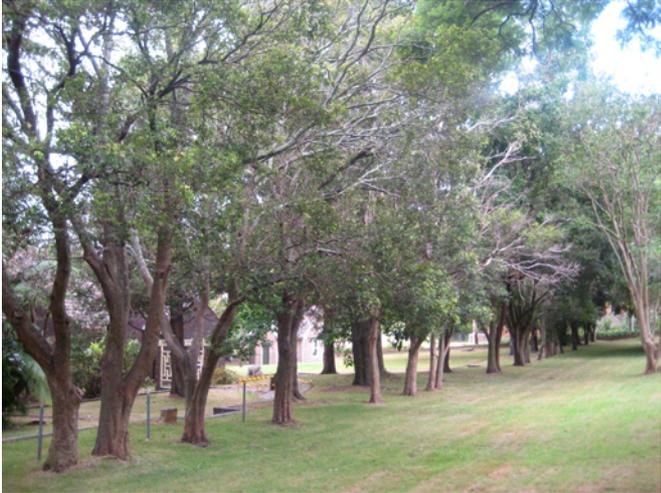
ITEM: LOCATION:	11L LILY PILLY ROW GRID: D8 ZONE: 7	
DESCRIPTION: Row of <i>Syzygium luehmannii</i> , Small Leaved Lilly pilly.

CONDITION:	Good	
HISTORY:	Assumed planted as part of 1930s garden development along edge of Estate garden however 1930s aerial photo shows shorter row of trees in this location and plantings of this species appear within 1890s plantings at Callan Park Asylum.	
REFERENCES:	Aerial photo 1930 – 1991 DPWS Heritage Study.	
SIGNIFICANCE:	Significant as a fine example of 1930s design element and major component of significant 1930s formal garden layout and sympathetic development of the earlier Estate garden.	
GUIDELINES:	Maintain. Incorporate into any future developments.

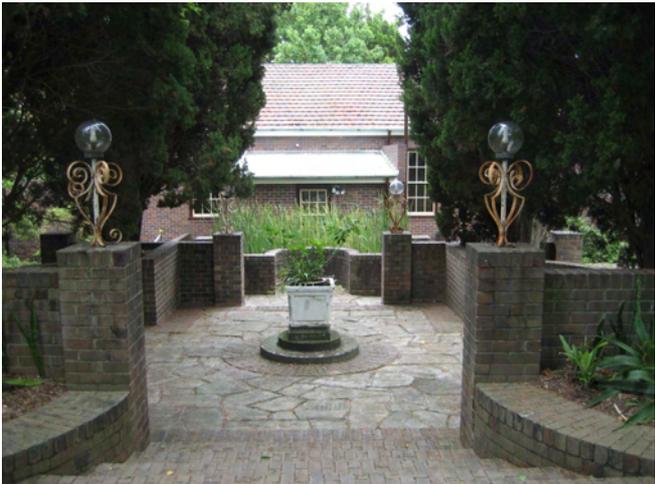
ITEM: LOCATION:	11M FORMAL STAIR, WALL & GARDEN GRID: D9 ZONE: 7	
DESCRIPTION: Entry walk from Broughton Hall to the recreation hall (B132) built on former Estate garden entry to formal oval lawn edged by garden. Intricate symmetric design of geometric shapes in pavements, low walls and stair focused on small pond formerly adorned with central urn carved Neptune like face (since removed). Low curved brick wall built on garden lawn edge of earlier Estate garden. Overgrown.

CONDITION:	Substantially intact.	
HISTORY:	Probably built in 1930s related to building of Recreation Hall (1933-35). Reflects the influence of Edna Walling's formal garden designs. Probably designed by Evan Jones – Clinic superintendent.	
REFERENCES:	1991 DPWS Heritage Study; Aerial photo 1930.	
SIGNIFICANCE:	Significant as representative example of 1930s garden design as a development of earlier Estate garden demonstrating the adaptation for institutional use and the concept of gardens and walks as therapy.

GUIDELINES:	Retain and conserve. Incorporate into future developments. Clean out pond, reinstate water and rationalize planting within it. Future development should maintain the integrity of the original estate lawn and garden areas and character as well as the 1930s overlay. Reconstruct or restore (if found) missing urn.

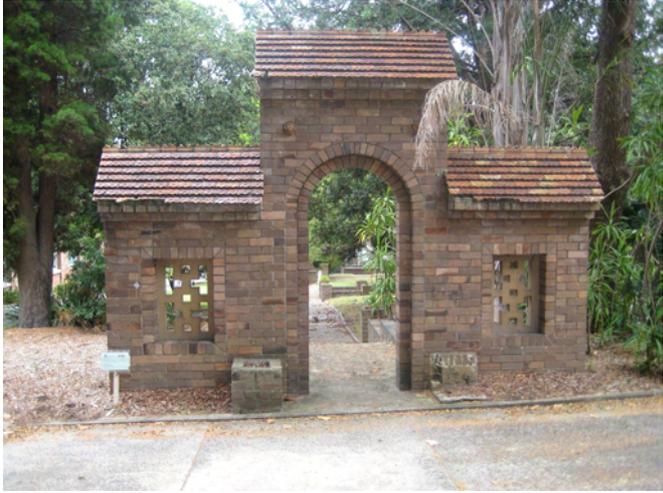
ITEM: LOCATION:	11N FORMAL WALK GRID: D8-9 ZONE: 7	
DESCRIPTION: Brick wall with pillars and planting urns on side access paths and with ornate brick arches at ends. The southern arch is oriental in character with a tile roof / coping. The brick walk is built over an earlier Estate garden path seen in 1930 aerial photo. Adjoining planting is likely to be a mix of Estate plantings and 1930s additions.

CONDITION:	Substantially intact. Tile roof is deteriorating with missing tiles at “eaves”.	
HISTORY:	Probably built in the 1930s. Reflects the influence of Edna Wallings’ formal garden designs. Probably designed by Evan Jones – Clinic superintendent.	
REFERENCES:	1991 DPWS Heritage Study; Aerial photo 1930.	
SIGNIFICANCE:	Significant as representative example of 1930s garden design and as a development of earlier estate garden demonstrating the adaptation for institutional use and the concept of gardens and walks as therapy. Intruded upon by Buildings B128 and B129.

GUIDELINES:	Preserve and maintain, incorporate into future developments. Reconstruct missing tiles. Future developments should maintain the integrity of the significant Estate garden and 1930s overlay and its relationship to the adjoining garden and lawn area.

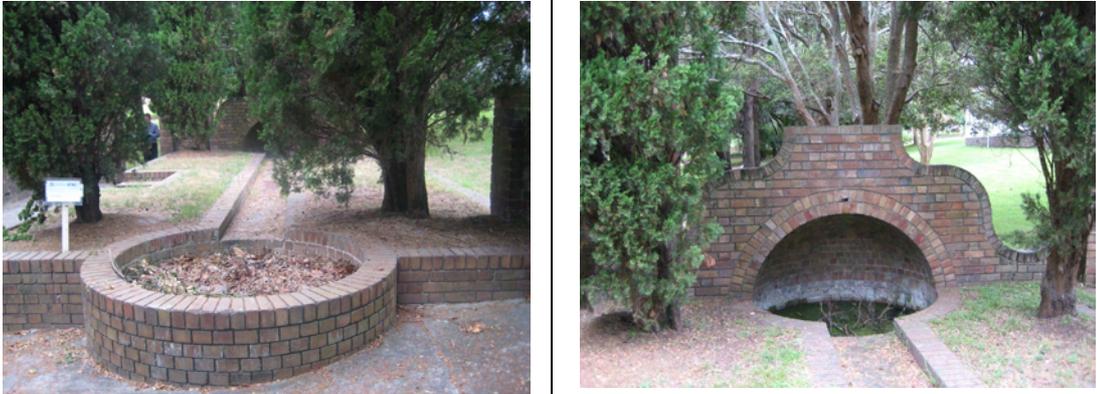
ITEM: LOCATION:	110 FORMAL POND GRID: D8 ZONE: 7	
DESCRIPTION: Symmetrical geometric pond and garden with end wall forming vault over circular pond with single spout – all in brick. End wall extends to form brick arch to residential garden.

CONDITION:	Intact	
HISTORY:	Probably built in 1930s. Pond design reflects the influence of Edna Walling's formal pond designed by Evan Jones – Clinic superintendent. Planting of Jacaranda and Illawarra Flame trees reflects fashion to introduce bold colour and feature trees.	
REFERENCES:	1991 DPWS Heritage Study; Aerial photo 1930.	
SIGNIFICANCE:	Significant as representative example of 1930s garden design and as the use of gardens and particularly water features as a therapeutic device. Intruded upon by Building B129.	
GUIDELINES:	Preserve and maintain planting. Future planting should reflect original design concept. Incorporate into future developments. Future development should maintain the integrity of the original 1930s design and its contextual relationship to the Lily-pilly row and formal walk.

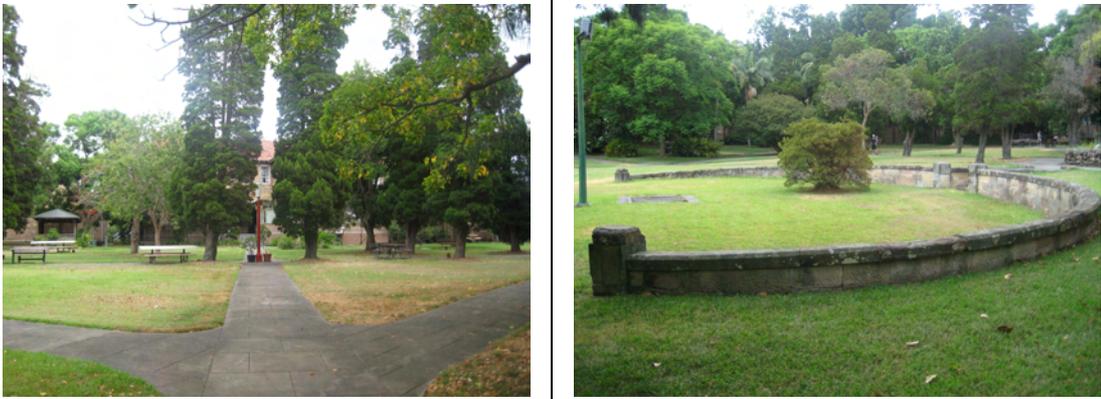
ITEM: LOCATION:	11P FORMAL GEOMETRIC GARDENS GRID: C8-9 ZONE: 7	
DESCRIPTION: <p>Geometric symmetrical path network set in lawn pivoted about a central section that formerly contained a circular pond (since removed) with formal central axis path studded with red painted light posts and cypress avenue. Stair and ½ elliptical low wall in lawn.</p>

CONDITION:	Intact	
HISTORY:	Diagonal paths established first in the 1920s linking Buildings B127, B121 and B193 to Broughton Hall. Formal axis and avenue trees and central pond and low wall and steps probably added in late 1930s when the naturalistic garden was built (1938). The path layout is a reflection of the building layout.	
REFERENCES:	1991 DPWS Heritage Study; Aerial photo 1930.	
SIGNIFICANCE:	Significant as representative example of 1920s / 1930s formal institutional garden and as one of 3 theme gardens designed by Evan Jones – Clinic Superintendent of therapeutic gardens.

GUIDELINES:	Maintain and preserve. Future development should maintain the context for and design integrity of this layout. Carry out investigation to identify original furniture and colour scheme and reinstate.

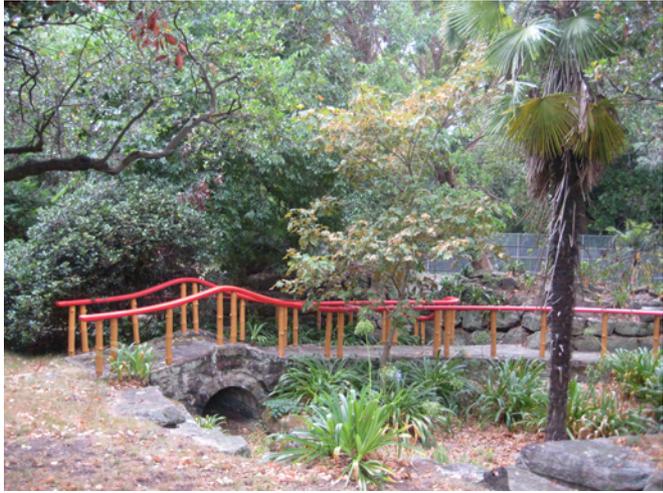
ITEM: LOCATION:	11Q NATURALISTIC GARDEN GRID: C-D 7-8 ZONE: 7	
DESCRIPTION: Naturalistic, gardens built as a series of bridges, pathways, gardens and secluded lawns edged in bush rock all focused on a small stream flowing over bedrock and designed around several Hoop Pines from the original Kalouan estate garden. The main bridge is a concrete construction formed and painted to resemble an oriental bamboo bridge. Planting includes both nature and exotic plants.

CONDITION:	Substantially intact – much of the stonework and bridges in need of maintenance.	
HISTORY:	Laid out in the late 1930s.	
REFERENCES:	1991 DPWS Heritage Study; Site investigations (path dated 1938)	
SIGNIFICANCE:	Significant as representative example of 1930s institutional theme garden and as one of 3 theme gardens designed by Evan Jones – Clinic superintendent of therapeutic gardens. Intruded upon by Building B129.	
GUIDELINES:	Maintain and preserve. Conserve 'bamboo' bridge. Maintain significant character of garden in any future development.

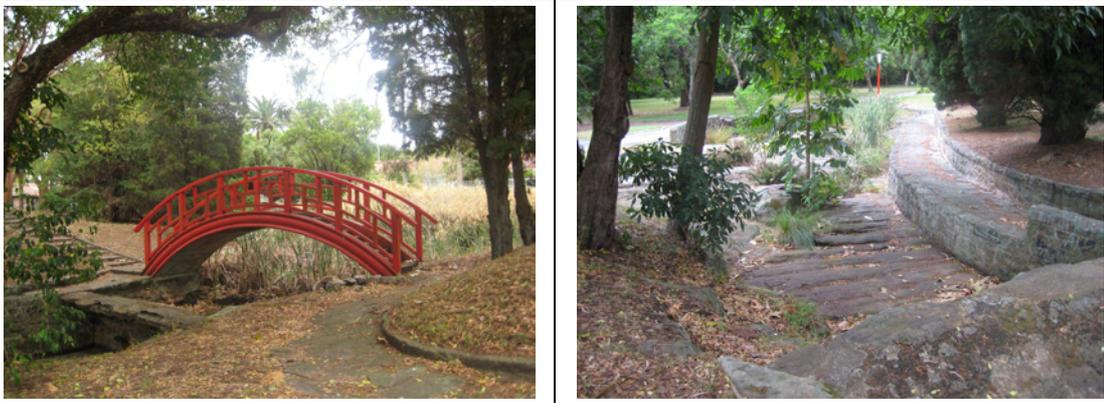
ITEM: LOCATION:	11R FORMAL CURVILINEAR GARDEN GRID: C7-D7 ZONE: 7	
DESCRIPTION:		
<p>A bold garden design with arc shaped earth moulds and depressions, curvilinear path network of sandstone in crazy paving pattern and curvilinear tree rows. An informal pond and ornate red painted Chinese bridge. Tree rows include Spotted Gum, Native Cypress, Lombardy poplar and palms.</p>

CONDITION:	Intact. Some paths in need of repair.	
HISTORY:	Probably built in 1930s in relation to construction of Building B195.	
REFERENCES:	1991 DPWS Heritage Study.	
SIGNIFICANCE:	Significant as a representative example of 1930s institutional theme garden and as one of 3 theme gardens as therapeutic gardens by Evan Jones, superintendent of the Clinic.	
GUIDELINES:	Maintain and repair paths. Whilst designed in combination with building 20 the integrity of the main body of the garden can be preserved even if the direct access paths to the building are removed.

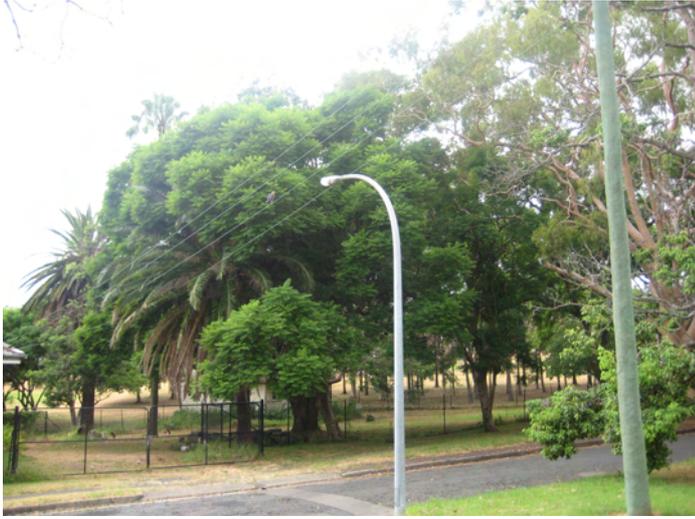
ITEM: LOCATION:	11S MIXED TREE GROUP GRID: E7 ZONE: 7	
DESCRIPTION: Species include: Camphor Laurel, Brush Box, Jacaranda, Box Elder, Illawarra Flame, Peppercorn, Lemon Scented Gum, Pink Ironbark and Willow, Canary Island Palm.

CONDITION:	Good to fair.	
HISTORY:	Tree rows along Wharf Road planted in late 1930s to 1940s with additional tree groups planted in the 1960s or 1970s.	
REFERENCES:	1991 DPWS Heritage Study.	
SIGNIFICANCE:	No evidence of heritage significance however the trees are a sympathetic and protective addition to the Estate and Clinic gardens.	
GUIDELINES:	Maintain.

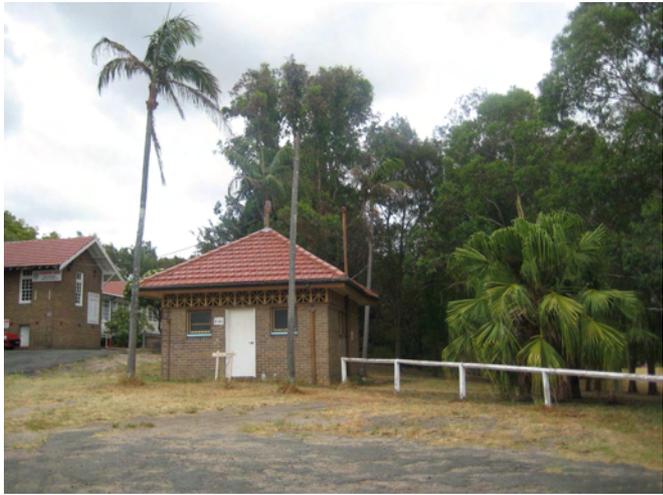
ITEM: LOCATION:	71 PALM GROUP GRID: ZONE: 7
DESCRIPTION: Group of Bangalow palms located around amenities block.

CONDITION:	Fair to poor. One tree has apparently died.
HISTORY:	Planted between 1918 and 1930s as part of extensive formal gardens to Building B502.
REFERENCES:	1991 DPWS Heritage Study; Aerial photos 1930 and 1952. Powell.
SIGNIFICANCE:	No evidence of heritage significance as integrity of original design has been lost. However the palms are sympathetic with significant fabric in adjoining Broughton Hall gardens.
GUIDELINES:	Replace dead tree. Incorporate into new development or transplant into Broughton Hall gardens or area of similar significance.

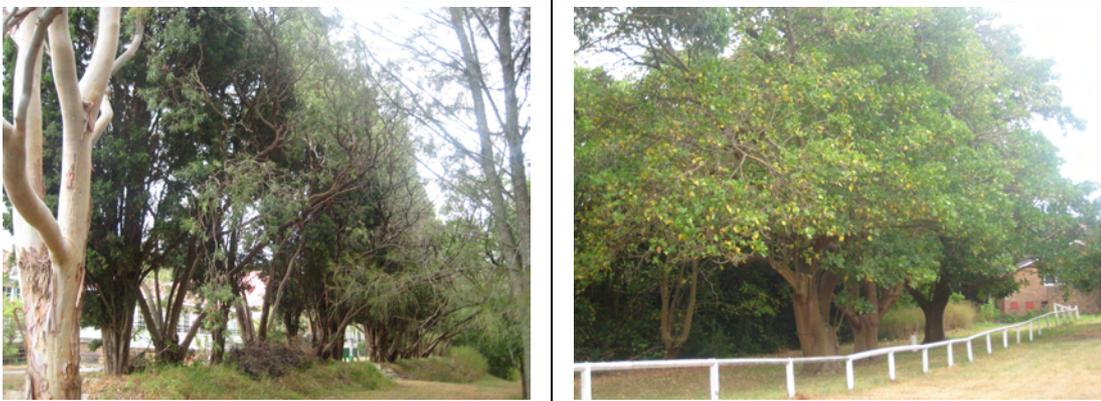
ITEM: LOCATION:	7J TREE ROWS GRID: C6-D6 ZONE: 7	
DESCRIPTION: Row of conifers in front of Building B502 and recent native tree plantings and row of Coral Trees and rows of Lombardy Poplars.

CONDITION:	Good to fair.	
HISTORY:	Remnants of extensive formal garden to Building B502 destroyed by 1970s landfill.	
REFERENCES:	1991 DPWS Heritage Study; Aerial photo 1952	
SIGNIFICANCE:	No evidence of heritage significance. Tree rows intrude on significant character of Broughton Hall gardens.	
GUIDELINES:	Over time replace with planting sympathetic to adjoining significant fabric in Broughton Hall. Coral trees may be integrated into new development where appropriate.
