## 4.0 Heritage Significance

### 4.3 Statement of Significance

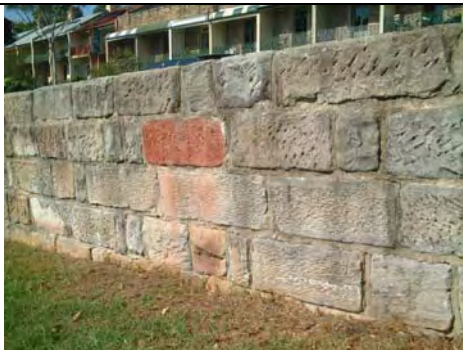
<p>HI 1</p>	<p>Sandstone block retaining wall between Grove St. and the park. Likely to have been built in conjunction with the development of the lower portion of Grove Road. Appears in its current form in photographs from the 1900s and 1910s and may date from as early as the 1860s after the subdivision of the Balmain land grant commenced.</p>	<p><b>Rating: 4</b></p> <p><b>Role:</b> An important retaining wall supporting Grove St. and defining the southern boundary of the Park. Its large, sparrow-picked blocks were probably quarried on the peninsula.</p>

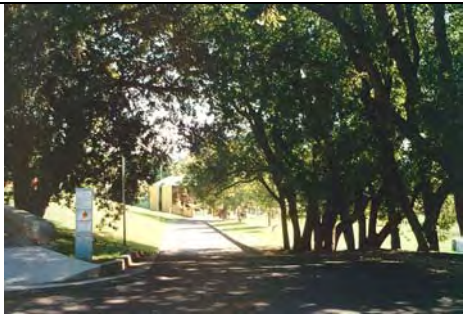
<p>HI 2</p>	<p>The Terrace roadway was laid out in the first subdivision in 1860. It has retained its same form ever since.</p>	<p><b>Rating: 4</b></p> <p><b>Role:</b> This access roadway from Grove St. to the upper (western) sector of the Park was the first access through the Park site prior to any reclamation works.</p>

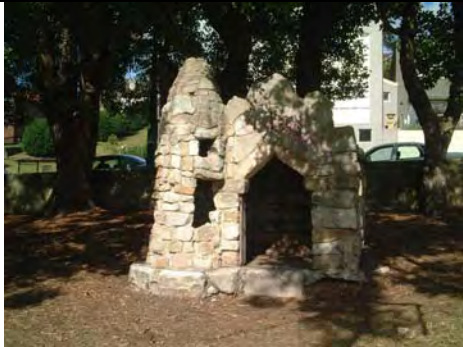
<p>HI 3</p>	<p>Children's sandstone playhouse.</p> <p>This rustic item sits in the lower, eastern end of the southern side of the Park, but its provenance is yet to be ascertained.</p>	<p><b>Rating: 2</b></p> <p><b>Role:</b> This bit of whimsy makes no contribution to the role of the Park as a sports and recreation ground, but a small contribution to its role as a playground for children.</p>

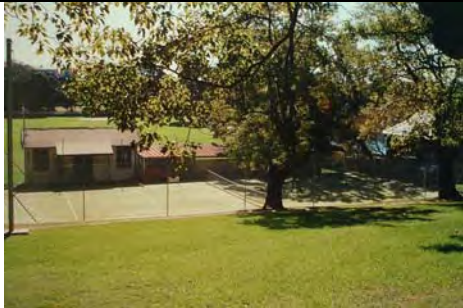
<p>HI 4</p>	<p>Tennis court and pavilion in the south-eastern sector were constructed c.1910, reputedly for nearby St. John's Church. The court was originally a hard-court, since resurfaced with artificial grass. It is not known what remedial works have been carried out on the original pavilion.</p>	<p><b>Rating: 3</b></p> <p><b>Role:</b> This court was not part of the original design of the Park as a sports ground but a response to pressure from a local group for the provision of a facility for their use. It is known as the Parkview Tennis Club. As that use has continued for nearly a century, it has social significance.</p>

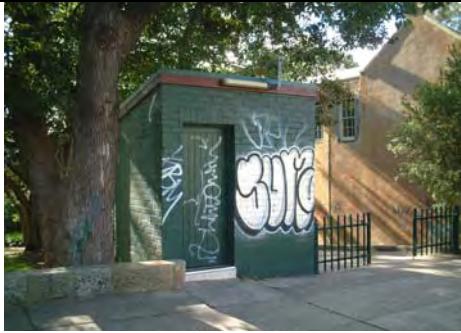
<p>HI 5</p>	<p>Bus drivers' rest room, on the corner of Grove Street and Deloitte Avenue.</p>	<p><b>Rating: 1</b></p> <p><b>Role:</b> This convenience has no role vis-à-vis the Park but only for drivers at the terminus of the Balmain bus route. It does, however, 'anchor' the south-east corner of the Park.</p>

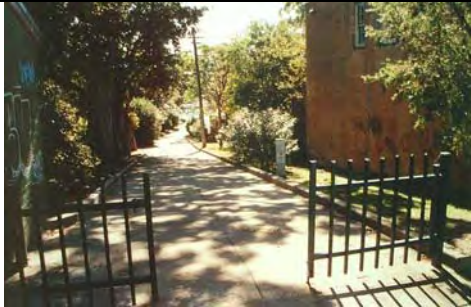
<p>HI 6</p>	<p>Deloitte Avenue, seen from its southern end. It was built after the c.1904 completion of the reclamation works and boundary seawall for the park to provide a harbourside accessway from Grove St. to Louisa Road. Because of rock benches at the northern end, the Avenue does not join Louisa Road as a road, only via a staircase.</p>	<p><b>Rating: 3</b></p> <p><b>Role:</b> Such an access road was not proposed in the 19<sup>th</sup> century subdivision plans, but has remained in place since c. 1904. It helps define the Park's eastern boundary and provides a pleasant esplanade along the waterfront for pedestrians to enjoy views to the city.</p>

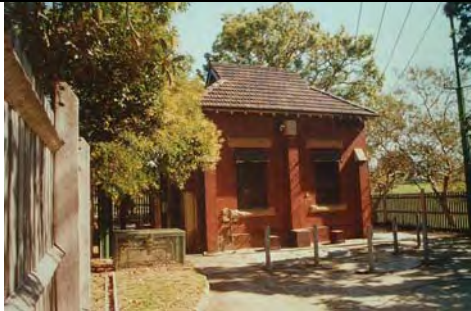
<p>HI 7</p>	<p>Sydney Water's sewerage pumping station adjoining Deloitte Avenue, built in the south-east corner of the Park during the mid 1910s as a matter of convenience. It is fenced off and does not contribute visually to the Park, nor is it an amenity to it.</p>	<p><b>Rating: 2</b></p> <p><b>Role:</b> Although this facility is located on the edge of the Park, it serves a wider role for the suburb beyond. It makes no heritage contribution to the Park..</p>

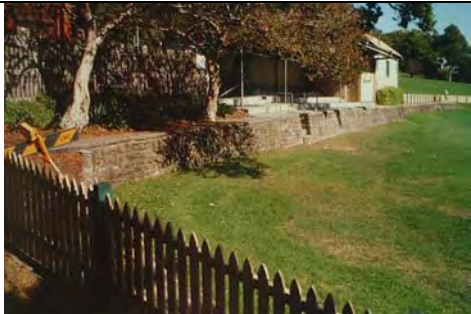
<p>HI 8</p>	<p>Sandstone block wall along the southern side of the oval past the tennis pavilion to the southern lawns. The date of construction of this wall is not certain, but it is likely to have been built concurrently with the reclamation works, c. late 1890s – early 1900s.</p>	<p><b>Rating: 3</b></p> <p><b>Role:</b> This eastern end of the retaining wall was not part of the original sea wall built around the northern edge of Snails Bay for the <i>Birch Grove</i> estate. It was built to define and contain the southern boundary of the oval from the slope behind it.</p>

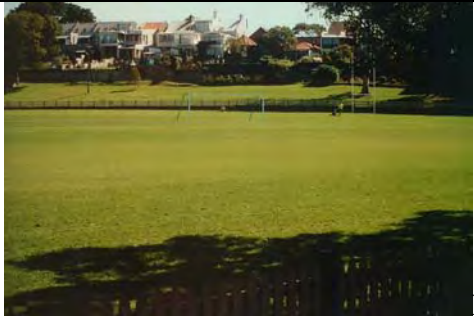
<p>HI 9</p>	<p>The oval, formed as a result of the reclamation works to Snails Bay, undertaken from the mid 1880s until 1904.</p>	<p><b>Rating: 4</b></p> <p><b>Role:</b> The oval itself is the core area of the Park deliberately created for active recreation sports, especially cricket. Only the rear of it formed part of the original land grant to George Whitfield, later known as the <i>Birch Grove Estate</i>.</p>

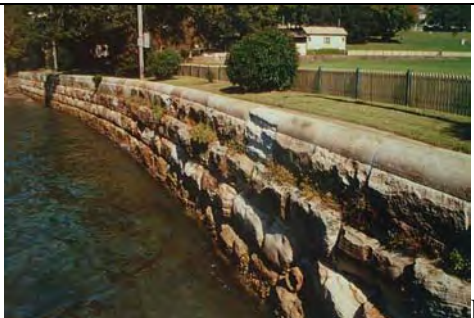
<p>HI 10</p>	<p>The seawall, completed c.1904, was not the original wall built to contain the imported fill for the reclamation works. The original wall was a rough dyke wall and was probably built just inward of the current block wall.</p>	<p><b>Rating: 4</b></p> <p><b>Role:</b> This wall formally marks the eastern edge of the Park precinct, separating it from the waters of the Bay. It was built with care, has been well maintained, and has some aesthetic merit.</p>

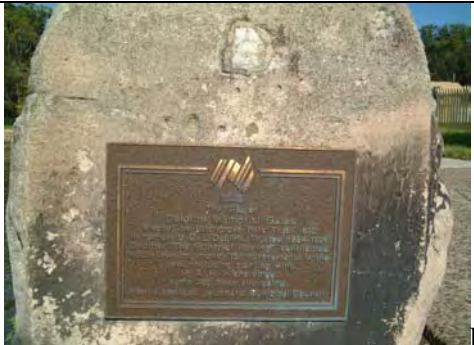
<p>HI 11</p>	<p>The commemorative plaque for the Deloitte gates, named in honour of the widely admired local sportsman Q.L. Deloitte. The gates were built in 1930, but their material and exact structure has not yet been ascertained. They were removed early in WWII and melted down as part of the war effort.</p>	<p><b>Rating: 2</b></p> <p><b>Role:</b> These gates once served to control entry into the Park through the boundary picket fence along Deloitte Ave. Such a role lasted only for a decade. They were not replaced.</p>

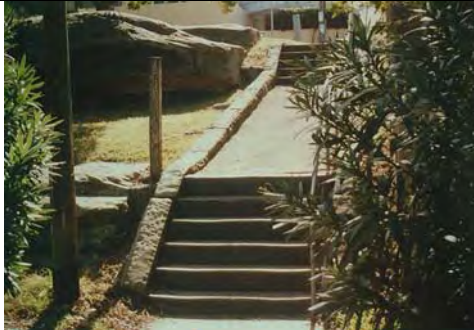
<p>HI 12</p>	<p>Old staircase connecting Louisa Road (at top of image) down to Deloitte Ave. and the Bay.</p> <p>The actual date of its construction is not yet known. The stringers of the staircase may be older than the steps, which appear to have been recast using the concrete mix typical of the late 1920s-30s.</p>	<p><b>Rating: 3</b></p> <p><b>Role:</b> These stairs mark the eastern limit of the Park on its northern side, and provide the only pedestrian access to the Bay from Louisa Road. They are not associated with <i>Birch Grove House</i> and are likely to have been built in the first decade of the 20<sup>th</sup> century when the sea wall and Deloitte Avenue were constructed.</p>

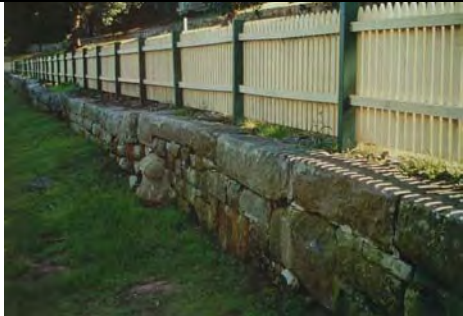
<p>HI 13</p>	<p>Sandstone rubble and block retaining wall on the northern side of the oval. This wall was the first sea wall built in Snails Bay, during the mid to late 1800s, presumably by one of the owners of <i>Birch Grove House</i>.</p>	<p><b>Rating: 4</b></p> <p><b>Role:</b> This wall would have retained the lowest terrace of the footslope below the ridge on which <i>Birch Grove House</i> was built, and separated it from the tides and mudflats of the original Bay.</p>

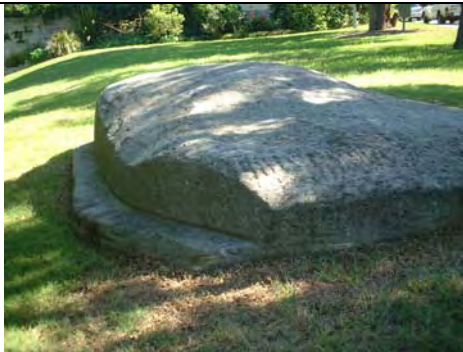
<p>HI14</p>	<p>Sandstone outcrop, just below Louisa Road, has a bench seat cut into its southern face. This cut may have been made during the first decades after the establishment of <i>Birch Grove House</i>, although no documentary evidence has yet been found to confirm this</p>	<p><b>Rating: 2</b></p> <p><b>Role:</b> This item, although indicative of the underlying rock benches that constitute the slope between the ridge and the original embayment, has a little natural and social interest, but makes no contribution to the Park's heritage values.</p>

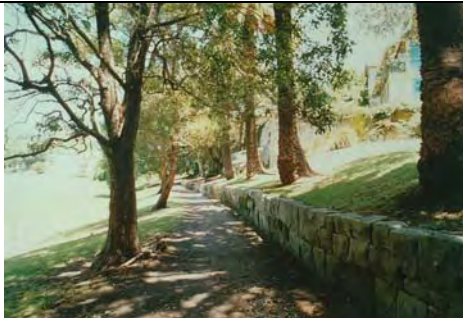
<p>HI 15</p>	<p>Sandstone block retaining wall along the northern pathway from Louisa Road around oval. The date of construction of this wall is unknown, but the flight of steps cut into it further to the west suggests that at least part of the wall may date from the mid to late 1800s. Note the Phoenix Palms at right.</p>	<p><b>Rating: 3</b></p> <p><b>Role:</b> This wall retains the midslope between the ridge of Louisa Rd. and the sports ground below, enabling an easy gradient pathway to be built from Louisa Rd. past the base of <i>Birch Grove House</i> grounds to link up with the northern arm of The Terrace to the west.</p>

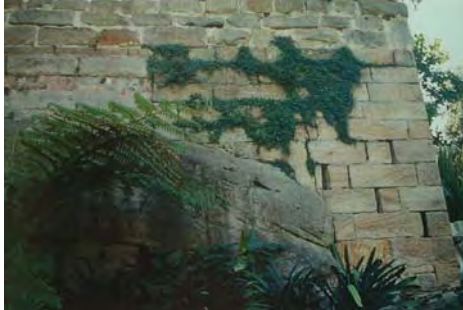
<p>HI 16</p>	<p>Sandstone block retaining wall on the north-east boundary of the park supporting a property along Louisa Road.</p> <p>It is not known exactly when this wall was constructed, but it was in place in the 1890s. It may have been built to create a platform for <i>Birch Grove House</i>, but could have been built for allotments created by the subdivision of 1878 or later.</p>	<p><b>Rating: 3</b></p> <p><b>Role:</b> This retaining wall supports the grounds of a house built on a lot east of <i>Birch Grove House</i> following the subdivisions of the rump of that estate in the early 20th century. It forms a clear edge to the Park &amp; demonstrates how such walls were grafted onto the rock benches between the ridge and the mudflats.</p>

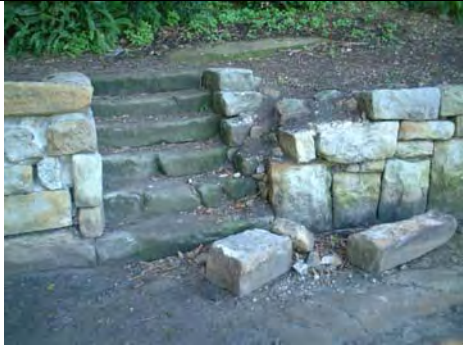
<p>HI 17</p>	<p>Sandstone block steps from the northern pathway around the oval past the base of the sandstone outcrops below the Louisa Road properties and on to Louisa Road itself.</p> <p>As is evident, early but skilled repairs are needed.</p>	<p><b>Rating: 4</b></p> <p><b>Role:</b> These stairs may have provided the first formal pedestrian access from <i>Birch Grove House</i> grounds to its seawall and Snails Bay during the 1800s.</p>

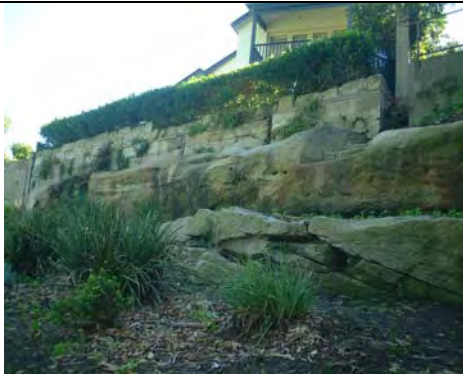
<p>HI 18</p>	<p>Another example of the way in which sandstone blocks were added to the existing natural rock benches in order to create level platforms for dwellings.</p> <p>The quality of the stonework varies and <i>ad hoc</i> repairs have been made, but it is likely these walls were built in the last decade of the 19<sup>th</sup> century or early in the 20<sup>th</sup> century</p>	<p><b>Rating: 3</b></p> <p><b>Role:</b> These retaining walls support the grounds of properties built on the south side of Louisa Road. They are not shown on Water Board maps of the 1880s, so may not be associated with <i>Birch Grove House</i>.</p>

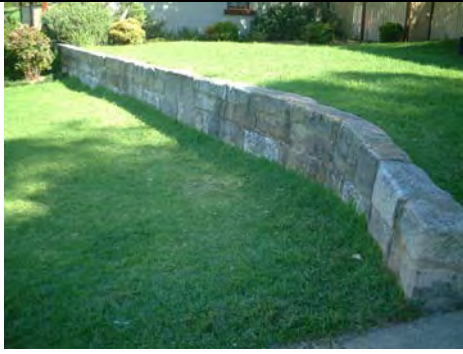
<p>HI 19</p>	<p>Sandstone wall north of the caretaker's cottage (originally called <i>Bay View House</i>), likely to have been built concurrently with that residence. According to a Sydney Water plan of 1888), a 'rough stone wall' in this location originally extended further to the north. It appears from the condition of this wall that it has been rebuilt in recent times.</p>	<p><b>Rating: 3</b></p> <p><b>Role:</b> A small retaining wall that provides a level terrace along part of the western slope of the Park, below the 1970s toilet block. Its predecessor may have been the rough sea wall separating the footslope from the mud-flats of the Bay, as the high water mark was closeby.</p>

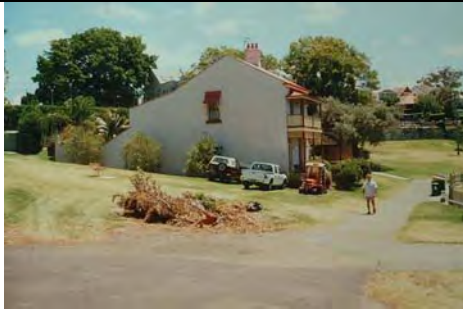
<p>HI 20</p>	<p>The caretaker's house, built originally for Mr. David Muir, in the early 1880s and known as <i>Bay View House</i>.</p> <p>This was the only house built along the northern arm of The Terrace after the 1878 subdivision.</p>	<p><b>Rating: 3</b></p> <p><b>Role:</b> The terrace house configuration reflects the narrow block pattern of the original subdivision and the row-house style of building to suit that. Its availability for use as the caretaker's residence was fortuitous, not pre-planned.</p>

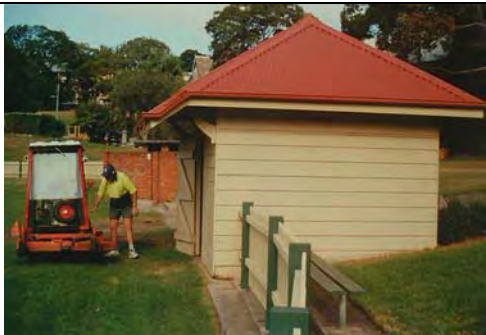
<p>HI 21</p>	<p>This small weatherboard maintenance shed has only been in this location since the late 1960s. It is not yet known if it was relocated from a position close to the junction of Ferdinand St. and The Terrace, where old plans indicate a similar WB structure was present earlier.</p>	<p><b>Rating:</b> 2-3</p> <p><b>Role:</b> This shed is a functional, contributory item of the Park and has a little heritage significance. Because its materials &amp; style suggest it may be an older structure (but relocated) it may warrant a 3 rating</p>

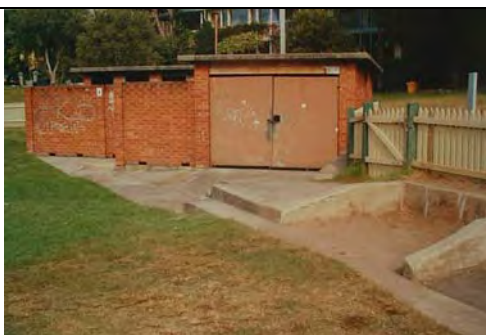
<p>HI 22</p>	<p>A service shed has existed in this corner for most of the 20<sup>th</sup> century, this red brick version having replaced an earlier weatherboard one. Unfortunately, its red brick colour and severely functional 'modernist' form are quite out of character with the rest of the Park structures, and its location at the most used entrance to the Park combine to make it visually intrusive.</p>	<p><b>Rating:</b> Intrusive</p> <p><b>Role:</b> Although the site and configuration of the landform behind it have long supported a service structure in this location, the actual buildings on it have changed. The present one has no heritage value. Its facilities should be moved to a less visually intrusive location, and in an architecturally more sympathetic building.</p>

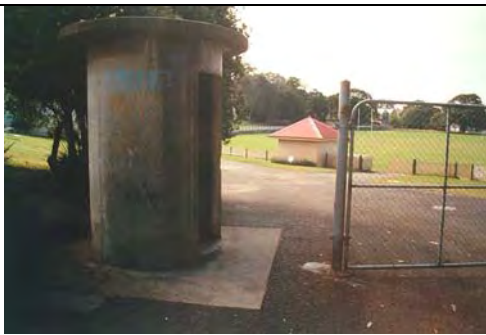
<p>HI 23</p>	<p>This old ticket collection booth beside the entrance gates at the junction of Ferdinand St and The Terrace is likely to date from the time when first grade cricket matches, and also rugby league matches, were held in the Park, for which admission was charged.</p>	<p><b>Rating:</b> 2</p> <p><b>Role:</b> Although of little intrinsic heritage value, this concrete ticket booth is a reminder of the days when major sporting matches drew large crowds to the Park. It thus has some social significance.</p>

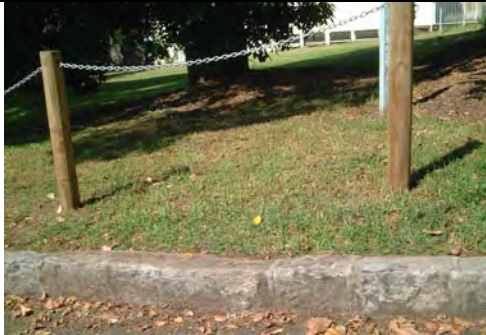
<p>HI 24</p>	<p>Sandstone kerbing along the southern edge of Ferdinand St. just before it meets with The Terrace.</p> <p>They mark the western entrance to the Park but have only been laid here in recent times. However, the blocks appear old and may have been relocated from elsewhere in the area.</p>	<p><b>Rating:</b> 2</p> <p><b>Role:</b> These kerb stones, are minor contributory elements but warrant retention.</p>

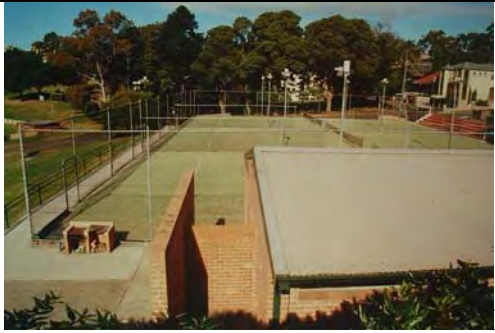
<p>HI 25</p>	<p>The oldest of the Park's tennis courts, built adjacent to the corner of Rose and Ferdinand Streets. Although their configuration has been changed around, they have existed at this site since about 1902. They are currently leased out to the North Western Tennis Association.</p>	<p><b>Rating:</b> 3</p> <p><b>Role:</b> These courts have both social and historical significance, having been continuously used for tennis in the same location for a century. The original timber clubhouse was replaced in the 1970s.</p>

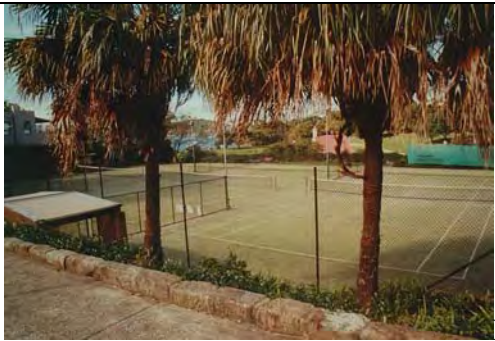
<p>HI 26</p>	<p>These courts were not constructed until 1970, but occupy land set aside for the Park in 1881.</p>	<p><b>Rating:</b> 2</p> <p><b>Role:</b> These courts have a little degree of social significance and enjoy fine views out to the Bay</p>

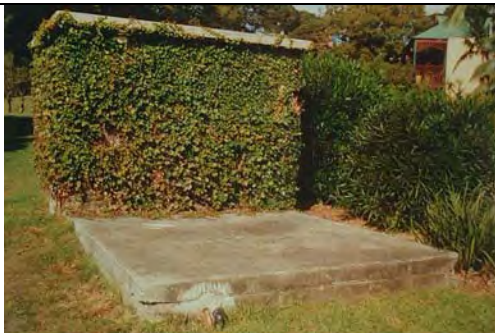
<p>HI 27</p>	<p>The concrete irrigation control shed, located on the eastern edge of southern arm of The Terrace. It appears to have been built in the late 1960s, though this has yet to be confirmed.</p>	<p><b>Rating:</b> Intrusive</p> <p><b>Role:</b> This structure serves a functional need of the Park but should be more sympathetically designed and located in a less visually sensitive location or cut into the slope so it would be partly underground.</p>

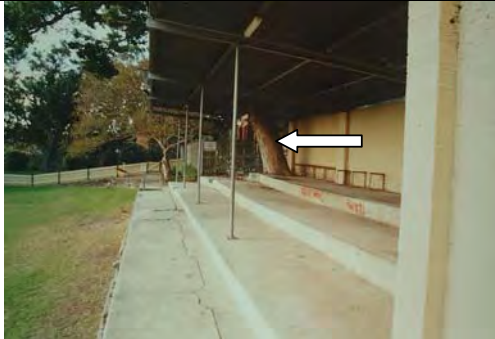
<p>HI 28</p>	<p>This crude pavilion &amp; change room was built at the eastern side of the tennis pavilion probably in the 1940s. It replaced the early timber change room for referees, and was also used as a shelter for people waiting for the ferry. It engulfs a Camphor Laurel tree (arrowed), probably planted in the 1920s. As a pavilion, it is poorly oriented, facing due north.</p>	<p><b>Rating:</b> 1</p> <p><b>Role:</b> This ugly structure, fortunately tucked into a corner, is not highly intrusive but has no heritage significance.</p> <p>It would be better demolished and if considered necessary, a new, sympathetically designed pavilion located in a more appropriate position.</p>

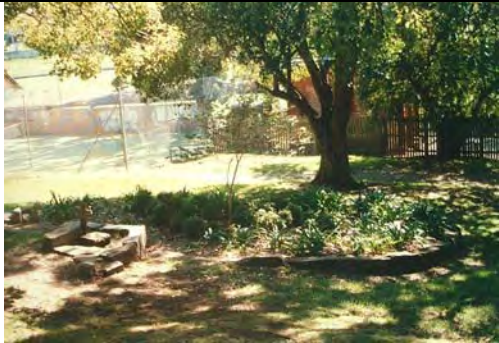
<p>HI 29</p>	<p>A small sandstone-edged garden feature near the south-east entry to the park, with the tennis court beyond.</p> <p>It contains the remains of a site laid out in 1977 as a Children's Building Playground (see also item HI 3). It contained a wattle and daub hut, and was planted with bamboo since removed.</p>	<p><b>Rating:</b> 1</p> <p><b>Role:</b> This feature is now irrelevant and uncharacteristic, and makes little contribution to the use or enjoyment of the Park.</p>

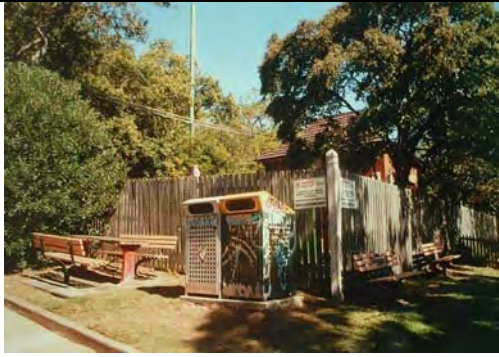
<p>HI 30</p>	<p>Picnic tables, chairs and rubbish bins located in a left-over space of the Park adjacent to Deloitte Ave. These are aesthetically unattractive, poorly located, and the tables in a rusted, decaying condition.</p>	<p><b>Rating:</b> 1</p> <p><b>Role:</b> These functional items, although not intrusive, have negligible aesthetic or social value</p>

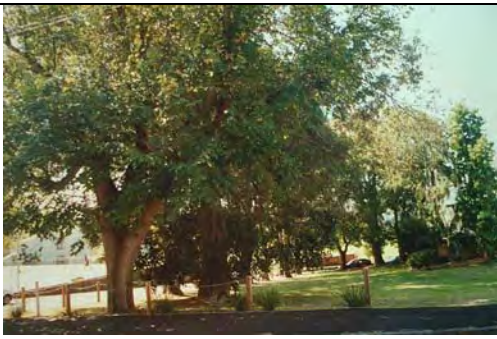
<p>T1</p>	<p>Trees around the northern boundary of the 'pocket park' on the southern side of the corner of Rose and Ferdinand Streets. These trees appear semi-mature in the 1930 aerial photo and may have been planted in the 1920s. The tree on the left is an Elm and to its right a <i>Ficus obliqua</i>. The rest are Brush Box.</p>	<p><b>Ranking:</b> 3</p> <p><b>Role:</b> Contributory items that help define the entry to the Park as well as the perimeter of this subsidiary open space. They also screen built items and help channel the view to the Harbour.</p>

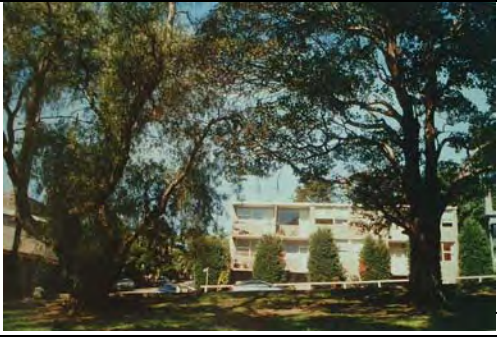
<p>T2</p>	<p>Mature trees including Camphor Laurels, Brush Box and Pepper Trees on the corner of Rose Street and Grove St., most of which appear semi-mature in the 1930 aerial photograph. They were probably planted in the period 1910 – 1920s.</p>	<p><b>Ranking:</b> 3</p> <p><b>Role:</b> Contributory items that define the south-west boundary of the Park and provide amenity to this corner of it. They also ameliorate the impact of surrounding built form beyond it.</p>

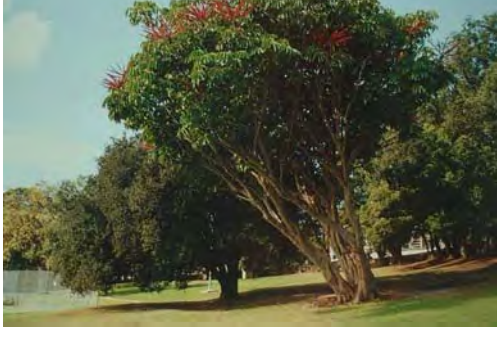
<p>T3</p>	<p>Multi-trunked Queensland Umbrella tree (<i>Brassaia actinophylla</i>) (at right, and Holm Oak (<i>Quercus ilex</i>) at centre, two of the early plantings (c. 1910-25) in the Park, already visible as semi-mature in the 1930 aerial photograph.</p>	<p><b>Ranking:</b> 3</p> <p><b>Role:</b> Contributory items of historical and aesthetic value that provide amenity and visual softening to this otherwise plain precinct of the Park.</p>

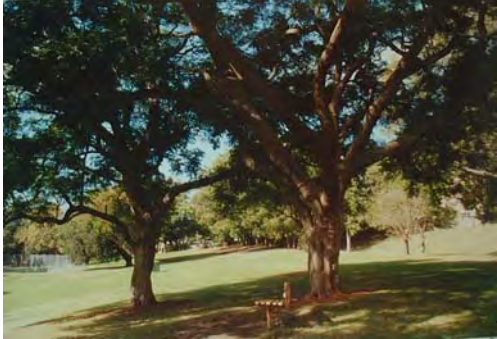
<p>T4</p>	<p>Two mature Jacaranda trees (<i>Jacaranda mimosaeifolia</i>) on the south-west slopes of the Park, which appear to have been planted in the period 1930-1950.</p>	<p><b>Ranking:</b> 2</p> <p><b>Role:</b> Items of modest historical and aesthetic value that have contributed to the amenity and visual quality of the south-west slopes of the Park for over half a century.</p>

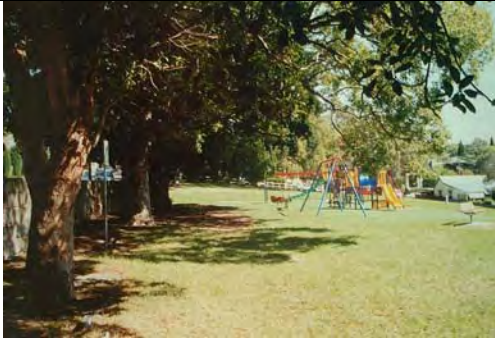
<p>T5</p>	<p>Mature trees along the Grove St park boundary, including Brush Box and Ficus species. Most of these appear to be young to semi-mature in a 1930 aerial photograph.</p>	<p><b>Rating: 3</b></p> <p><b>Role:</b> Contributory items helping to define the southern boundary of the Park and providing some amenity and sense of enclosure, as well as some screening of built items along Grove St.</p>

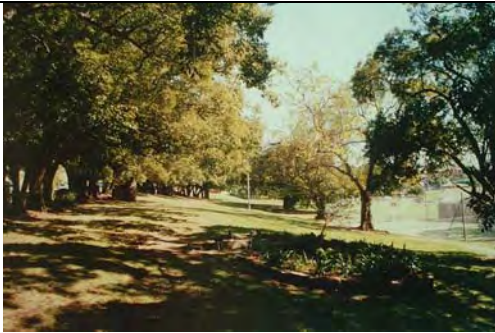
<p>T6</p>	<p>Camphor Laurels (left) and a Coral Tree between the tennis court and Grove Street. All these plantings appear as semi-mature or mature in a 1930 aerial photograph of the site, and may be plantings from c.1910. One senescent Camphor Laurel &amp; the Coral tree are damaged &amp; will soon be removed.</p>	<p><b>Rating: 3</b></p> <p><b>Role:</b> Contributory items helping to define the southern boundary of the Park and providing some amenity and screening of built items along Grove St.</p>

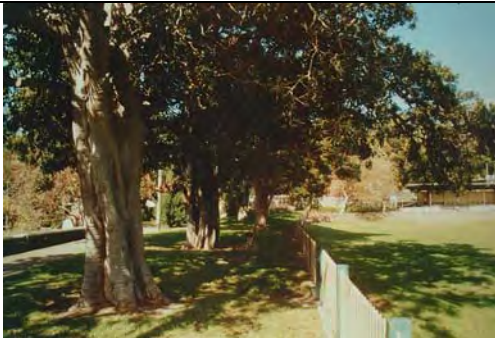
<p>T7</p>	<p>This line of seven Fig Trees along the western side of the southern half of Deloitte Avenue was planted in the 1920s, and the one Brush Box was interplanted slightly later, as an infill for a failed Fig.</p>	<p><b>Rating: 3</b></p> <p><b>Role:</b> Contributory items helping to define the eastern boundary of the Park and providing some amenity and framing of views to the Harbour from the western slopes of the Park.</p>

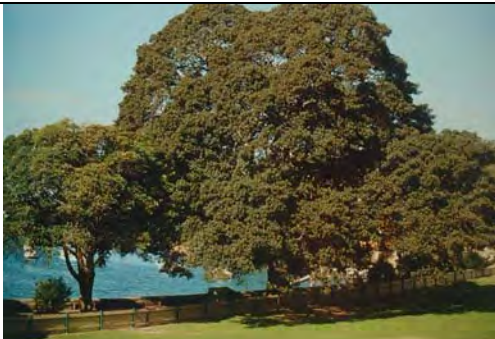
<p>T8</p>	<p>The large old Fig Tree, flanked by later Brush Box plantings, at the northern end of the eastern boundary of the Park, outside the picket fence and adjacent to Deloitte Ave. This Fig appears as semi-mature in the 1930 aerial photo, but not in images of the Park grounds before 1910. It was probably planted about then.</p>	<p><b>Rating: 3</b></p> <p><b>Role:</b> The oldest and grandest contributory item to the eastern boundary of the Park, it frames views to the Harbour from the western slopes of the Park. It also provides welcome shade and amenity.</p>

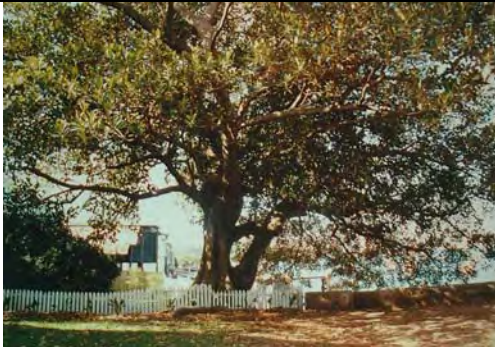
<p>T9</p>	<p>One of the oldest Fig trees at the northern corner of Snails Bay, it actually lies within private property, on the eastern side of Deloitte Ave.</p>	<p><b>Rating:</b> Not directly applicable, since it lies outside the Park.</p> <p><b>Role:</b> This tree, together with that described above, makes a major visual contribution to the setting and sense of enclosure to the Park.</p>

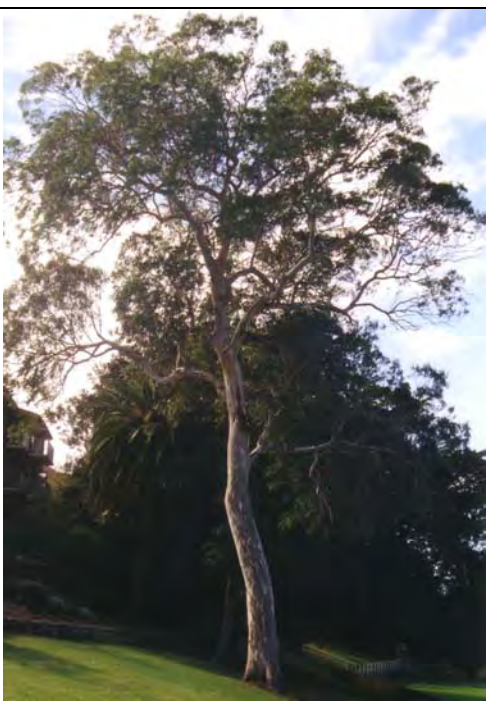
<p>T10</p>	<p>A good specimen of Forest Red Gum (<i>Eucalyptus tereticornis</i>) probably planted c. 1970. Although of good form and mature, it is not endemic to the area and is not a remnant or regenerated species of the original open forest.</p>	<p><b>Rating:</b> 2</p> <p><b>Role:</b> This attractive, clean-trunked tree is a welcome addition to the north-west upper slopes of the Park from which earlier mature trees have been removed over the last few decades.</p>

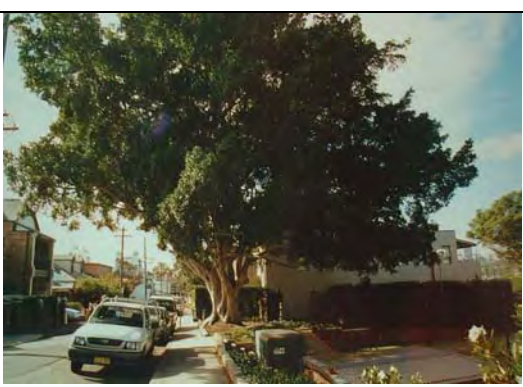
<p>T11</p>	<p>This Hills Fig (<i>Ficus Hillii</i>) lies just inside the grounds of the Park near the upper tennis courts.</p> <p>It does not appear to have been part of any deliberate street tree or park planting.</p>	<p><b>Rating:</b> 3</p> <p><b>Role:</b> From its size (canopy and trunk) and location, this tree appears old enough to have been a planting associated more with former <i>Birch Grove House</i> than the Park.</p>

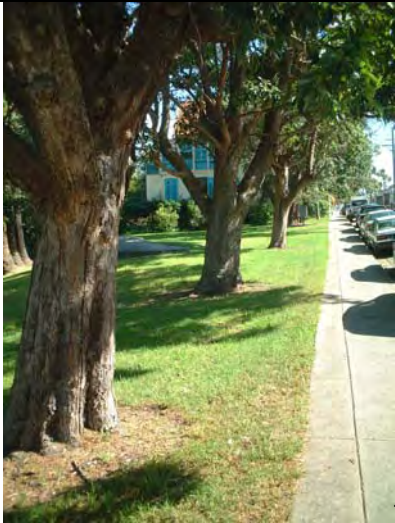
<p>T12</p>	<p>Five mature Brush Box trees along Louisa road, on the northern boundary of the Park.</p> <p>From aerial photos, it appears these trees were planted here in the 1920s.</p>	<p><b>Rating: 3</b></p> <p><b>Role:</b> These trees define the north-east edge of the Park, helping to provide a sense of enclosure and to soften and partly screen the built forms across Louisa Road.</p> <p>They also provide shade and amenity to this oddment of space.</p>

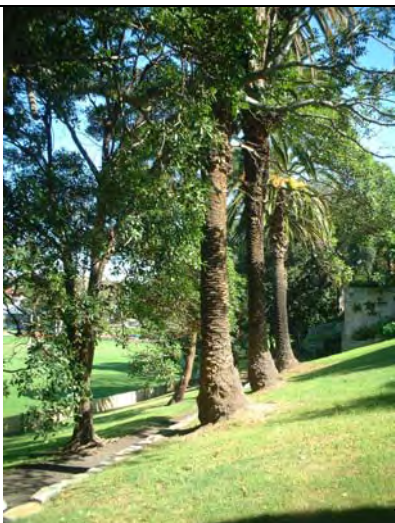
<p>T13</p>	<p>A short row of mature Phoenix palms abutting the pathway from the Louisa Street entry to the park.</p> <p>It seems likely these are some of the trees planted at the instigation of Q. L. Deloitte and A. Fitzhardinge in the 1920s.</p>	<p><b>Rating: 3</b></p> <p><b>Role:</b> These Palms were planted to flank the pathway down from Louisa Road into the north-west sector of the Park. They were favourite plantings of the period 1910-1930.</p>

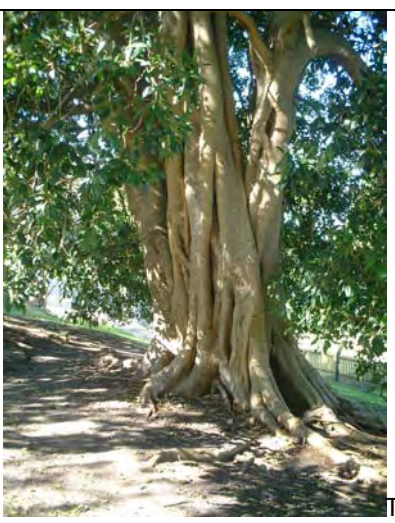
<p>T14</p>	<p>A very old Fig (<i>Ficus obliqua</i>) abutting the pathway from the Louisa Street entry to the park. From its girth, it appears to be one of the oldest Figs in the Park,</p>	<p><b>Rating: 4</b></p> <p><b>Role:</b> This Fig is possibly associated with the grounds of former <i>Birch Grove House</i>, and appears to date from the 19<sup>th</sup> century.</p>

However, when the 19<sup>th</sup> century Fig Tree plantings along the northern boundary fail and have to be removed, difficult decisions will arise. If fungal agents are proven to be present, then the choice is either to excavate and remove all the infected soil (very difficult in this rock-benched location) or to replace them with a different species which is immune to the particular fungus. However, not enough research has yet been done to be certain which such species are. A complicating factor is that the soil at this location is in continual shade, caused partly by the overhanging rock benches, retaining walls and tall buildings along Louisa Road, and partly by the density of the present tree canopies. Being on a south-facing slope anyway exacerbates the problem.

Even if fungal infection is not present, or can be dealt with by soil replacement or remediation, consideration could be given to replacing them with smaller growing Figs, such as Sandpaper Fig (*Ficus fraseri*) or Rock Fig (*F. platypoda*). This is because the height of the canopy of the present over-mature Figs is such as to interfere with views to the Harbour and City from houses along the south side of Louisa Road. Given the high dollar value of such views, the removal of the tall existing trees would be welcomed by some house owners, but their replacement with the same species – with the future prospect of a return to view impairment – would not. Covert means of ensuring that they did not reach that stage cannot be excluded.

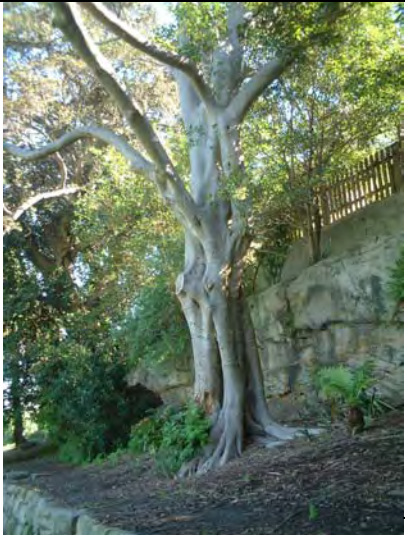
<p>T15</p>	<p>One of several very old Figs growing on the slopes to the north of the sports oval. These Figs appear in photos of <i>Birch Grove House</i> from the late 1800s.</p>	<p><b>Rating: 4</b></p> <p><b>Role:</b> This Fig (<i>Ficus Hillii</i>) is associated with the grounds of former <i>Birch Grove House</i>, and appears to date from the 19<sup>th</sup> century. It is in poor condition, though appears to be recovering somewhat.</p>

Pruning and removal of dead branches should be done in the cooler months, and insect and fungal infestations dealt with appropriately as soon as signs of attack appear. The Hills Figs are susceptible to attack from the *Phellinus* species (a white rot fungus), and *Armillaria inteobubalina*, which resides in the soil and causes root rot. *Phytophthora cinnamomi* can also be present. It is understood that a few of the Hills Figs have been attacked by one of these fungal agents, and as no cure or control has yet been devised, they may have to be removed soon if they are considered to be in danger of toppling over.

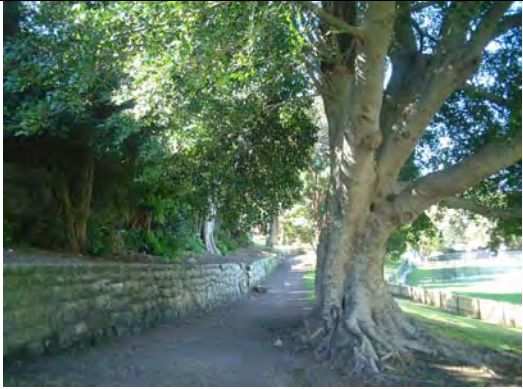
<p>T16</p>	<p>Another Hills Fig along the northern pathway, below the grounds of <i>Birch Grove House</i>.</p>	<p><b>Rating: 4</b></p> <p><b>Role:</b> This Fig (<i>Ficus Hillii</i>) is associated with the grounds of former <i>Birch Grove House</i>, and appears to date from the 19<sup>th</sup> century.</p>

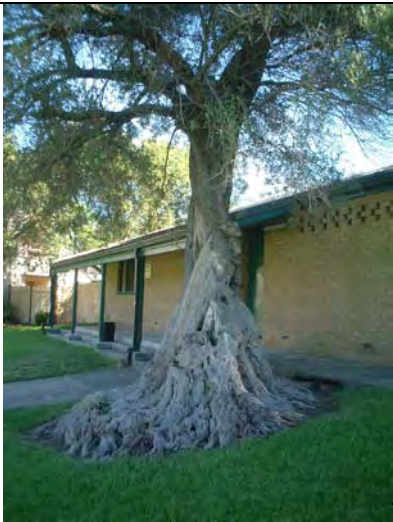
<p>T17</p>	<p>A very old Olive in front of the 1970s toilet block,</p>	<p><b>Rating: 4</b></p> <p><b>Role:</b> This tree is likely to be associated with the early orchard of the <i>Birch Grove estate</i>.</p>

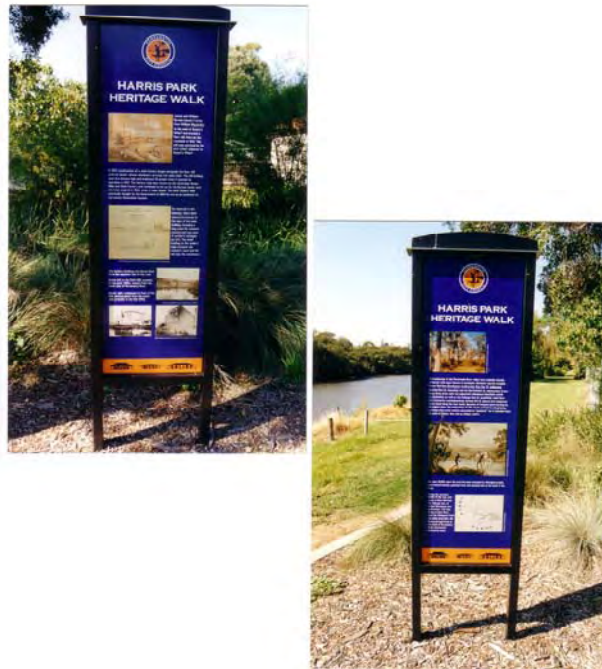
An example of this type of sign, prepared by the present consultant for a landscape heritage walk at Harris Park (near Parramatta) is provided below. These have proved to be very durable and vandal resistant. The colour of the frame and background can be selected to suit the Park. Preparation of such signage, however, would need to be the subject of a future commission.
